Commonwealth Edison
Dresden Nuclear Power Station
R.R. #1
Morris, Illinois 60450
Telephone 815/942-2920

LICENSEE EVENT REPORT (LER)

Dresden Nuclear Power Station, Unit 2/3

Elevated HPCI Discharge Piping Temperature Due to Reactor Feedwater System Back Leakage

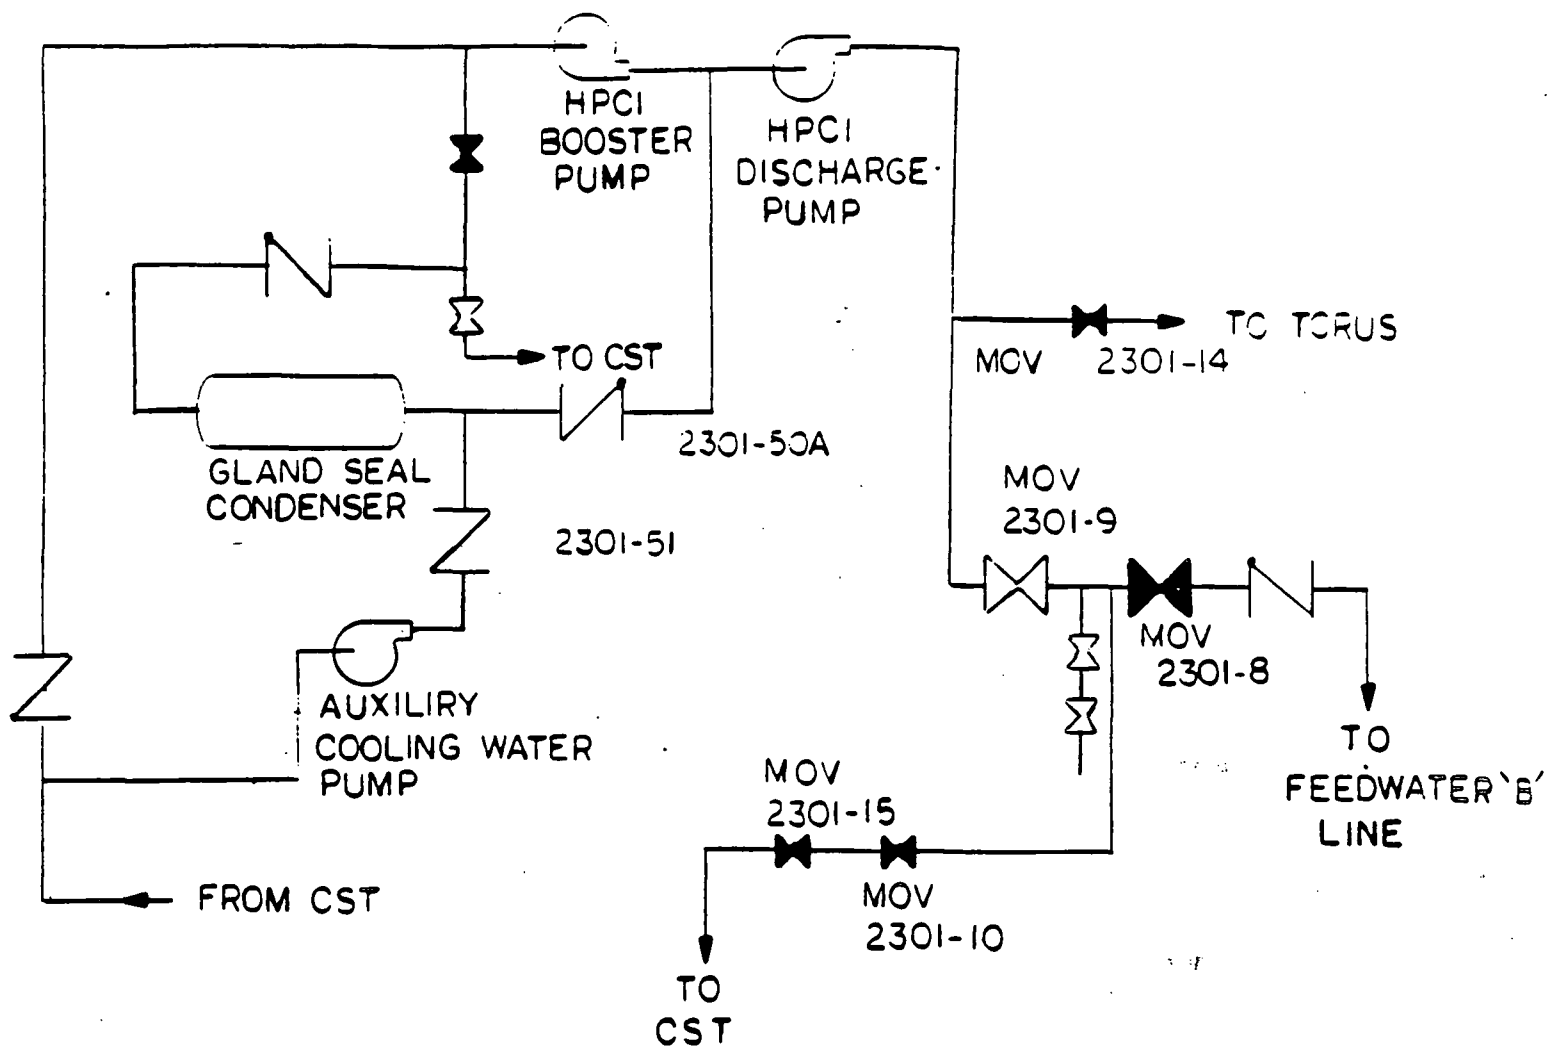
FIGURE 1
Basic HPCI system Drawing

The root cause of the Reactor Feedwater system back leakage into the HPCI discharge piping on both Units 2 and 3 was attributed to leakage past HPCI pump discharge valve MOV 2(3)-2301-8. Additionally, HPCI pump discharge check valve 2(3)-2301-7 also allowed feedwater back leakage into the HPCI system. The HPCI system is configured to inject into the reactor vessel via the "B" Feedwater line. The 2(3)-2301-7 check valve and MOV 2(3)-2301-8 valve are in series and are provided for isolating the feedwater system from the HPCI system. (It should be noted that neither of these valves are primary containment isolation valves.) A review of a MOV 2-2301-8 motor operators current trace characteristic obtained on October 26, 1989, indicates an abnormally high current, which may indicate a bent valve stem. It is presently believed that the Unit 3 MOV 3-2301-8 is experiencing seat leakage due to a worn seat.

As a temporary corrective action to prevent further feedwater back leakage into the HPCI system, the HPCI system standby lineup has been revised. This revision changes valve configurations MOV 2(3)-2301-9 (normally open) in a closed position, and MOV 2(3)-2301-8 (normally closed) in an open position. This revised, off-normal, valve lineup was reviewed in accordance with 10 CFR 50-59 Safety Evaluation Guidelines. The following items were addressed (237-200-89-15901).
