Dresden Nuclear Power Station

LICENSEE EVENT REPORT (LER)

Title (4)
Reactor Building Fire Rated Wall Degraded by an Unauthorized Penetration Opening Due to Management Deficiency

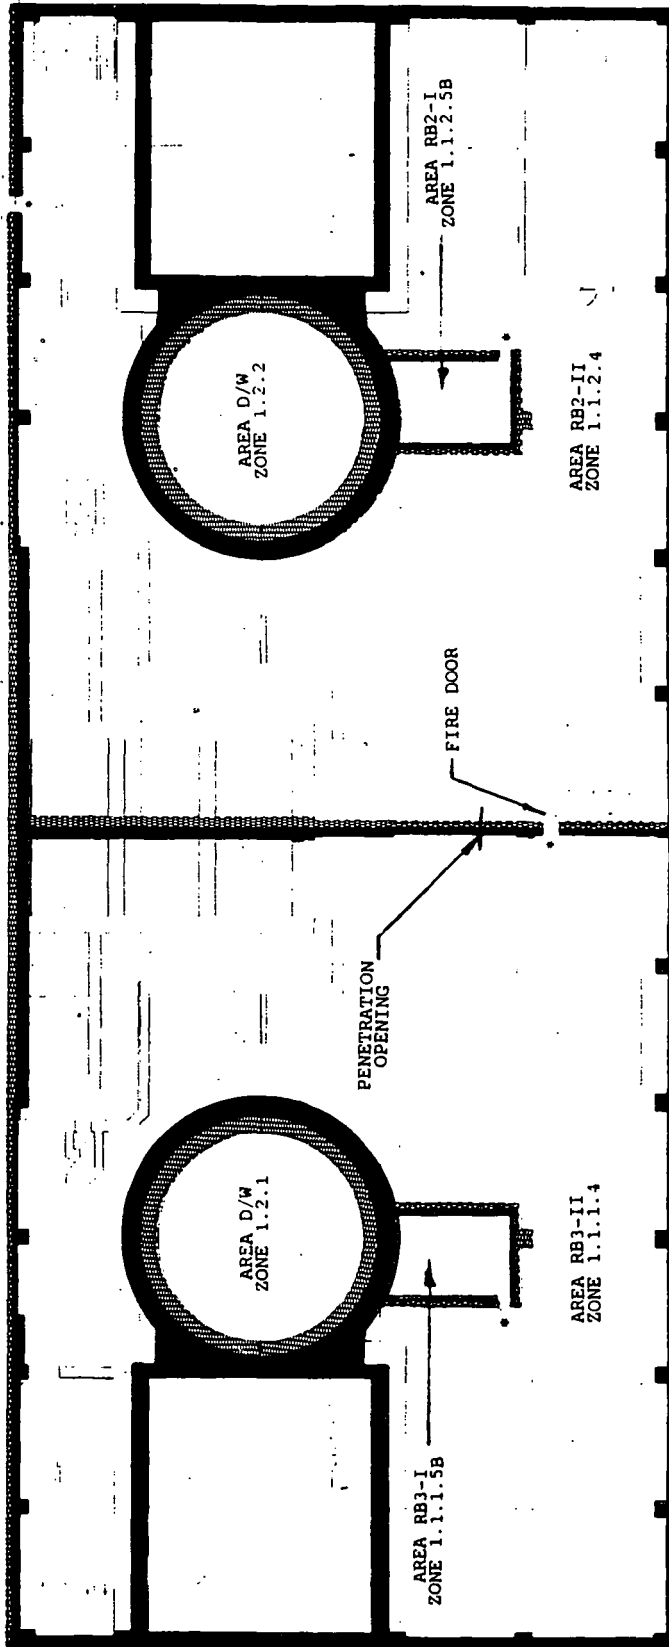
Figure 1

In the event of severe fire in fire area RB2-II (refer to Figure 1), Dresden Safe Shutdown Procedure (DSSP) 100-B1, Hot Shutdown Procedure Path B1, would be used to achieve hot shutdown for Unit 2. Similarly, DSSP 100-A1, Hot Shutdown Procedure Path A1, would be used for a fire in area RB3-II for hot shutdown of Unit 3. Each procedure requires the use of each Unit's Isolation Condenser [BL], the Unit 2/3 Diesel Generator [KK], and the opposite Unit's electrical distribution system. A study of the Safe Shutdown Analysis report revealed that 125 VDC distribution panel 3 [EJ] and 480 V Motor Control Center (MCC) 38 [ED], equipment necessary for hot shutdown of Unit 2, are located directly opposite of the open penetration in Unit 3 fire zone 1.1.1.4 (see Figure 1). Also, 125 VDC Distribution Panel 2 [EJ] and 480 V MCC 28 [ED], are located opposite the penetration in Unit 2 fire zone 1.1.2.4. Thus, it is postulated that the hot shutdown path for each unit could be impaired if a fire were to breach the Reactor Building common wall fire barrier.

The Unit 2 and Unit 3 Reactor Building common wall at floor elevation 570'-0" separates fire zone 1.1.1.4 which is a part of Unit 3 fire area RB3-II and fire zone 1.1.2.4 which is a part of Unit 2 fire area RB2-II. The wall is a minimum 2'-0" thick reinforced concrete and is rated as a three hour fire barrier. The maximum fire loading in either zone is 7460 BTU per square foot which is comprised chiefly of cable insulation located in electrical panels and cable trays. This combustible loading is rather low by comparison to the ASTM E119 Standard Time/Temperature Curve which defines a combustible load of 80,000 BTU per square foot for a one hour fire. The penetration is centered 12 inches off of the floor. The closest fixed combustibles in the vicinity of this opening is cabling in cable trays on either side of the opening located 30 feet away horizontally and 11 feet overhead. Any heat generated from a fire in these trays would be concentrated at the upper elevations which would make propagation of flames or heat through the opening extremely unlikely. The Safe Shutdown electrical distribution panels and MCCs have a minimum spatial separation of approximately 100 feet between units, and the Reactor Building common wall would still provide a substantial fire barrier. Both fire zones are monitored by ionization detection [IC] throughout, and are equipped with various fire water hose reels and hand held fire extinguishers. The detection system alarms both locally and in the control room. Any fire would be promptly detected, and the fire brigade would be quickly dispatched to extinguish the fire. Transient combustibles in the area are minimal, and are administratively controlled by Dresden Administrative Procedure (DAP) 3-3, Control of Transient Combustibles. Additionally, regular housekeeping inspections are performed in accordance with DAP 3-11, Station Material Condition and Housekeeping Program. Therefore, the safety significance of this event is considered to be minimal.

UNIT 2 AND UNIT 3 REACTOR BUILDING PLAN
ELEVATION 570'-0"
