Commonwealth Edison
Dresden Nuclear Power Station
R.R. #1
Morris, Illinois 60450
Telephone 815/942-2920

LICENSEE EVENT REPORT (LER)

Title (4) Primary Containment Group I Isolation and Reactor Scram Due to Procedure Deficiency

Unit 2 Reactor Scram and Primary Containment Group I Isolation Due to a Pressure Transient on the Main Steam Line High Flow Switch Common Header During a Calibration Surveillance Due to a Procedure Deficiency.

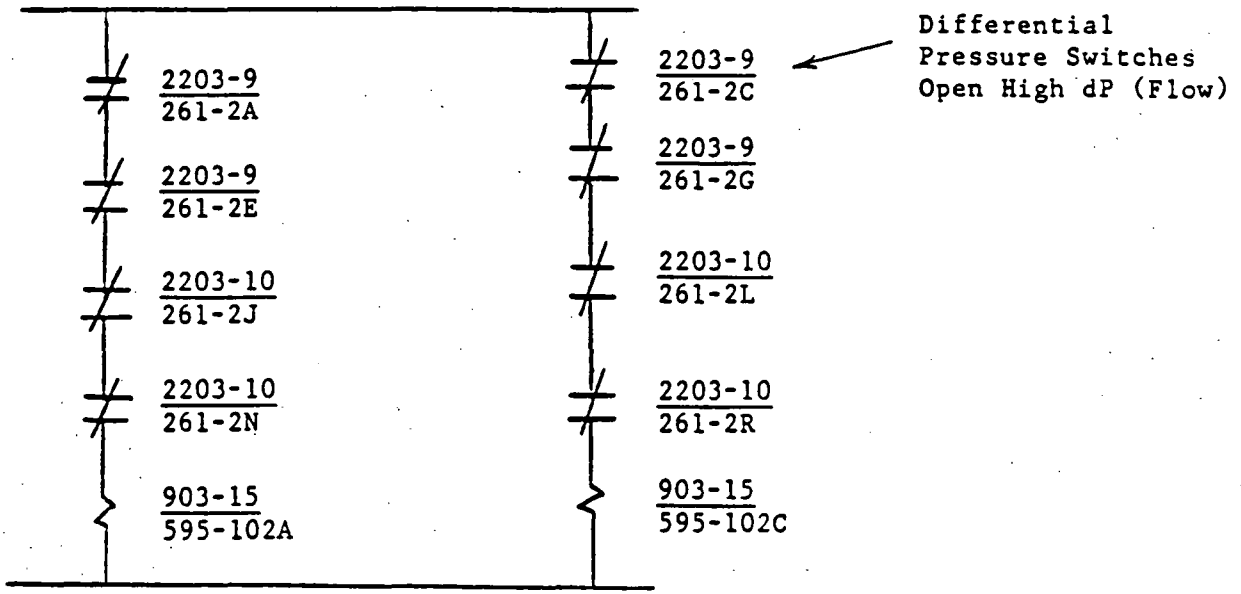
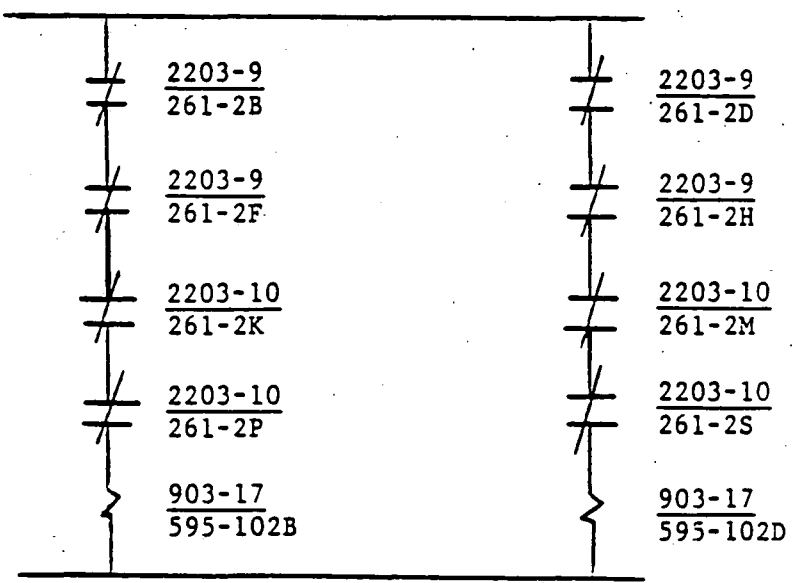
Based on a review of the event and interviews of the personnel involved, the root cause of the event has been determined to be a procedural deficiency within DIS 250-1. This procedure provided inadequate precautionary controls to prevent a potential pressure transient large enough to cause a trip on instruments in both trip channels, located on a common instrument sensing line header. It is believed that a pressure spike was induced into the common sensing line header when the instrument isolation valve was opened. The common instrument header supplies the process pressure which supplies four high flow switches (2-261-2E, -2F, -2G, and -2H). Two of the switches are located on the A Channel and two on the B Channel. (See Figure 1).

The Main Steam Line high flow Group I Isolation logic is arranged in a 1 out of 2 twice logic. There are two safety system channels with each one consisting of two subchannels which contain four differential pressure switches. See Figure 1 for the logic arrangement. In order to initiate a Group I isolation, at least one of the pressure switches must trip in each of the safety system channels. The pressure switches actuate on high differential pressure. Since pressure switch DPIS 2-261-2H was the only switch being calibrated at the time of the scram, a half Group I Isolation occurred as required as part of the surveillance after loading the switch with a high differential pressure. However, because of a high differential pressure between the instrument pressure and the header pressure, a pressure transient in the header occurred while valving the switch back into service. The 16 differential pressure indicating switches utilized in this trip system are divided such that four sets of four switches use a common sensing header. The sensing header for DPIS 2-261-2H is also used by DPISs 2-261-2E, -2F and -2G. Each of these four switches input into a separate subchannel of the logic system as shown on Figure 1. Therefore, the pressure transient that occurred on this sensing header resulted in the actuations of DPIS 2-261-2E and/or DPIS 2-261-2G on the A channel and DPIS 2-261-2F and/or DPIS 2-261-2H on the B channel, which in turn caused a full Group I Isolation. The safety significance of this event was minimal since the pressure switches operated as designed and actuated on high differential pressure, thus initiating the primary containment Group I Isolation and subsequent reactor scram.
