February 15, 1990

LICENSEE EVENT REPORT (LER)

Facility Name (1) Dresden Nuclear Power Station Unit 2										Docket Number (2) 0 15 10 10 10 12 13 17				Page (3) 1 of 1 9				
Title (4) Reactor Scram Following Condensate/Condensate Booster Pump Failure and Subsequent Loss of Offsite Power																		
Event Date (5)			LER Number (6)				Report Date (7)			Other Facilities Involved (8)								
Month	Day	Year	Year	Sequential Number	Revision Number		Month	Day	Year	Facility Names				Docket Number(s)				
0	1	1	6	9	0	9	0	0	0	2	0	0	0	2	1	5	9	0
OPERATING MODE (9)			THIS REPORT IS SUBMITTED PURSUANT TO THE REQUIREMENTS OF 10CFR (Check one or more of the following) (11)															
POWER LEVEL (10) 1 0 0			20.402(b)			20.405(c)			X			50.73(a)(2)(iv)			73.71(b)

Reactor Scram Following Condensate/Condensate Booster Pump Failure and Subsequent Loss of Offsite Power

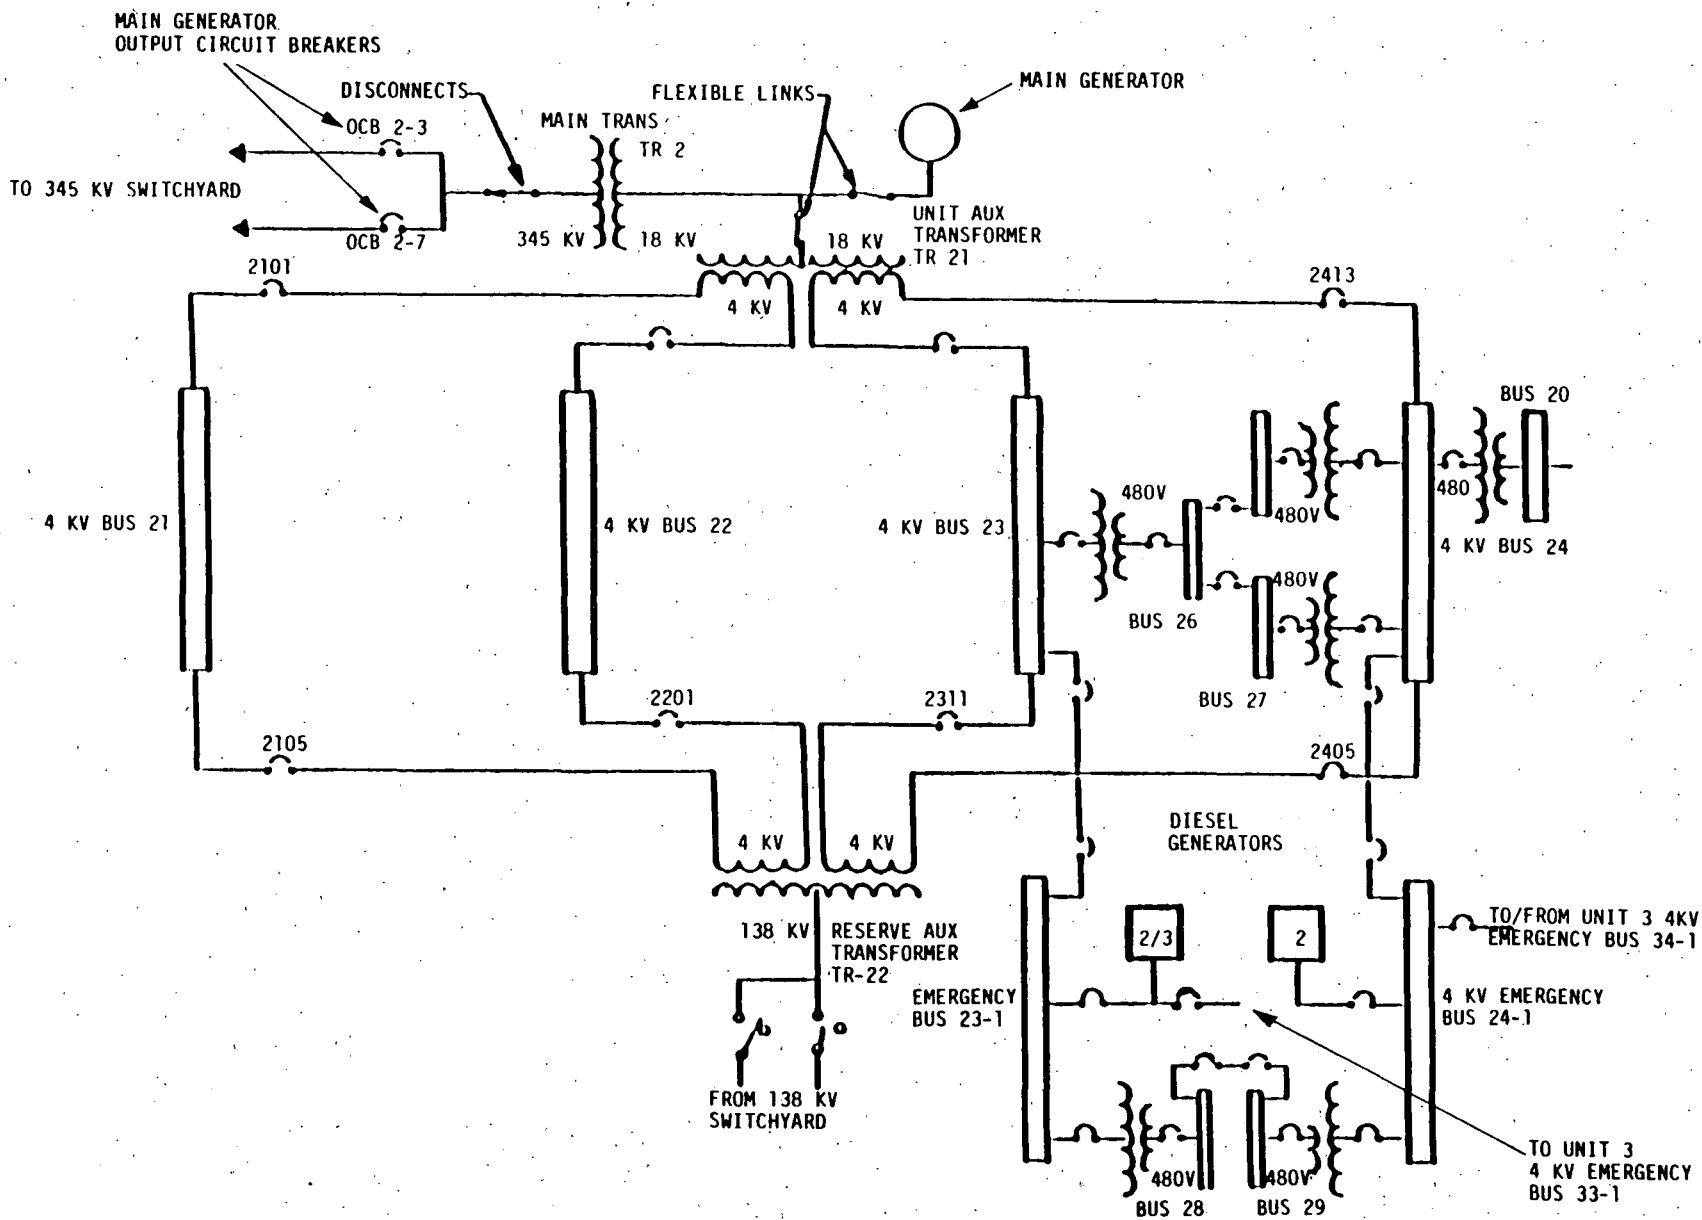
Figure 1

Unit 2 Electrical Distribution.
