SAFETY EVALUATION

DRESDEN NUCLEAR POWER STATION

RECIRCULATION PUMP

COOLING SYSTEM LEAKAGE ALTERATION

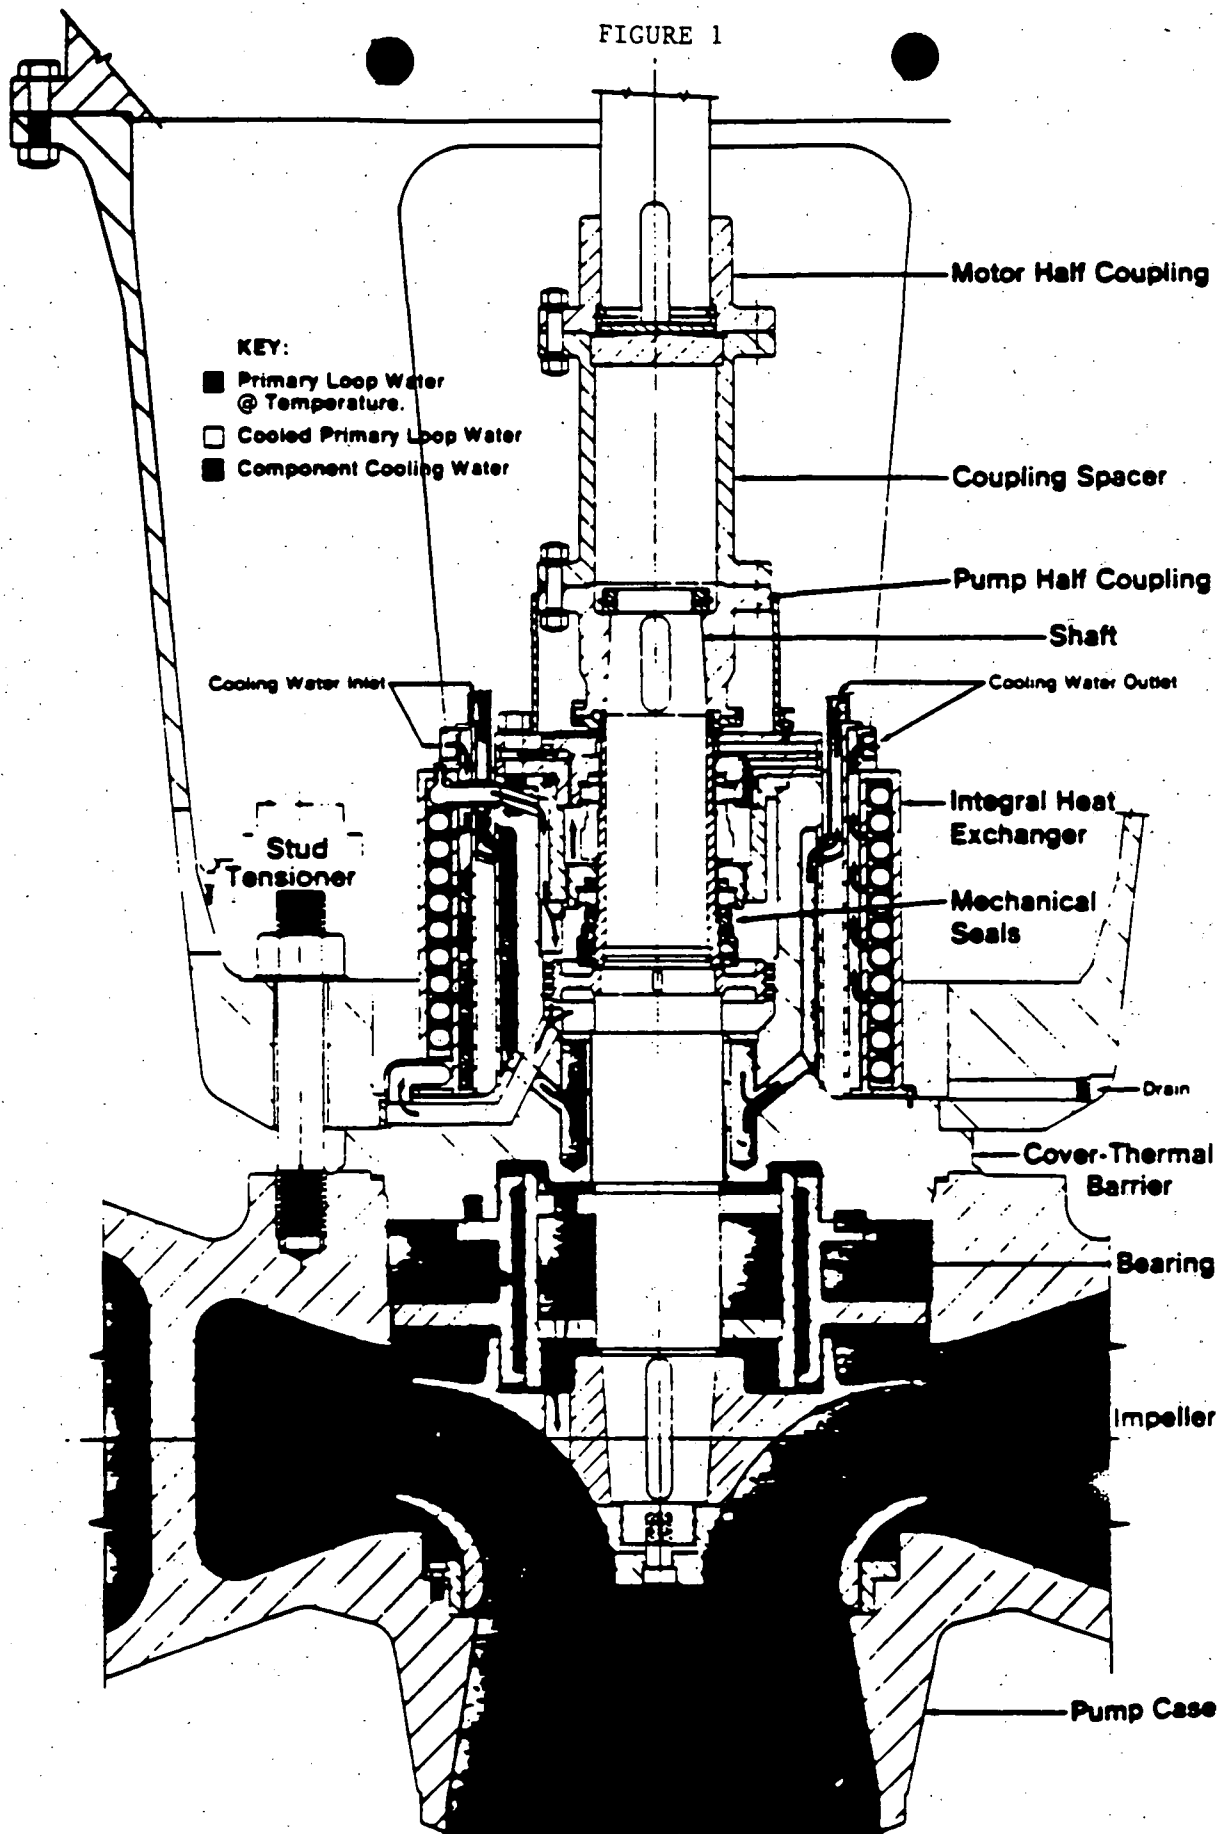
FIGURE 1

The Dresden 3 recirculation pumps are shown pictorially in Figure 1. There are three coolant flows used to maintain the seal cavity at temperatures within the seal design limits:

There are fifteen vertical drilled holes of 1 1/2 inch diameter. The inlet and outlet to the drilled hole passages consist of two 1 1/8 inch diameter holes, one at the inlet and one at the outlet. These 1 1/8 inch holes lead to the water jacket which is formed of plate welded to the outside of the pump cover casting. The pressure rating of the water jacket is 150 psig. The drilled 1 1/2 inch diameter holes, the slanting 1 1/8 inch diameter inlet and exit holes and the water jacket can be seen in Figure 1.

The construction of the cover casting results in a ligament thickness of approximately 0.30 inches between the vertical drilled holes and the cover bore, however the minimum ligament thickness only occurs at the points of tangency. The geometry would allow axial cracking as has been observed in some pump inspections but does not favor fragmentation.
