# SAFETY EVALUATION

## DRESDEN NUCLEAR POWER STATION

### RECIRCULATION PUMP

### COOLING SYSTEM LEAKAGE ALTERATION

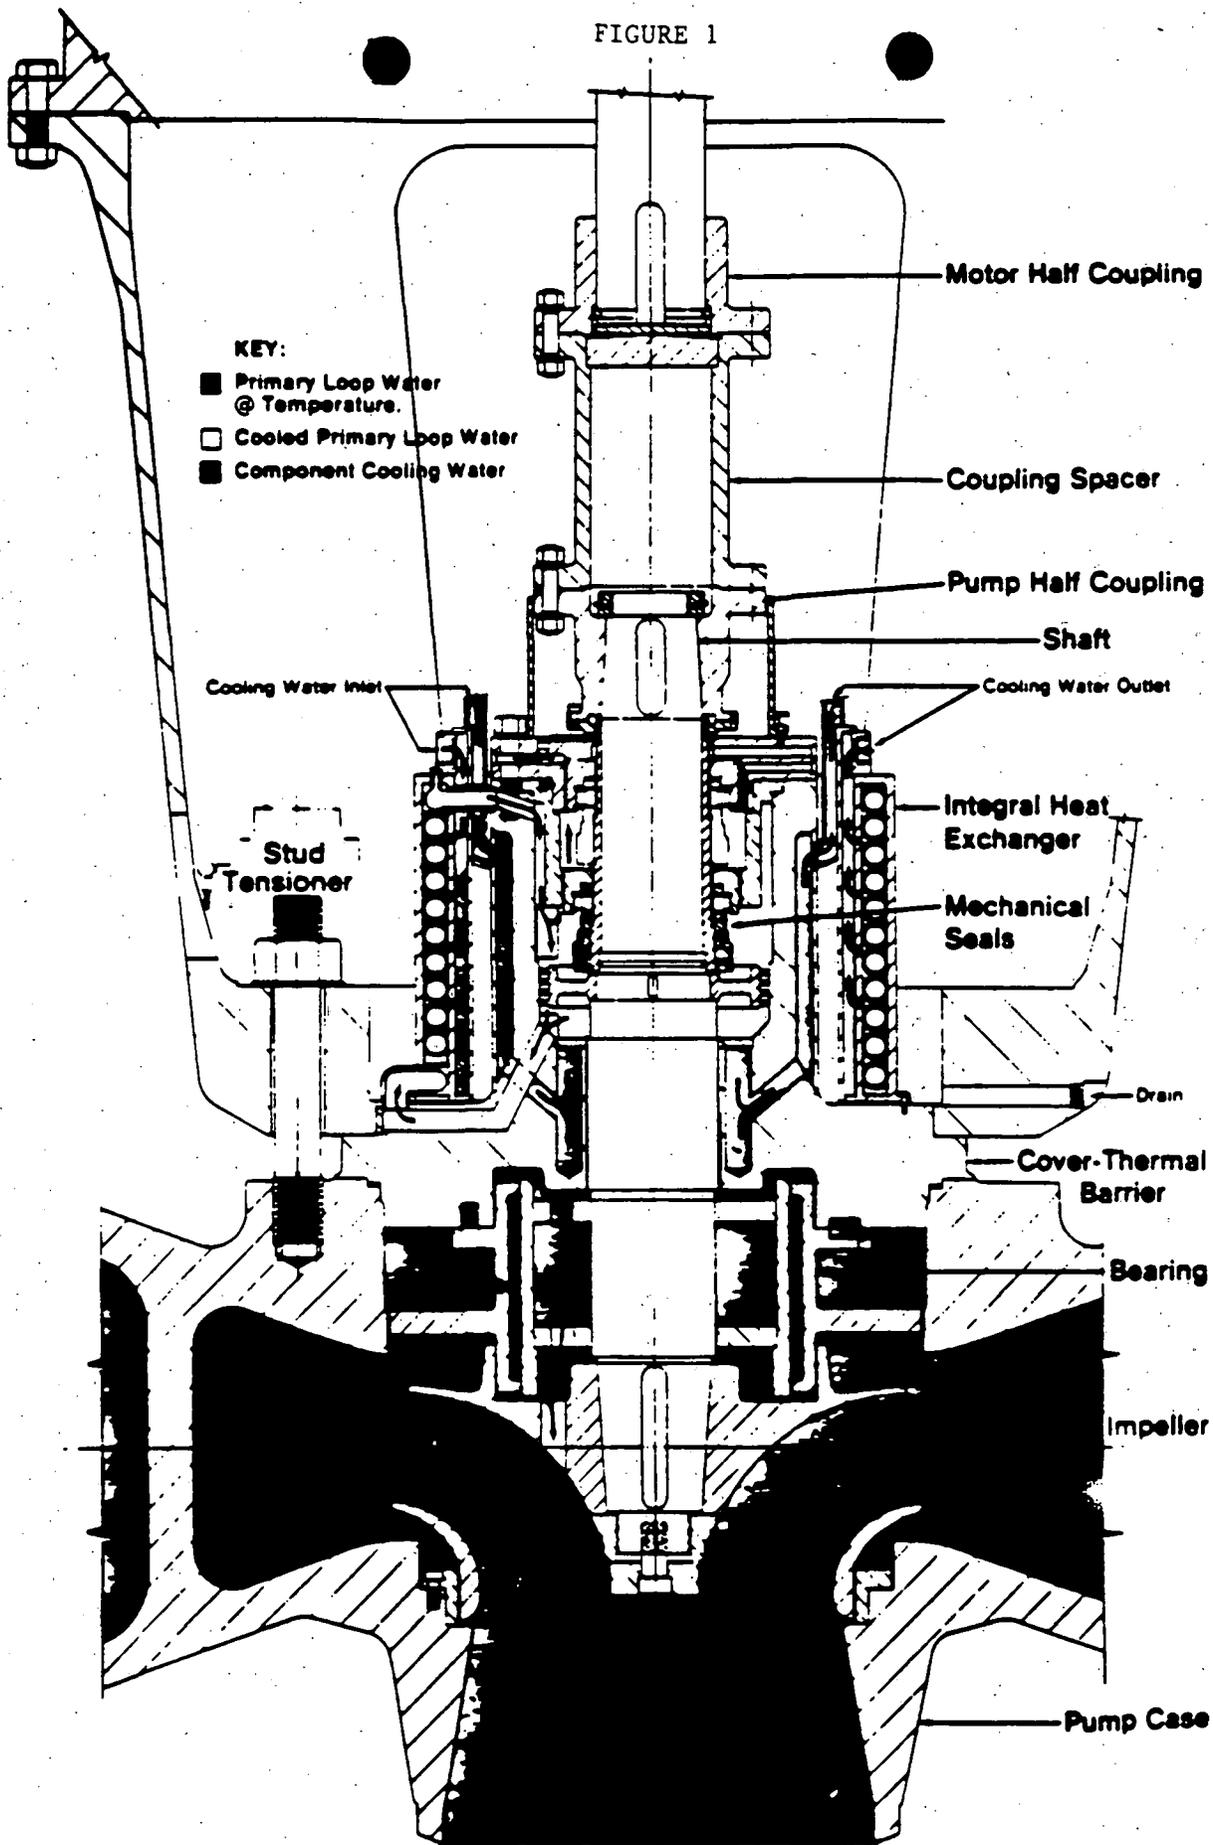
FIGURE 1

The Dresden 3 recirculation pumps are shown pictorially in Figure 1. There are three coolant flows used to maintain the seal cavity at temperatures within the seal design limits:

There are fifteen vertical drilled holes of 1 1/2 inch diameter. The inlet and outlet to the drilled hole passages consist of two 1 1/8 inch diameter holes, one at the inlet and one at the outlet. These 1 1/8 inch holes lead to the water jacket which is formed of plate welded to the outside of the pump cover casting. The pressure rating of the water jacket is 150 psig. The drilled 1 1/2 inch diameter holes, the slanting 1 1/8 inch diameter inlet and exit holes and the water jacket can be seen in Figure 1.

The construction of the cover casting results in a ligament thickness of approximately 0.30 inches between the vertical drilled holes and the cover bore, however the minimum ligament thickness only occurs at the points of tangency. The geometry would allow axial cracking as has been observed in some pump inspections but does not favor fragmentation.
