EDE LTR #90-566

LICENSEE EVENT REPORT (LER)

Facility Name (1) Dresden Nuclear Power Station, Unit 2 Docket Number (2) 0 15 10 10 10 12 13 17 Page (3) 1 of 0 9

Title (4) Target Rock Safety-Relief Valve Fails Open Due to a Steam Cut Pilot Valve Disc

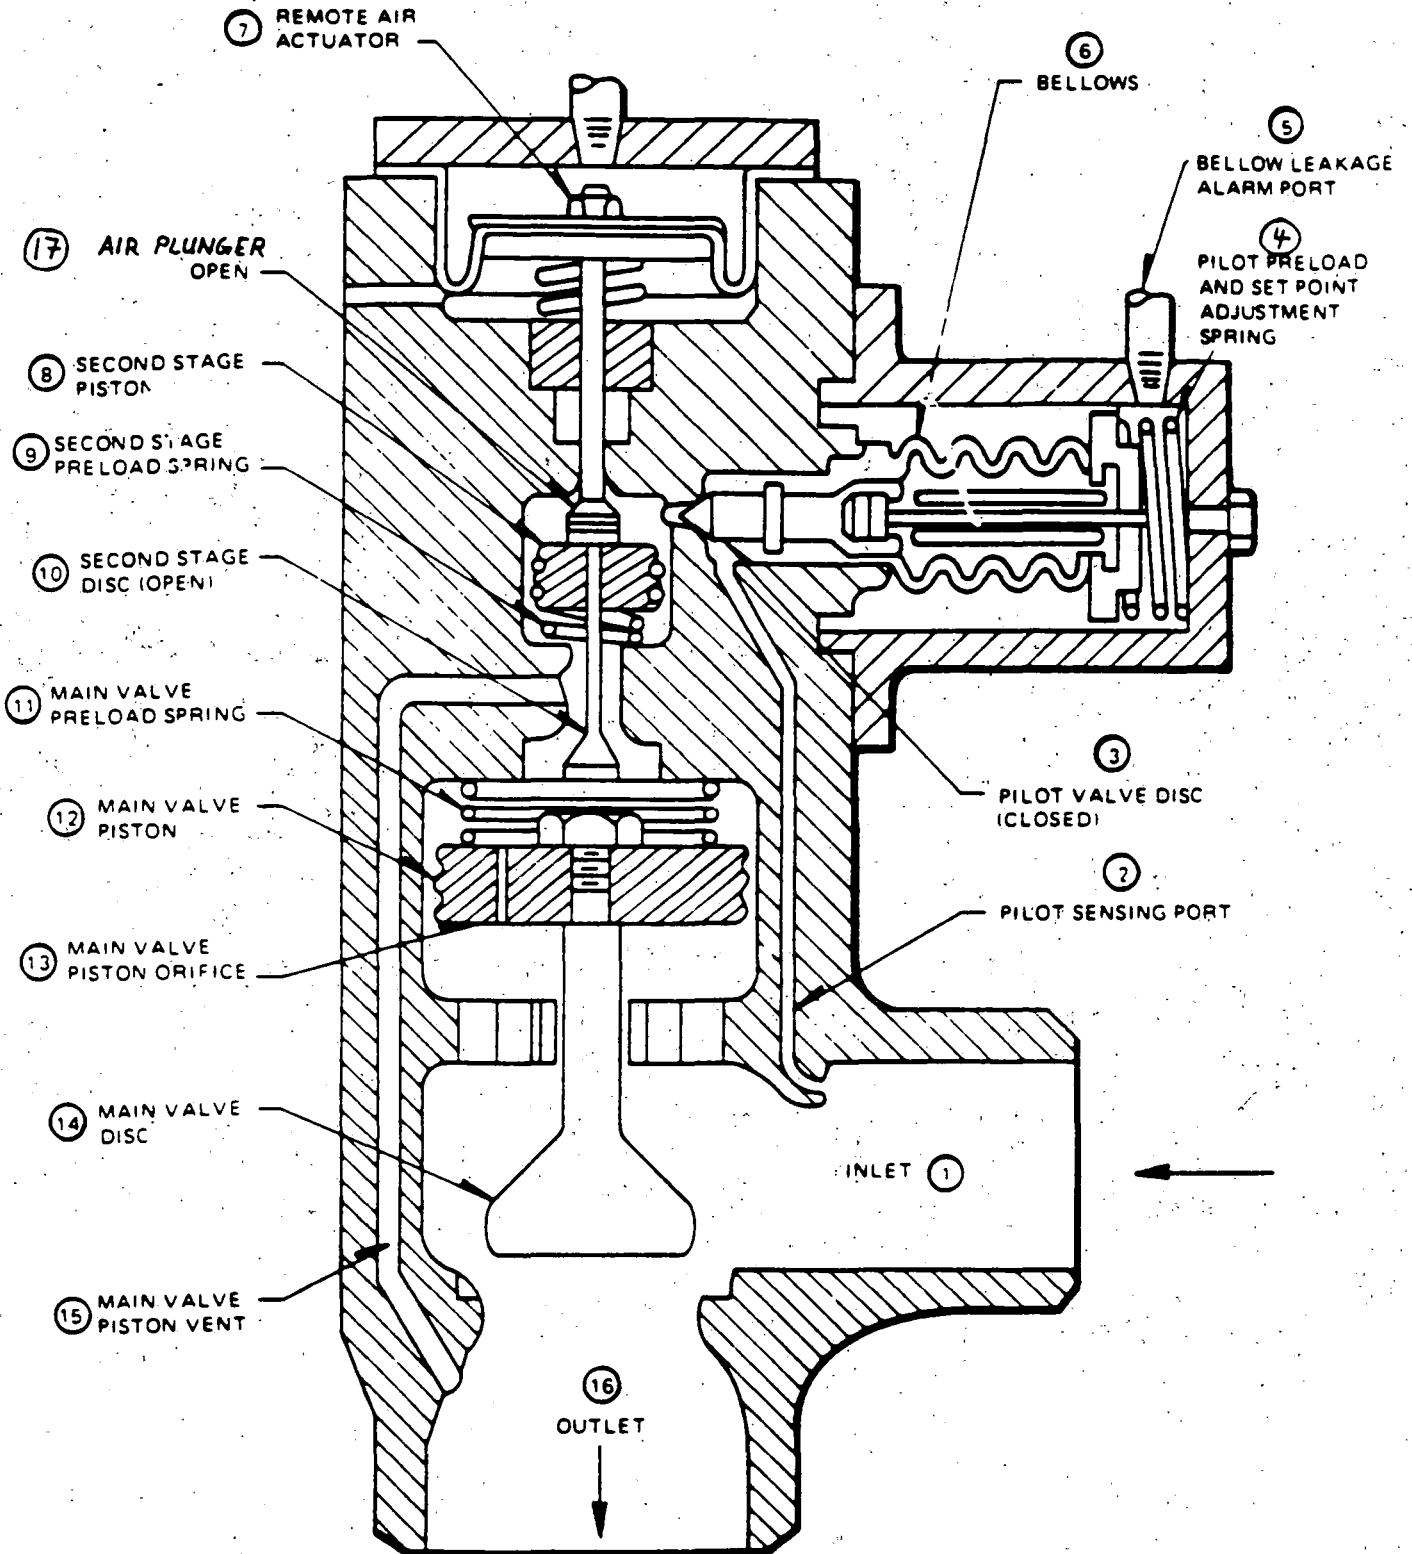
FIGURE 1

Self actuation occurs as follows (refer to Figure 1): Pressure is sensed at the pilot sensing port (2). The bellows (6) expands at a pressure setpoint of 1135 psig. This moves the pilot valve disc (3) allowing pressure to be transferred to the second stage piston (8). The second stage (8) is forced down moving the second stage disc (10) away from its seat. This permits the pressure from the top of the main valve piston (12) to be vented via the second stage disc (10) and out the main valve piston vent (15). A differential pressure is created across the main valve piston (12) due to the small size of the main valve piston orifice (13) as compared to the main valve piston vent (15). Reactor pressure then lifts the main valve piston (12) and the main valve disc (14). The final result is that reactor steam is directed through the discharge line to the suppression chamber. When steam pressure is approximately 50 psig below the setpoint pressure of 1135 psig, the pilot preload and setpoint adjustment spring (4) forces the pilot valve (3) closed. The second stage disc (10) then closes equalizing the pressure across the main valve piston (12). Spring force from the main valve preload spring (11) closes the main valve disc (14). If the bellows (6) ruptures, a pressure switch (5) results in an alarm in the Control Room on the 902-4 panel (annunciator D-23, TRSRV Inoperable) at 25 psig. This indicates that the self actuation mode of the TRSRV is inoperable.

The apparent cause of the failure of the TRSRV was the severely steam cut pilot valve disc (refer to Figure 1). Excessive steam leakage through the pilot sensing port (2) and past the pilot valve (3) via the severe steam cuts allowed pressure to be transferred to the second stage piston (8). The second stage piston (8) was forced down, moving the second stage disc (10) away from its seat. This permitted pressure from the top of the main valve piston (12) to be vented via the second stage disc (10) and out the main valve piston vent (15). This created a differential pressure across the main valve piston (12). Reactor pressure then lifted the main valve piston (12) and main valve disc (14), thus, opening the valve. When reactor pressure reached approximately 100 psig, the main valve preload spring (11) force overcame the reactor pressure force and the main valve disc (14) subsequently closed. The root cause for the steam cuts on the pilot disc is an inherent design deficiency.

TARGET ROCK SAFETY - RELIEF VALVE (external actuation)

5. A satisfactorily leak tested, rebuilt TRSRV was installed per WR 90929 (237-200-07505).

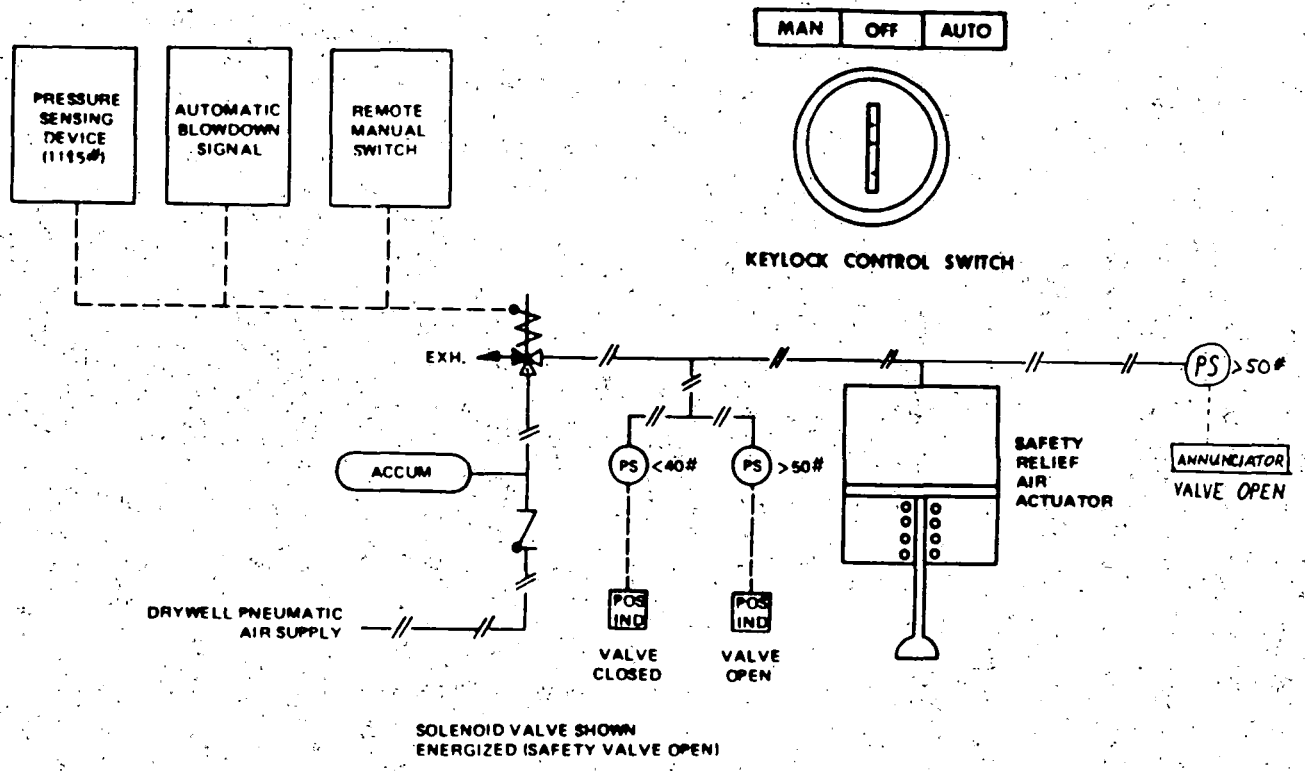
FIGURE 2

The TRSRV valve controls are shown in Figure 2. The control switch is a three-position, key operated switch. The three positions are "MANUAL", "OFF" and "AUTO". In the "MANUAL" position, the solenoid is always energized. In the "OFF" position, the solenoid only energizes from an automatic depressurization signal; it does not energize from a relief signal sent from the controller. In the "AUTO" position, the solenoid energizes from either an automatic depressurization signal or a relief signal sent from the Controller. The accumulator-check valve arrangement stores sufficient nitrogen to operate the TRSRV in the event of a loss of drywell pneumatic air (nitrogen). The pressure switches act as position indicators in the following manner: At less than 40 psig, the TRSRV indicates "Closed". At greater than 50 psig, the TRSRV indicates "Open". At greater than 50 psig, a Control Room annunciator also indicates valve actuation. Also, an acoustic monitor in the drywell monitors the TRSRV discharge piping and alarms in the Control Room when there is pipe vibration due to steam flow.

The TRSRV indicator on the front panel showed a closed position due to the position indicators receiving their signals from the pressure switches on the drywell pneumatic air line between the solenoid and the TRSRV. The indicator/pressure switches performed satisfactorily since the TRSRV air operator was not actuated when the TRSRV opened. The air operator was not responsible for the valve failure.

TARGET ROCK SAFETY - RELIEF CONTROLS
