Commonwealth Edison  
Dresden Nuclear Power Station  
R.R. #1  
Morris, Illinois 60450  
Telephone 815/942-2920

## LICENSEE EVENT REPORT (LER)

Facility Name (1) Dresden Nuclear Power Station, Unit 2										Docket Number (2) 0 15 10 10 10 12 13 17				Page (3) 1 of 0 5			
Title (4) Leakage Path Discovered During Primary Containment ILRT Due to Management Deficiency

Leakage Path Discovered During Primary Containment ILRT Due to Management Deficiency

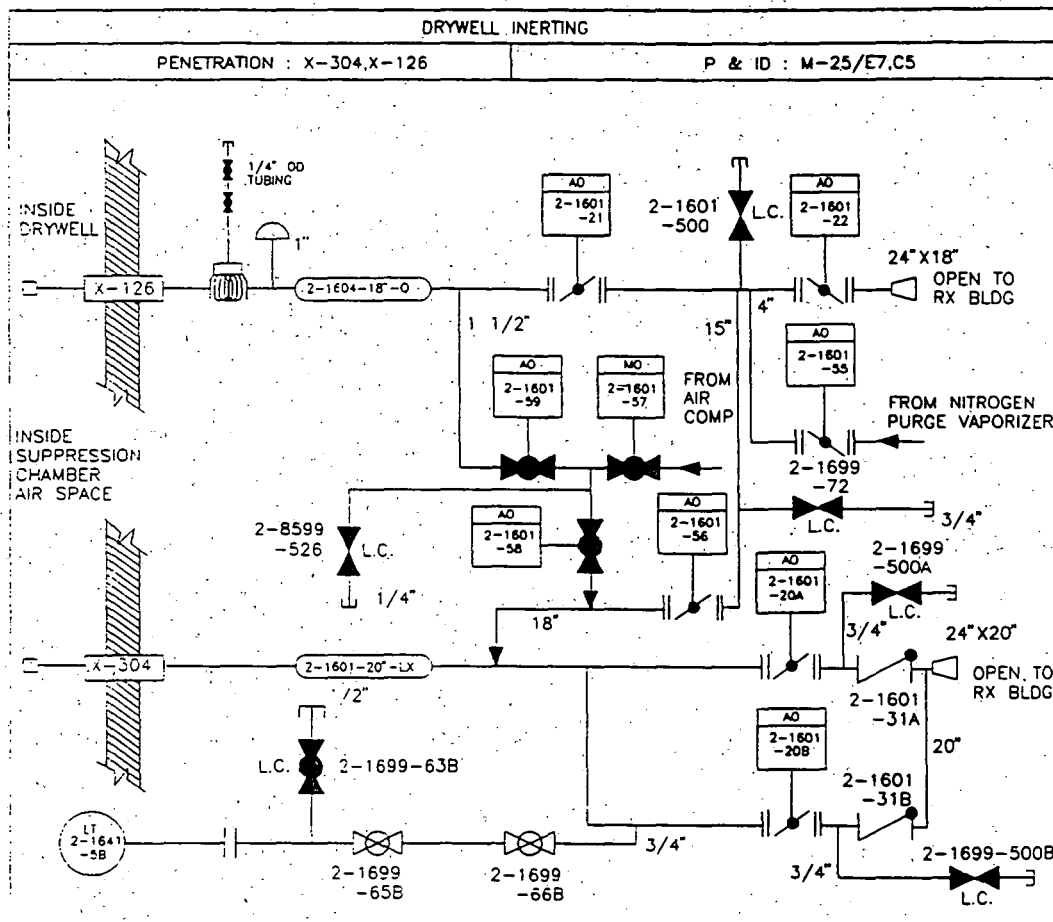
**FIGURE 1**

Maintenance Procedure (DMP) 1601-2, Drywell and Pressure Suppression Chamber Air Operated Butterfly Valve Maintenance, required only a Local Leak Rate Test (LLRT); the LLRT for valve A02-1601-20A was performed by pressurizing the volume of piping between valves A02-1601-20A and 2-1601-31A (see Figure 1) with air to 48 psig and monitoring the makeup flow required to maintain that pressure. With this LLRT configuration, the inboard flanged connection is not challenged. Consequently, since this valve was not removed since the last refueling outage, it was determined that this particular flanged connection was potentially in a degraded condition during the past operating cycle. At 0800 hours on 12/18/90 it was determined that this event was reportable under 10CFR 50.72 (b)(2)(i) requirements. The event was also classified as a Potentially Significant Event (PSE), initiating prompt notification of all Commonwealth Edison sites.

The cause of the leakage from the inboard flanged connection of valve A02-1601-20A was inadequate tightening at the flange bolts following the replacement activity. Review of the work package for the replacement activity shows that the flange bolts were first snugged to insure gasket contact and then several passes were made in order to tighten them. The work package allowed use of an impact wrench or full effort of a man using an ordinary spud wrench for the final tightening. A Quality Control Inspector physically observed this activity. Additional passes with a slugging wrench were performed on 12/18/90 to correct the leakage.

This condition was not discovered due to an ineffective post maintenance test performed after the valve was replaced during the previous refueling outage. The LLRT performed following the replacement never challenged the inboard flange; had a proper pressure test on the inboard flange been performed, the leakage from the flange would have been discovered, and the appropriate corrective actions taken prior to entering a mode of operation requiring primary containment integrity. It should be noted that this flanged connection configuration is not currently testable via an LLRT.

1. A supplemental report will be submitted in order to provide the results of the 10CFR 100 analyses (237-200-90-15201).
2. DMP 1601-2 will be revised by the Maintenance Staff to include requirements for use of an impact or slugging wrench for final tightening of the flange bolts and performance of a LLRT or comparable test on the inboard flange of this valve and other similar valves (1601-20B, 21, 23, 56, and 60) whenever the integrity of these connections is disturbed (237-200-90-15202).
3. Currently, modifications are being evaluated which will allow localized testing of the subject flanges. The final design/decision will be reported in the supplement to this report (237-200-90-15203).
