Dresden Nuclear Power Station

LICENSEE EVENT REPORT (LER)

Facility Name (1) Dresden Nuclear Power Station, Unit 2						Docket Number (2) 0 15 10 10 10 12 13 17			Page (3) 1 of 0 5		
Title (4) Leakage Path Discovered During Primary Containment ILRT Due to Management Deficiency

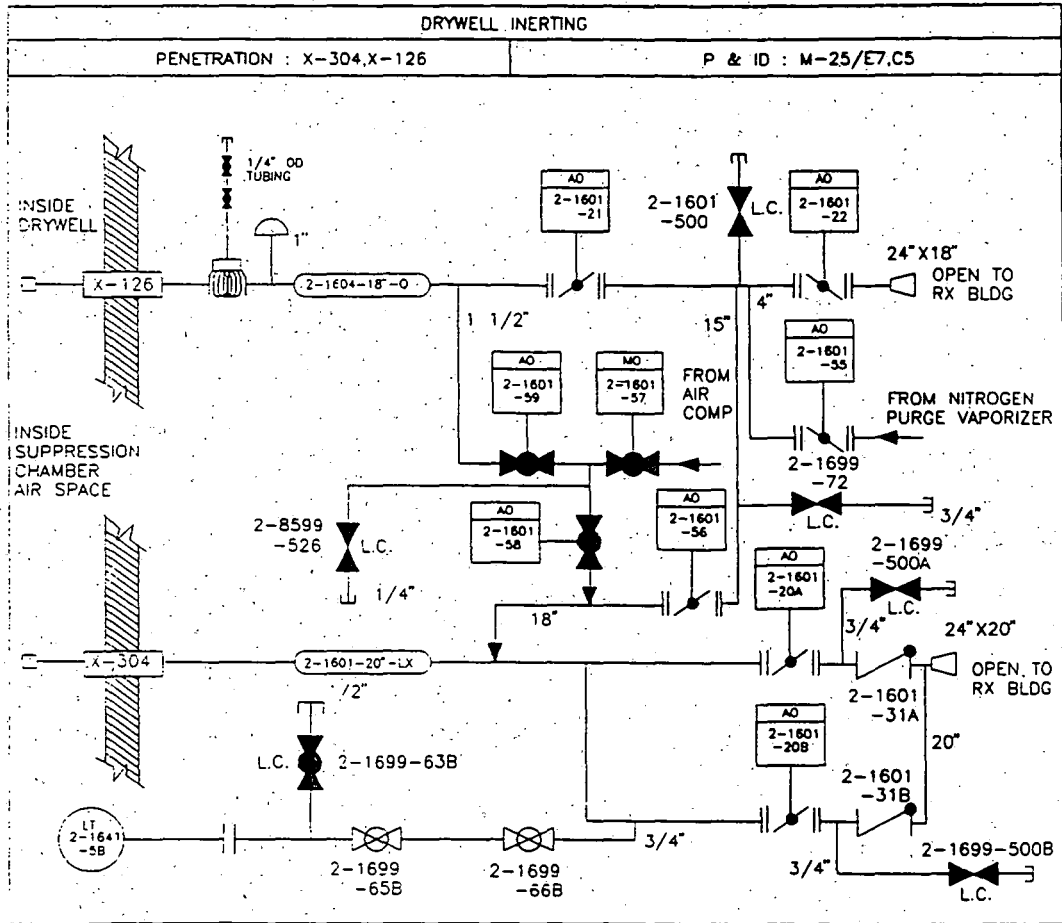
FIGURE 1

Maintenance Procedure (DMP) 1601-2, Drywell and Pressure Suppression Chamber Air Operated Butterfly Valve Maintenance, required only a Local Leak Rate Test (LLRT); the LLRT for valve A02-1601-20A was performed by pressurizing the volume of piping between valves A02-1601-20A and 2-1601-31A (see Figure 1) with air to 48 psig and monitoring the makeup flow required to maintain that pressure. With this LLRT configuration, the inboard flanged connection is not challenged. Consequently, since this valve was not removed since the last refueling outage, it was determined that this particular flanged connection was potentially in a degraded condition during the past operating cycle. At 0800 hours on 12/18/90 it was determined that this event was reportable under 10CFR 50.72 (b)(2)(i) requirements. The event was also classified as a Potentially Significant Event (PSE), initiating prompt notification of all Commonwealth Edison sites.

The cause of the leakage from the inboard flanged connection of valve A02-1601-20A was inadequate tightening at the flange bolts following the replacement activity. Review of the work package for the replacement activity shows that the flange bolts were first snugged to insure gasket contact and then several passes were made in order to tighten them. The work package allowed use of an impact wrench or full effort of a man using an ordinary spud wrench for the final tightening. A Quality Control Inspector physically observed this activity. Additional passes with a slugging wrench were performed on 12/18/90 to correct the leakage.

This condition was not discovered due to an ineffective post maintenance test performed after the valve was replaced during the previous refueling outage. The LLRT performed following the replacement never challenged the inboard flange; had a proper pressure test on the inboard flange been performed, the leakage from the flange would have been discovered, and the appropriate corrective actions taken prior to entering a mode of operation requiring primary containment integrity. It should be noted that this flanged connection configuration is not currently testable via an LLRT.

1. A supplemental report will be submitted in order to provide the results of the 10CFR 100 analyses (237-200-90-15201).
2. DMP 1601-2 will be revised by the Maintenance Staff to include requirements for use of an impact or slugging wrench for final tightening of the flange bolts and performance of a LLRT or comparable test on the inboard flange of this valve and other similar valves (1601-20B, 21, 23, 56, and 60) whenever the integrity of these connections is disturbed (237-200-90-15202).
3. Currently, modifications are being evaluated which will allow localized testing of the subject flanges. The final design/decision will be reported in the supplement to this report (237-200-90-15203).
