Commonwealth Edison
Dresden Nuclear Power Station
R.R. #1.
Morris, Illinois 60450
Telephone 815/942-2920

LICENSEE EVENT REPORT (LER)

Facility Name (1) Dresden Nuclear Power Station, Unit 2
 Docket Number (2) 0 5 10 10 10 12 13 17
 Page (3) 1 of 0 5

Title (4) Electromatic Relief Valve Pressure Switch Outside Technical Specification
 Due to Instrument Setpoint Drift

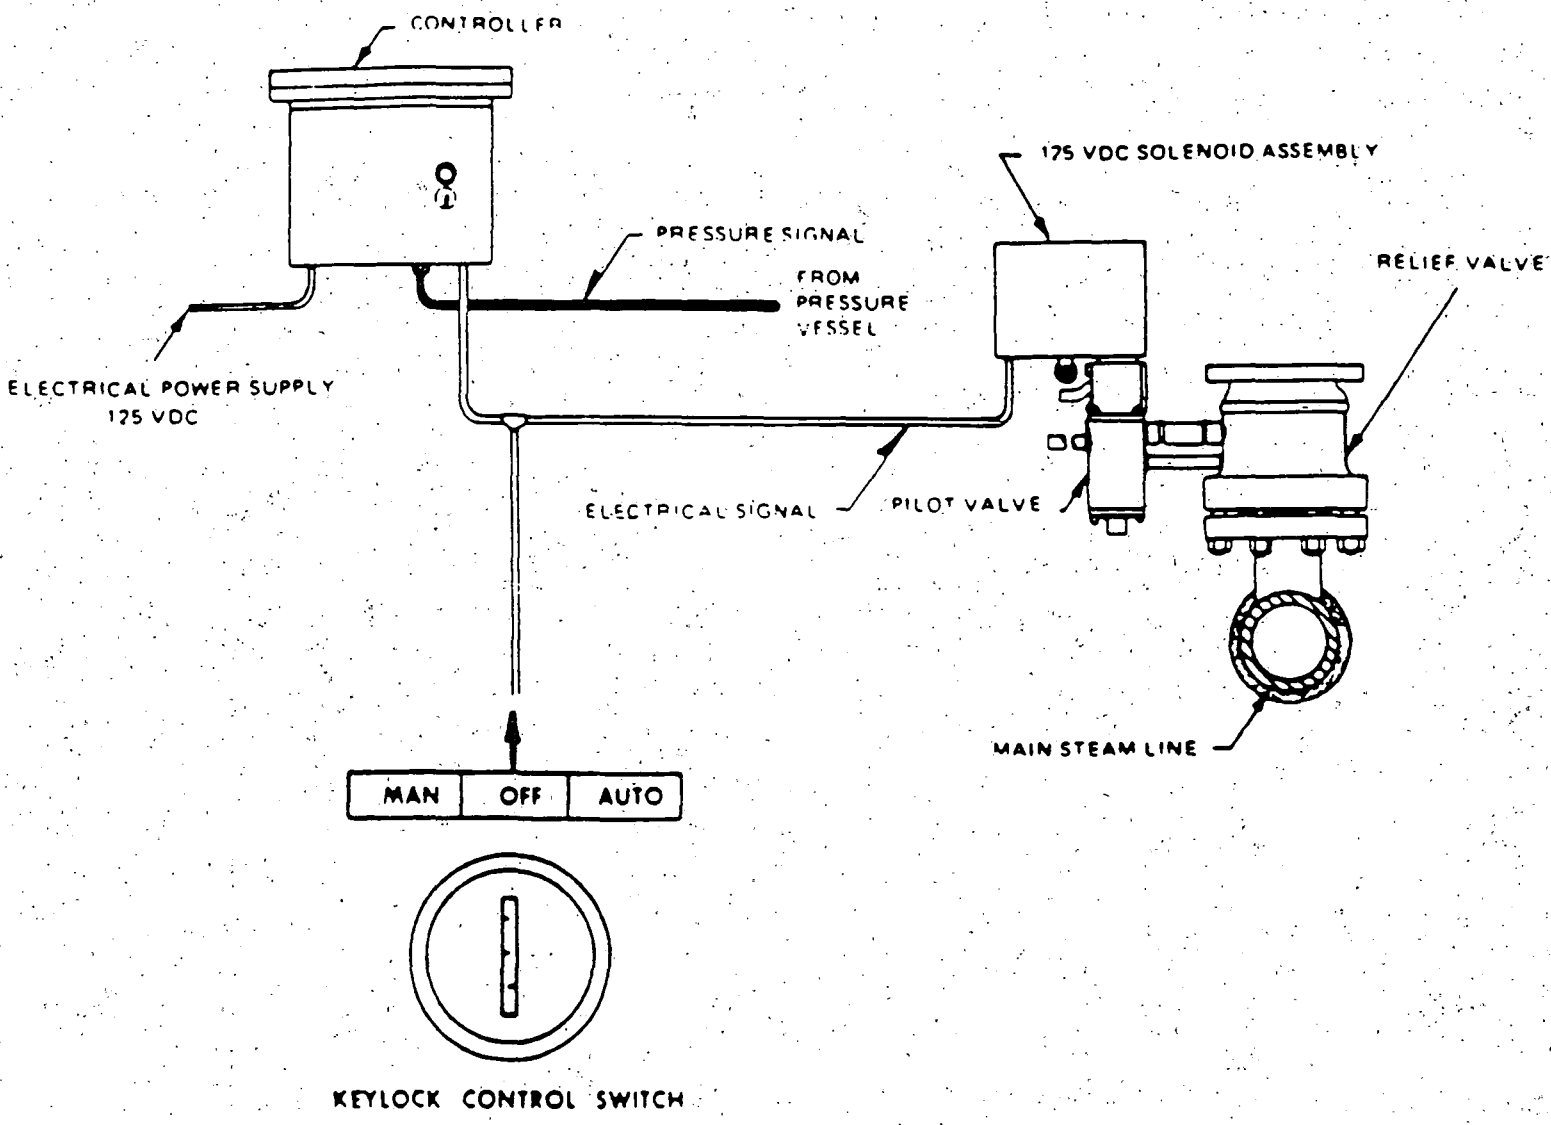
Figure 1

ELECTROMECANICAL RELIEF VALVE AND CONTROLS
