Dresden Nuclear Power Station

LICENSEE EVENT REPORT (LER)

Facility Name (1) Dresden Nuclear Power Station, Unit 2	Docket Number (2) 0 15 10 10 10 12 13 17	Page (3) 1 of 0 4
Title (4) Partial Group I Isolation Due To Shorting of 1B MSIV Position Indicating Light Socket

Partial Group I Isolation Due To Shorting of 1B MSIV Position Indicating Light Socket

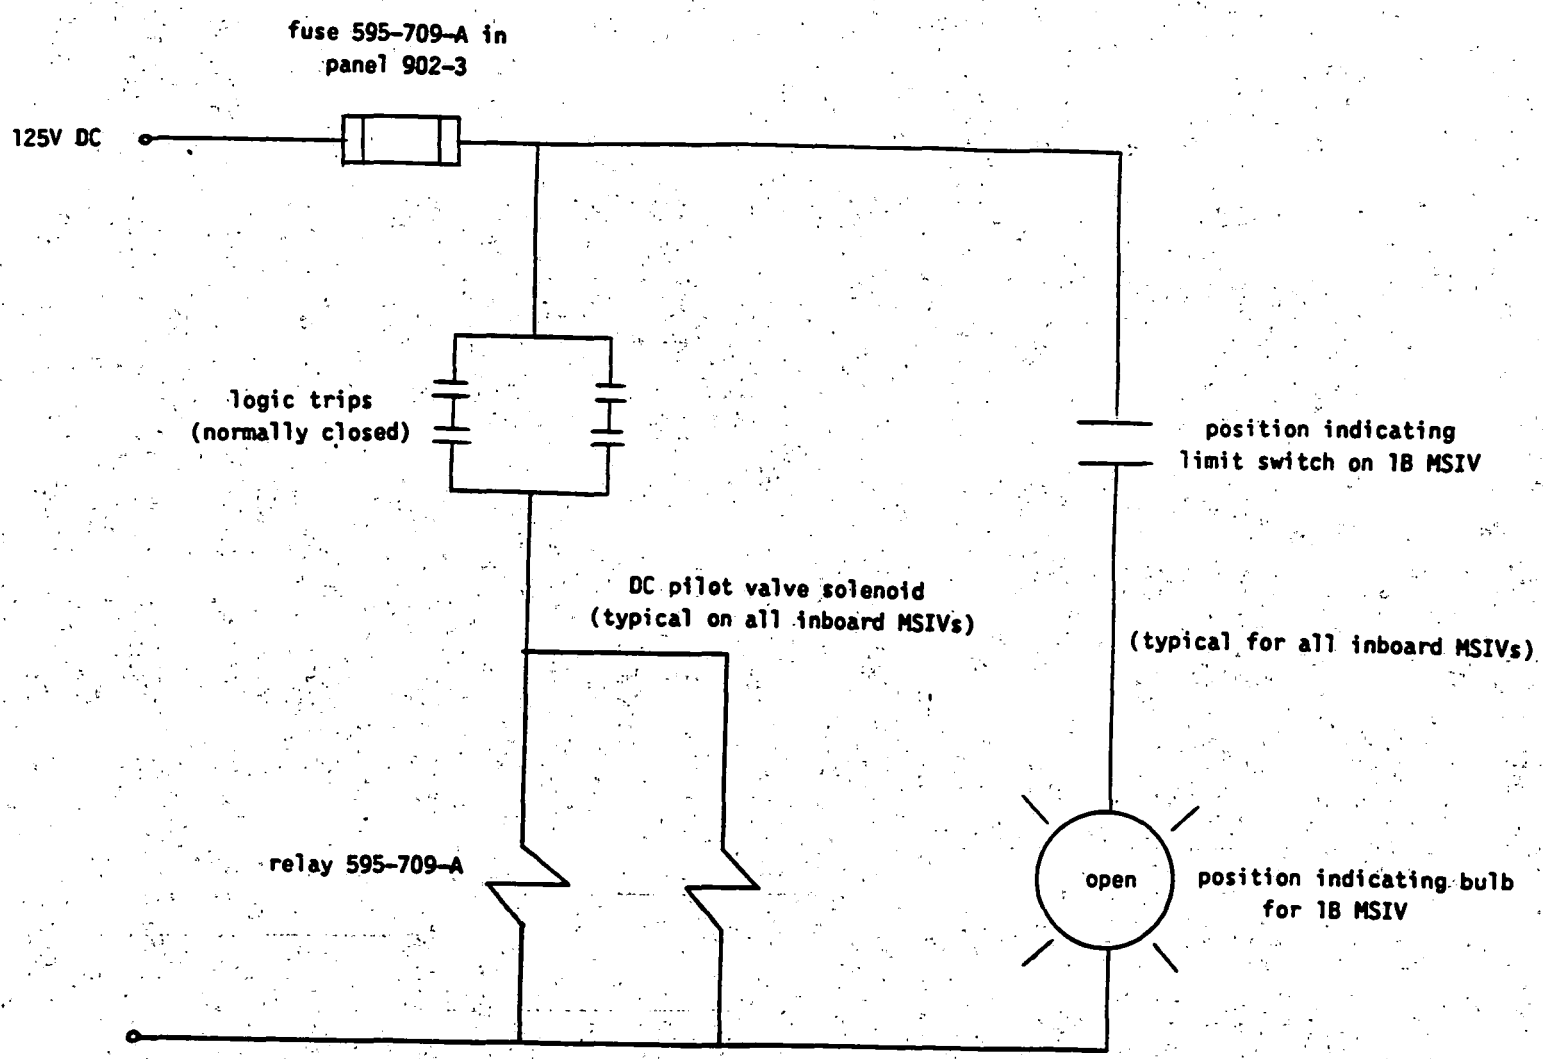
FIGURE 1

The apparent cause of the 1B MSIV light bulb socket failure was the introduction of foreign material into the light bulb socket. The area beneath the lens cover was vacuumed prior to removal of the burned out bulb, as required by DOP 040-4. It should be noted that all horizontal Unit 2 Control Room panel sockets had also been vacuumed prior to startup. After the bulb was removed, the NSO began vacuuming the light socket per DOP 040-4, at which time the socket shorted. It is believed that foreign material, which had either originally been in the socket or had fallen from the vacuum snorkel, positioned itself between the base of the socket and the center contact point, providing an electrical path, or short, to ground. The establishment of increased current through the related Group I isolation logic resulted in the blown fuse 595-709-A. A Maintenance History Review indicated the previous LER described in Section F below.

At the time of this event fuse 595-709-A immediately blew upon the shorting of the light bulb socket, therefore performing its intended function by keeping excessive current from damaging related Group I isolation circuitry. The closure of Recirculation Loop Sample Valve 2-220-44 and Main Steam Line Drain Valve 2-220-1 was an expected occurrence of the partial Group I isolation which was received as a result of the de-energization of relay 595-111-A. Although all DC pilot valve solenoids de-energized as a result of the blown fuse, none of the inboard MSIVs experienced automatic closure since all AC pilot valve solenoids on the MSIVs were energized (de-energization of both AC and DC solenoids are required to cause MSIV closure). Even if all MSIVs had closed during this event, all Electromatic Relief Valves and main steam Safety Valves were operable to ensure reactor vessel protection from an overpressurization transient. Unexpected closure of the Recirculation Loop Sample Valve and Main Steam Line Drain Valve had minimal effect on plant operation. For these reasons, the safety significance of this event was minimal.

SIMPLIFIED DIAGRAM OF AFFECTED CIRCUITRY

As immediate corrective actions, the light bulb socket for the open indication on the 1B MSIV was replaced under Work Request 97472. The new light socket and nearby areas were again vacuumed before bulb replacement and energization of the circuitry. Fuse 595-709-A in Control Room panel 902-3 was then replaced and DOS 250-2 was satisfactorily completed for all inboard MSIVs. Recirculation [AD] Loop Sample Valve 2-220-44 and Main Steam Line Drain Valve 2-220-1 were also re-positioned after replacement of fuse 595-709-A. Prior to Unit 2 Startup, all horizontal Control Room panels had been vacuumed. DOP 040-4, requiring vacuuming of Control Room panel light sockets before and after installation of new light bulbs, will help prevent recurrences of this type.
