Dresden Nuclear Power Station

Dresden Nuclear Power Station, Unit 3

Title (4) De-energization of Reactor Protection System Due to Procedural Deficiency

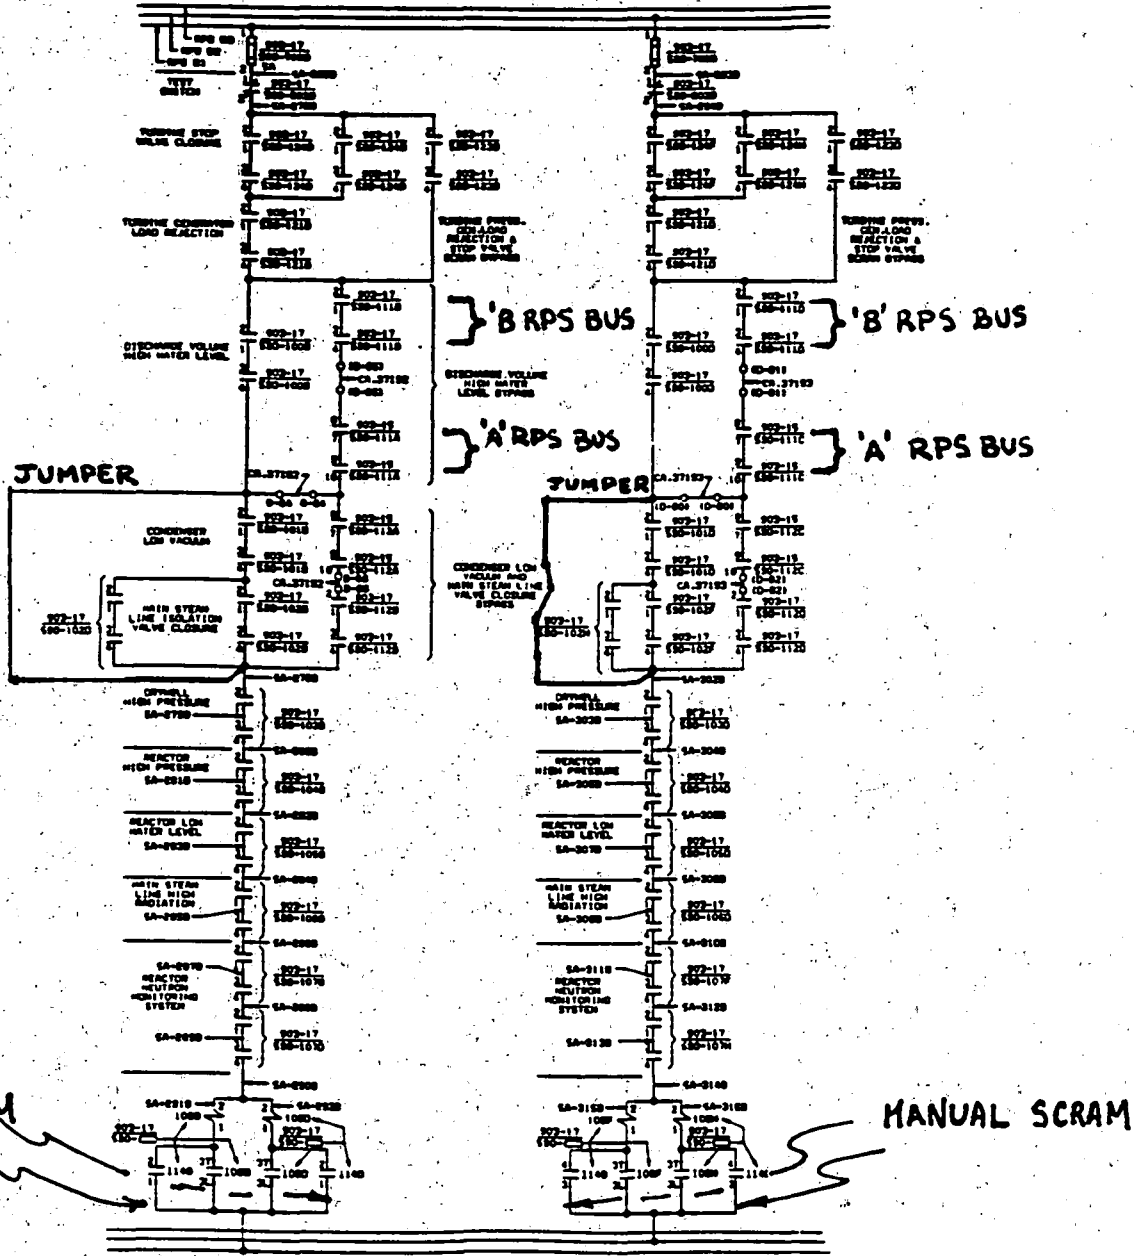
FIGURE 1

The RPS circuitry consists of two independent channels containing two subchannels. The RPS circuitry is normally energized. During DTS 500-2 jumpers are installed over the condenser low vacuum and main steam line isolation valve closure circuit contacts on all four subchannels to prevent a full scram from occurring by de-energizing the RPS bus (A or B) at less than 600 psig reactor pressure (refer to Figure 1 attached). The reactor was in Shutdown mode and a manual scram had been initiated; therefore, the scram valves were open, the manual scram relays were de-energized, and the SDV volume was filled giving a SDV high water level indication and tripping open the SDV high water level contacts (590-100B and D). The SDV High Water Level Bypasses were energized, because the keylock switch on the 903-5 panel was in the "Bypass" position. The SDV Bypasses contain contacts common to both RPS trip channels. With the SDV high water level contacts dropped out and the Bypasses engaged, when the RPS B bus was de-energized the SDV Bypass circuit contacts common to both trip channel de-energized. This caused the unplanned scram signal.

RPS B BUS SCRAM CIRCUITRY
