Dresden Nuclear Power Station

Licensee Event Report #91-004-0, Docket #050237 is being submitted as required by Technical Specification 6.6, NUREG 1022 and 10 CFR 50.73(a)(2)(iv).

Unit 2 Reactor Scram and Containment Group I Isolation [JM] Due to Main Steam Line [SB] High Radiation Caused by Resin Intrusion.

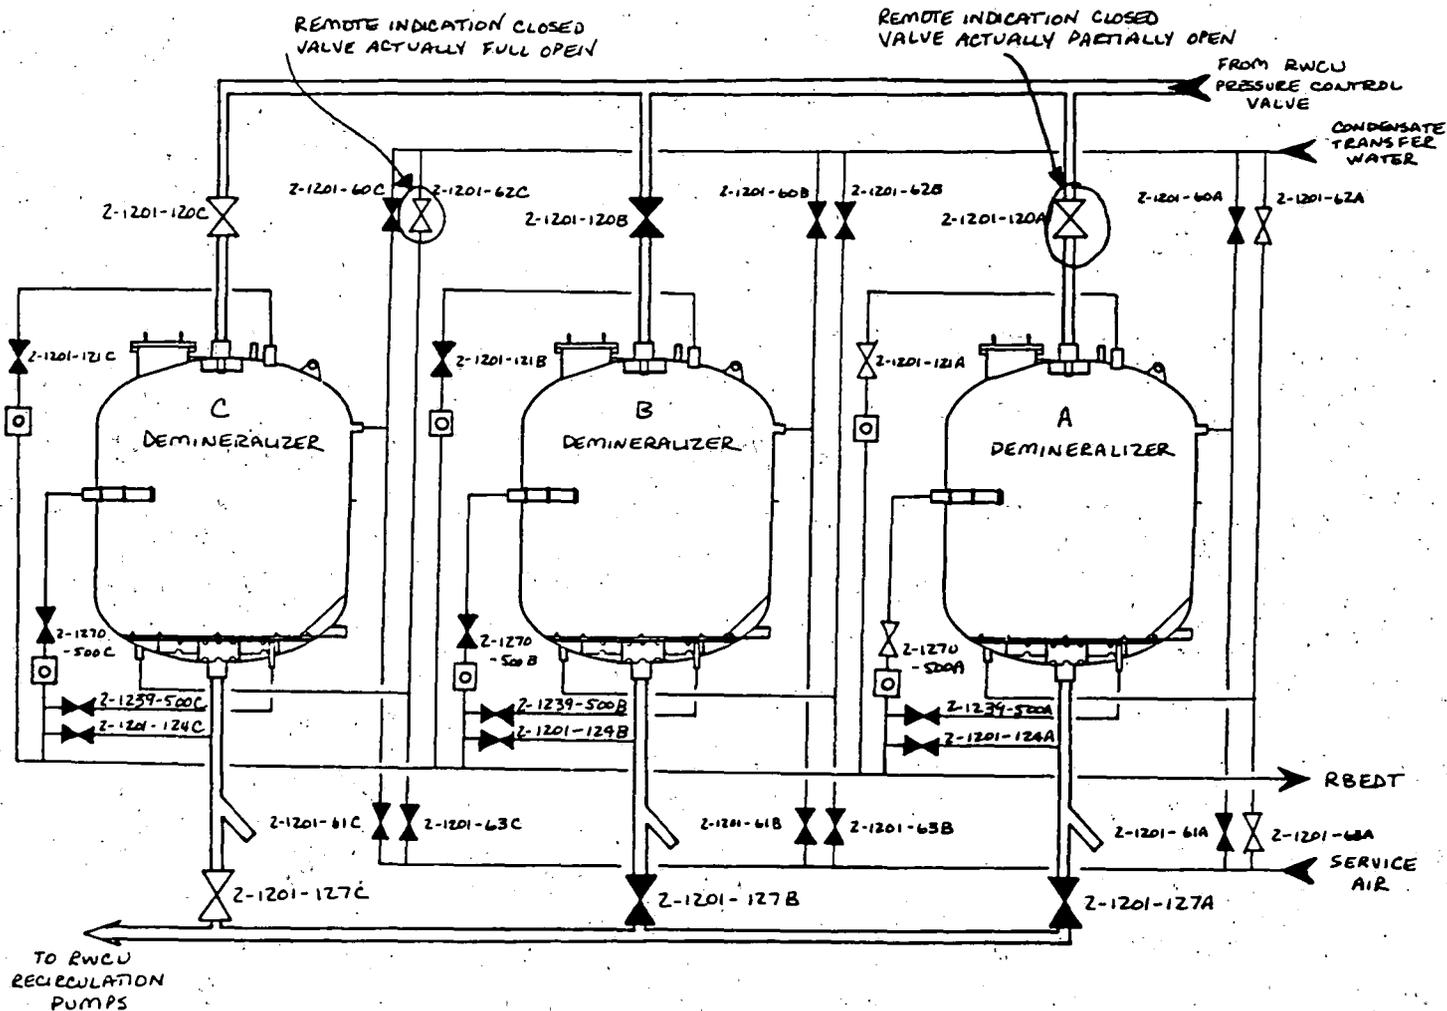
FIGURE 1
Cleanup System Demineralizer

After isolating the 2A RWCU demineralizer, Operations personnel began the resin transfer by supplying Condensate Transfer [SD] water to the reactor building. They were unaware that the 2-1201-62C valve was open, allowing condensate water to enter the 2C RWCU demineralizer beneath the underdrain. The operators then opened the 2-1201-62A valve to supply condensate water, at approximately 40 gallons per minute (gpm), to the 2A RWCU demineralizer. The 2-1201-121A valve was opened as a vent for the 2A demineralizer. The sightglass downstream of the 2-1201-121A vent valve was checked, by the operators, to verify condensate water flow from the 2A demineralizer. However, no flow was observed. Since the RWCU system pressure is 50-60 pounds per square inch (psi), the condensate water supply, which was about 80 psi, would have flowed into the RWCU system flow through the fully open 2-1201-62C valve. The partially open 2-1201-120A valve also allowed condensate water to backflow through the 2A demineralizer and over to the 2C demineralizer carrying resin fines from the 2A to the 2C demineralizer. As another means to verify the entry of water to the demineralizer, Operations personnel then opened the freeboard drain valve (2-1270-500A) for the 2A RWCU demineralizer. Flow was seen through a sightglass on the freeboard drain line. The air sparging of the 2A demineralizer bed was then begun by opening the 2-1201-63A valve. At this point, service air, which was at a higher pressure than the condensate water supply, pushed back through the 2-1201-62A valve and through the open 2-1201-62C valve, supplying air into the 2C demineralizer beneath the underdrain. Service air also would have pushed back through the 2-1201-120A and introduced air into the 2C demineralizer bed through the 2-1201-120C valve. The control room immediately noticed flow and pressure oscillations in the RWCU system.

The introduction of the air agitated the 2C demineralizer resin bed allowing resin fines to be carried through the 2C demineralizer underdrain and into the post-strainer. As the resin fines collected in the post-strainer, the differential pressure (dP) increased to the point of post-strainer degradation. Some of the fines passed through the post-strainer and into the RWCU recirculation pump suction. As more resin fines entered the post-strainer, water flow through the strainer was restricted, causing a low suction pressure transient on the RWCU recirculation pumps, which then tripped. However, the resin fines had already passed through the RWCU recirculation pumps and into the reactor vessel. The reactor then scrambled due to high radiation in the main steam lines.

The intrusion through to the 2C demineralizer underdrain was confirmed by the presence of resin fines found in a sample line [KN] that taps in between the underdrain and the post-strainer. It was noted that the post-strainer dP on the 2C demineralizer was 9 psid just following the scram. On February 12, 1991 the 2C post-strainer dP was 1.8 psid, and after backflushing the post-strainer after the scram, the dP decreased to 1.6 psid.

The 2C RWCU demineralizer underdrain and post-strainer will be inspected before the demineralizer unit is returned to service (237-200-91-02502). The 2A RWCU demineralizer resin transfer was completed in accordance with Operating Order 16-91 and DOP 1200-5 and returned to service before startup of the reactor.

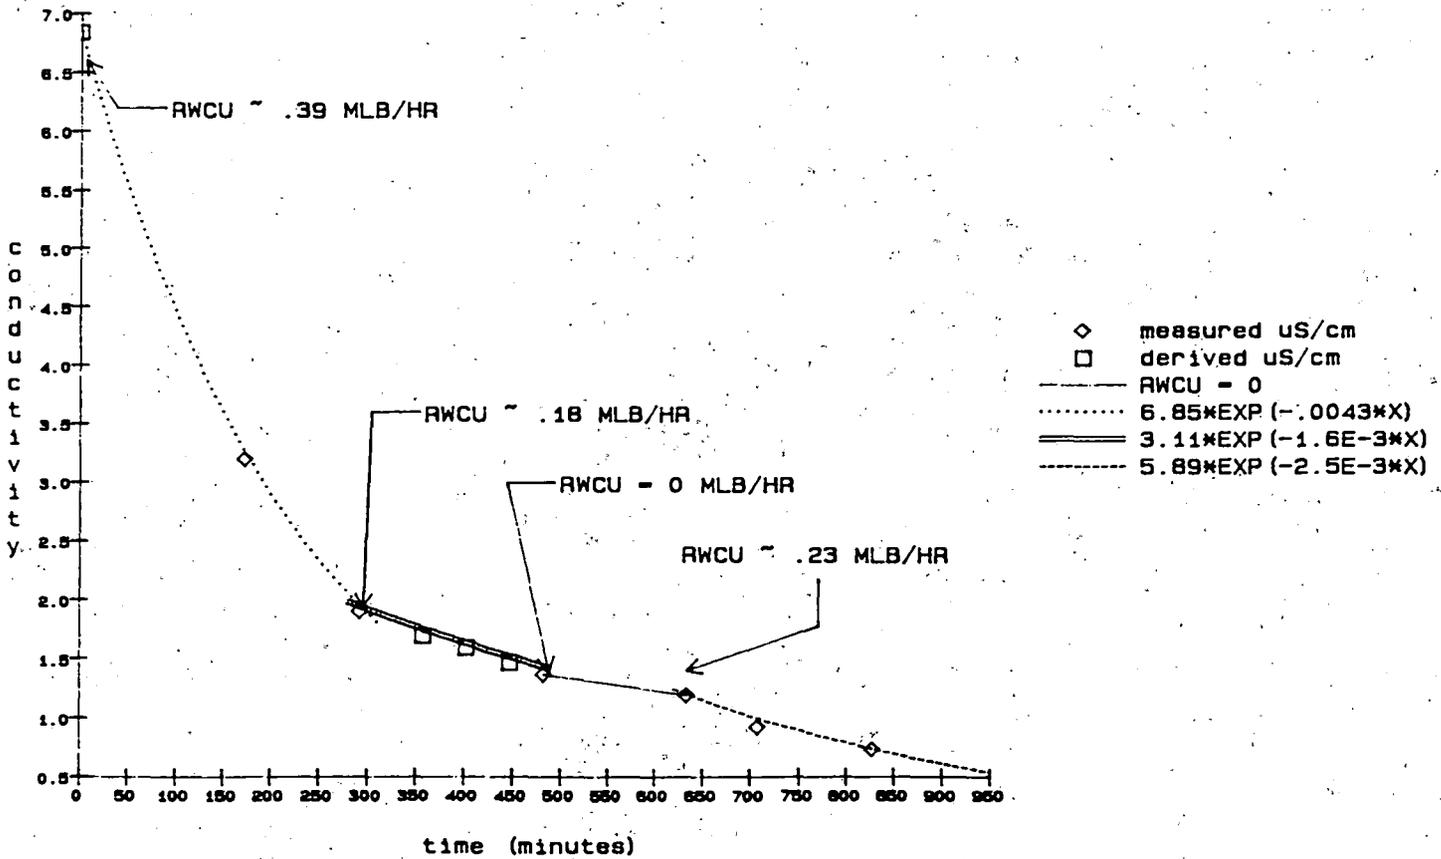
FIGURE 2
Conductivity Trend

The conductivity of the reactor coolant reached 6.85 micro-mhos per centimeter during the event. Figure 2 shows the coolant conductivity trends after the event. Before the event, the conductivity measured 0.075 micro-mho per centimeter at 0810 hours on February 12, 1991.

During the event, the concentration of sulfates reached 400-500 parts per billion (ppb). However, this is believed to have minimal impact on primary system Intergranular Stress Corrosion Cracking (IGSCC) due to the extremely short duration of the conductivity transient. Several other factors also mitigated the consequences of the high concentration of sulfates. After the reactor scram and Primary Containment Group I Isolation, the main steam isolation valves (MSIVs) were left closed. This kept the dissolved oxygen levels in the coolant down. The reactor was also allowed to cool down after the reactor scram. By keeping the oxygen level low and cooling the reactor, IGSCC concerns were minimized. In addition, the RWCU system was returned to service about ten minutes after the scram and resulted in a timely and controlled decrease in conductivity (see Figure 2). During startup of the reactor, power was increased in steps to ensure that coolant chemistry requirements were being met at all times. These factors decreased the potential for IGSCC. The Station also has an inservice inspection program that periodically inspects IGSCC susceptible materials and welds per Generic Letter 88-01.
