Dresden Nuclear Power Station

LICENSEE EVENT REPORT (LER)

Title (4) Unit 2 Reactor Scram and Containment Group I Isolation Due to Main Steam Line High Radiation Caused by Resin Intrusion

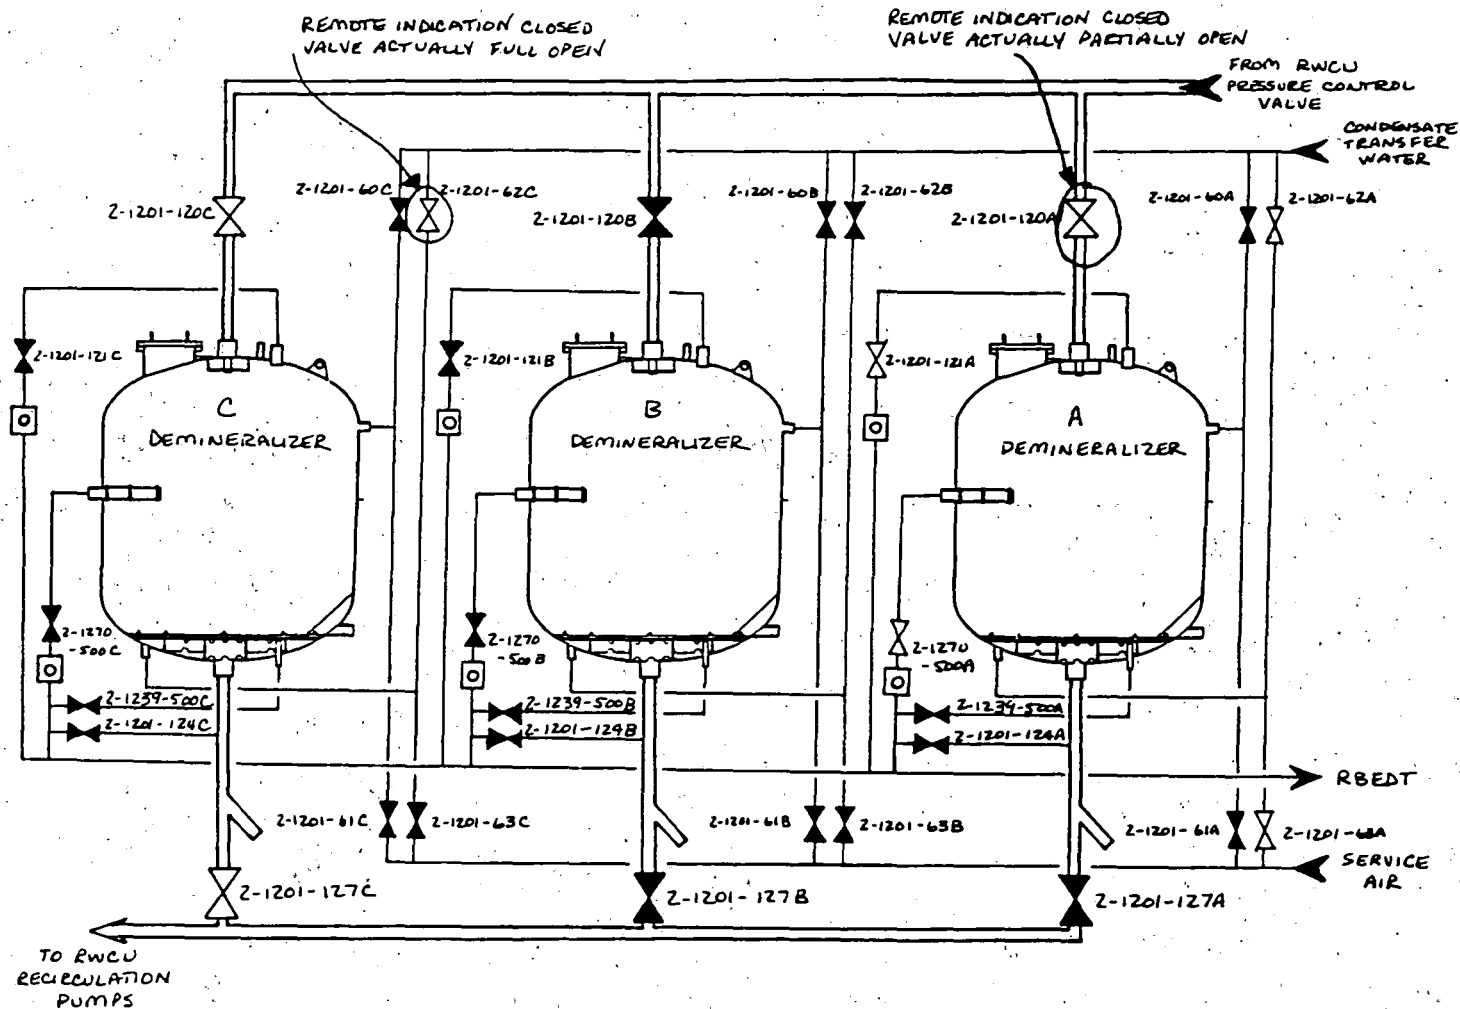
FIGURE 1  
Cleanup System Demineralizer

After isolating the 2A RWCU demineralizer, Operations personnel began the resin transfer by supplying Condensate Transfer [SD] water to the reactor building. They were unaware that the 2-1201-62C valve was open, allowing condensate water to enter the 2C RWCU demineralizer beneath the underdrain. The operators then opened the 2-1201-62A valve to supply condensate water, at approximately 40 gallons per minute (gpm), to the 2A RWCU demineralizer. The 2-1201-121A valve was opened as a vent for the 2A demineralizer. The sightglass downstream of the 2-1201-121A vent valve was checked, by the operators, to verify condensate water flow from the 2A demineralizer. However, no flow was observed. Since the RWCU system pressure is 50-60 pounds per square inch (psi), the condensate water supply, which was about 80 psi, would have flowed into the RWCU system flow through the fully open 2-1201-62C valve. The partially open 2-1201-120A valve also allowed condensate water to backflow through the 2A demineralizer and over to the 2C demineralizer carrying resin fines from the 2A to the 2C demineralizer. As another means to verify the entry of water to the demineralizer, Operations personnel then opened the freeboard drain valve (2-1270-500A) for the 2A RWCU demineralizer. Flow was seen through a sightglass on the freeboard drain line. The air sparging of the 2A demineralizer bed was then begun by opening the 2-1201-63A valve. At this point, service air, which was at a higher pressure than the condensate water supply, pushed back through the 2-1201-62A valve and through the open 2-1201-62C valve, supplying air into the 2C demineralizer beneath the underdrain. Service air also would have pushed back through the 2-1201-120A and introduced air into the 2C demineralizer bed through the 2-1201-120C valve. The control room immediately noticed flow and pressure oscillations in the RWCU system.

The introduction of the air agitated the 2C demineralizer resin bed allowing resin fines to be carried through the 2C demineralizer underdrain and into the post-strainer. As the resin fines collected in the post-strainer, the differential pressure (dP) increased to the point of post-strainer degradation. Some of the fines passed through the post-strainer and into the RWCU recirculation pump suction. As more resin fines entered the post-strainer, water flow through the strainer was restricted, causing a low suction pressure transient on the RWCU recirculation pumps, which then tripped. However, the resin fines had already passed through the RWCU recirculation pumps and into the reactor vessel. The reactor then scrambled due to high radiation in the main steam lines.

The intrusion through to the 2C demineralizer underdrain was confirmed by the presence of resin fines found in a sample line [KN] that taps in between the underdrain and the post-strainer. It was noted that the post-strainer dP on the 2C demineralizer was 9 psid just following the scram. On February 12, 1991 the 2C post-strainer dP was 1.8 psid, and after backflushing the post-strainer after the scram, the dP decreased to 1.6 psid.

The 2C RWCU demineralizer underdrain and post-strainer will be inspected before the demineralizer unit is returned to service (237-200-91-02502). The 2A RWCU demineralizer resin transfer was completed in accordance with Operating Order 16-91 and DOP 1200-5 and returned to service before startup of the reactor.

The Station is also evaluating replacement of the post-strainers on all the Unit 2 and 3 RWCU demineralizers with a model that decreases the potential of resin breakthrough (237-200-91-02503).

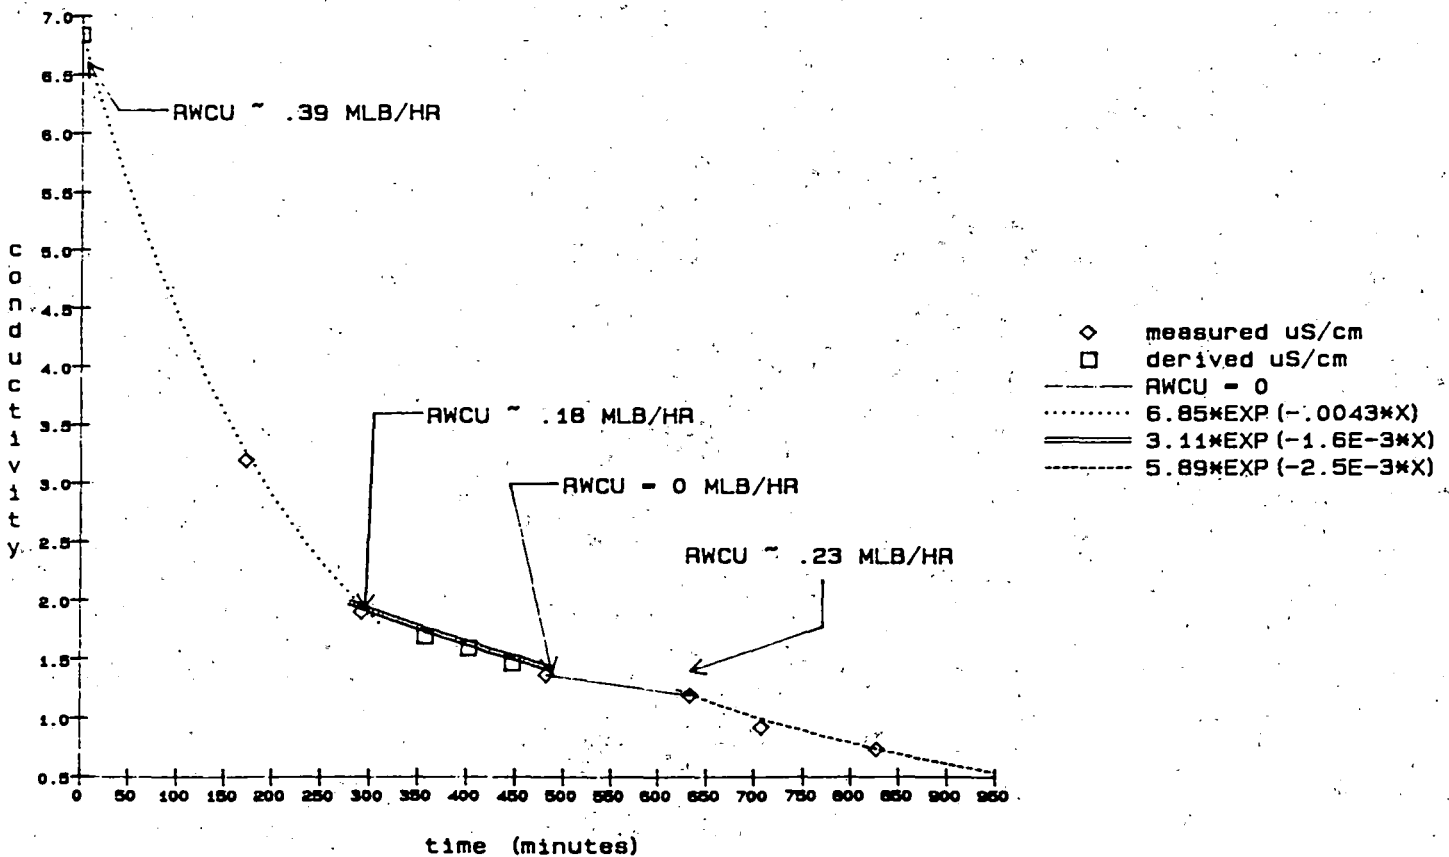
FIGURE 2  
Conductivity Trend

The conductivity of the reactor coolant reached 6.85 micro-mhos per centimeter during the event. Figure 2 shows the coolant conductivity trends after the event. Before the event, the conductivity measured 0.075 micro-mho per centimeter at 0810 hours on February 12, 1991.
