Dresden Nuclear Power Station

LICENSEE EVENT REPORT (LER)

Facility Name (1) <b>Dresden Nuclear Power Station, Unit 2</b>	Docket Number (2) <b>0 15 10 10 10 12 13 17</b>	Page (3) <b>1 of 0 5</b>
Title (4) Orderly Unit Shutdown Due to Leakage Through Primary Containment <b>Isolation Valves A0 2-220-44 and A0 2-220-45</b>

Orderly Unit Shutdown Due to Leakage Through Primary Containment Isolation [JM] Valves A0 2-220-44 and A0 2-220-45

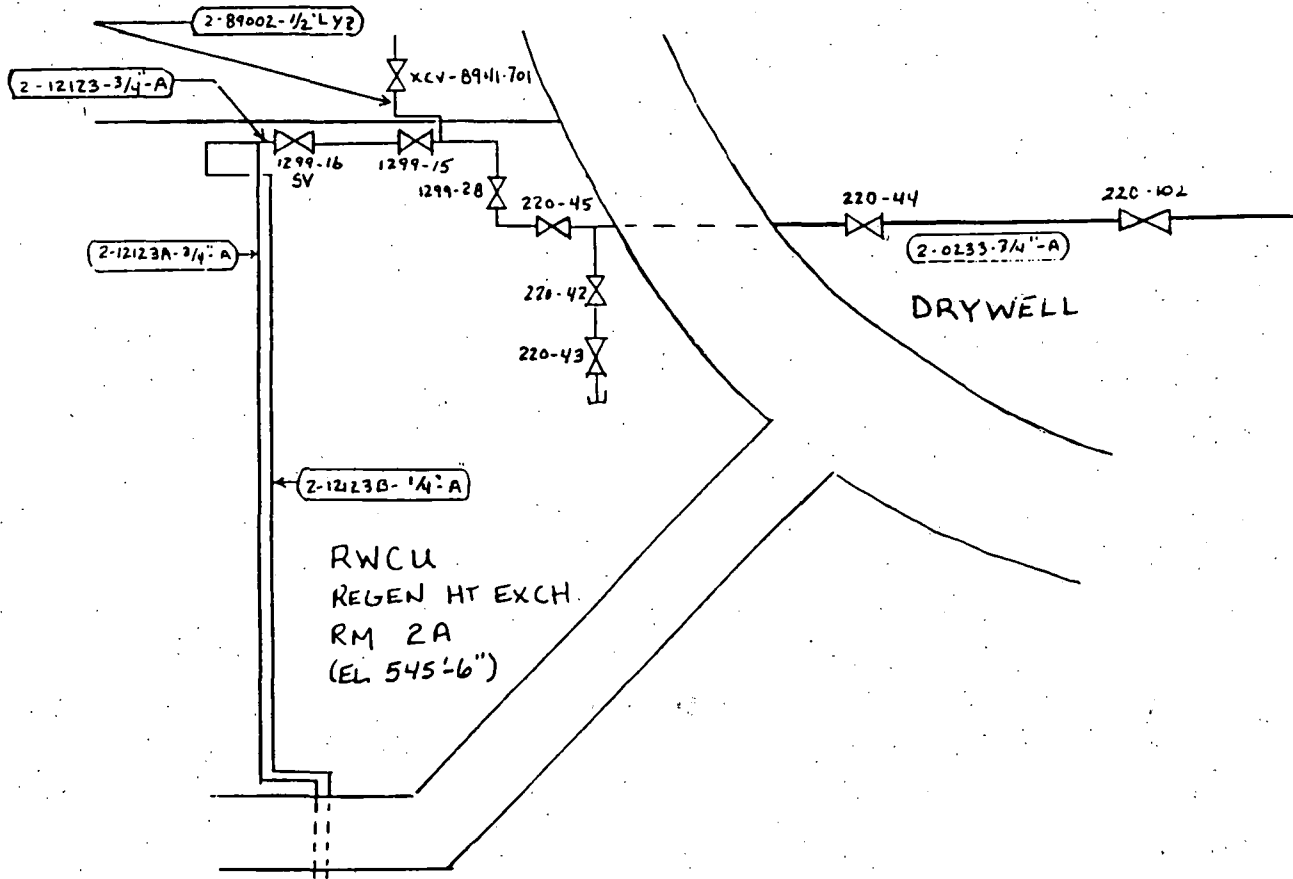
FIGURE 1

At 1740 hours on March 4, 1991, with Unit 2 at 73% power while performing a modification test for a Process Sampling Sample Panel [KN] modification, a small steam leak was found upstream of the 2-1299-16 valve (see Figure 1, attached). A call to the Control Room was then made for the Operator to isolate the leak. The air operated (A0) Reactor Recirculation [AD] sample line Primary Containment isolation valves A0 2-220-44 and A0 2-220-45 were then closed; however, the leak did not stop. A Shift Supervisor then closed the 2-1299-15 valve located in the "A" Reactor Water Clean-Up [CE] Heat Exchanger Room and the leak stopped, indicating that both containment isolation valves were leaking through. The A0 2-220-44 and A0 2-220-45 valves were then declared inoperable, resulting in entry into a 24 hour Limiting Condition for Operation (LCO) per Technical Specification 3.7.D.3, and an orderly Unit 2 shutdown was initiated to perform repairs. A primary containment drywell entry was also performed to close the upstream valve 2-220-102. Cold shutdown conditions were achieved at 1728 hours on March 5, 1991.
