A. RO Inspection Report No. 050-237/72-05
050-249/72-03

RO Inspection Report No. 050-237/72-05
RO Inspection Report No. 050-249/72-05

Dresden Units 2 and 3
Morris, Illinois

DIKE FAILURE OF THE COOLING WATER POND - DRESDEN STATION - COMMONWEALTH EDISON COMPANY, DOCKET NOS. 50-10, 50-237, AND 50-249

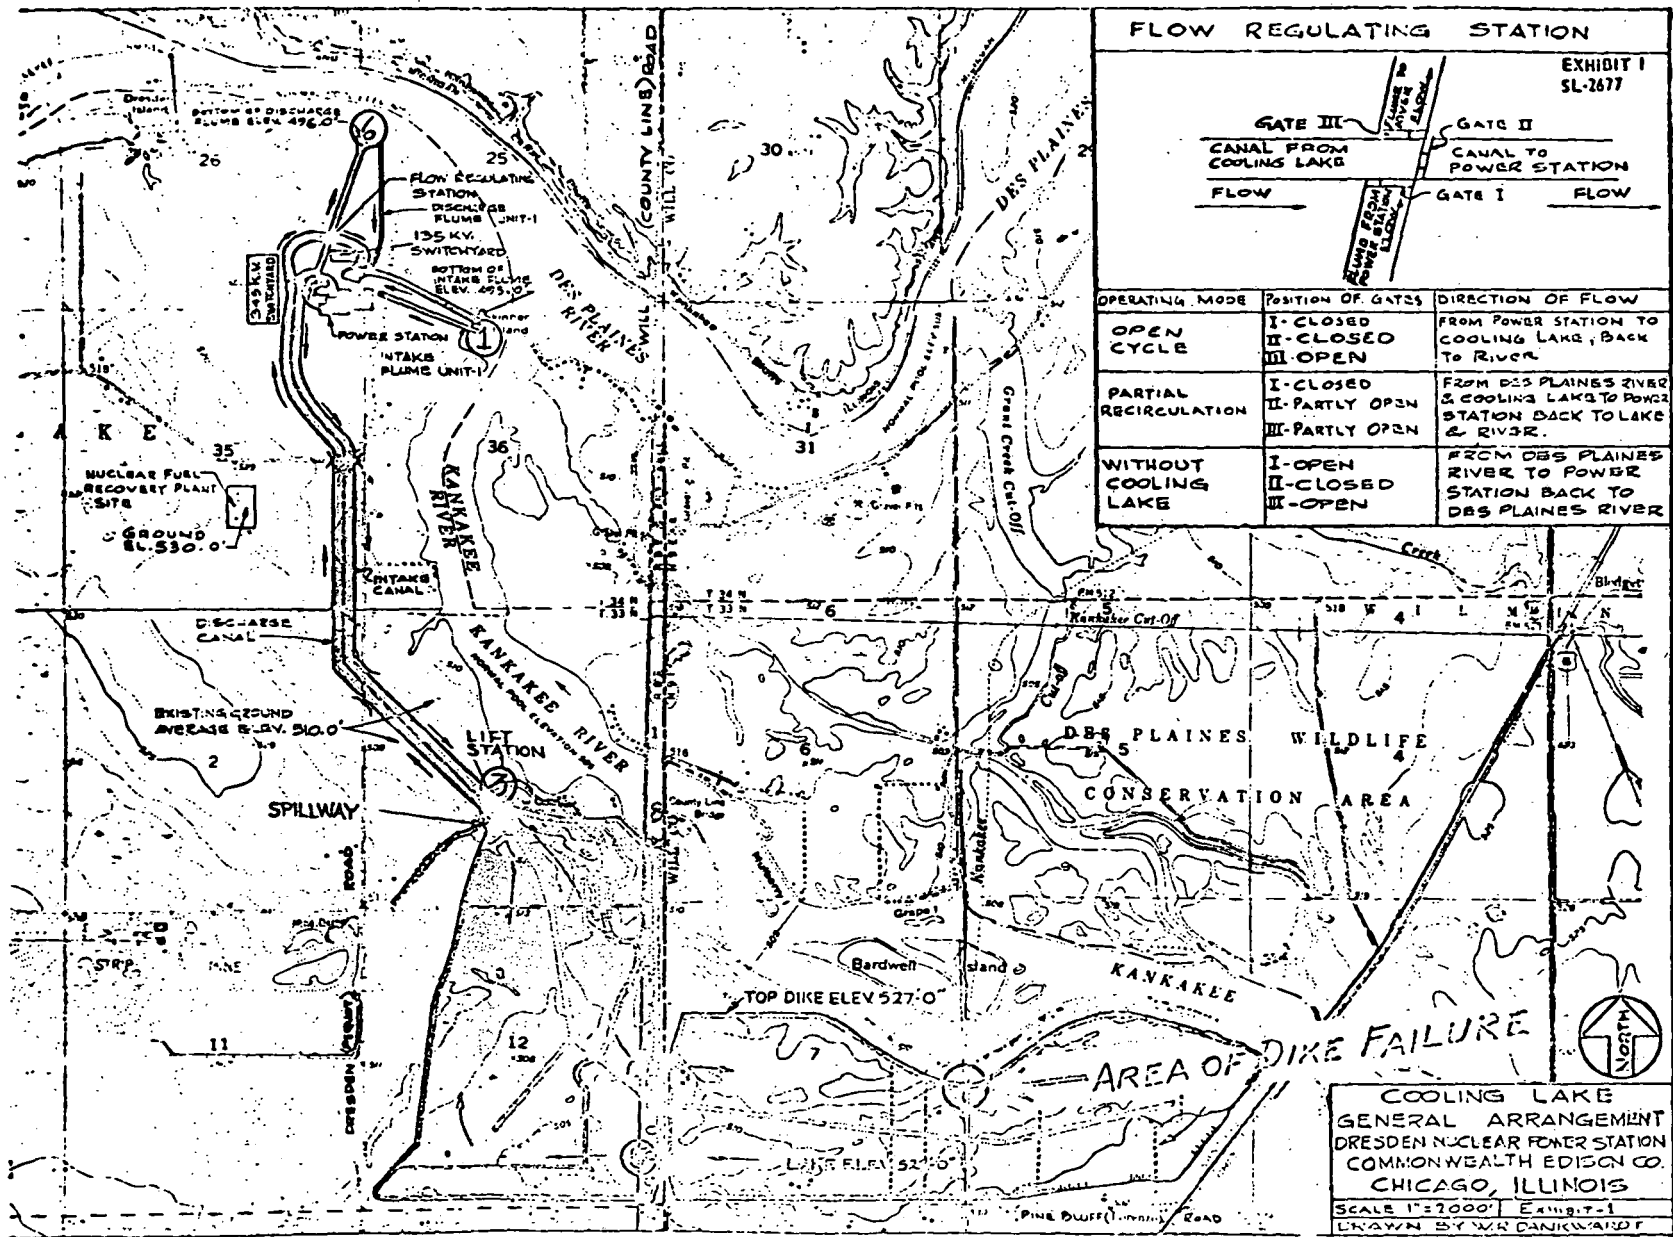
Fig. 1

Mr. Zar showed slides of the failed section of the dike taken from the air. The breach in the dike occurred over a length of approximately 100 feet along the north side of the lake paralleling the Kankakee River and opposite Bardwell Island, see fig. 1. Upon reviewing the aerial photograph of the plant site it was noted that the failed section of the dike crossed over an old filled stream bed or drainage ditch which had eroded the limestone bedrock to a considerable depth below the adjacent bedrock level. This old channel had filled with sand, gravel and soil over the years. The original exploration for the dike failed to reveal this anomaly in the bedrock. A boat slip for a proposed marina had been dredged into the river bank opposite the failed section of the dike. The deeply bedded sand and gravel layer in the eroded channel provide the seepage path for the water in the lake. As the fines were washed out and the permeability increased, the foundation soils became less stable and resulted in the dike failure.

The repair consists of removing all permeable soils from the failed section and beyond, down to bedrock and replacing it with an impermeable clay soil fill. The breached section of the dike is being reconstructed using a selected, test controlled compacted material. Particular attention is being given to keying the old and new dike sections together. Additional borings are being made along the dikes to make certain that all permeable soil layers have been intercepted by the clay cut off wall which is part of the dike design.

To insure that there is a positive cut off along the north dike a sheet pile cut off wall is being driven behind the inside face through the top of the dike into the bedrock. It is estimated that the total length of the sheet pile wall will be approximately 4000 feet. This length may be modified as additional boring information becomes available.
