UNITED STATES  
NUCLEAR REGULATORY COMMISSION  
OFFICE OF INSPECTION AND ENFORCEMENT  
WASHINGTON, D.C. 20555

IE Circular No. 79-02

FAILURE OF 120 VOLT VITAL AC POWER SUPPLIES

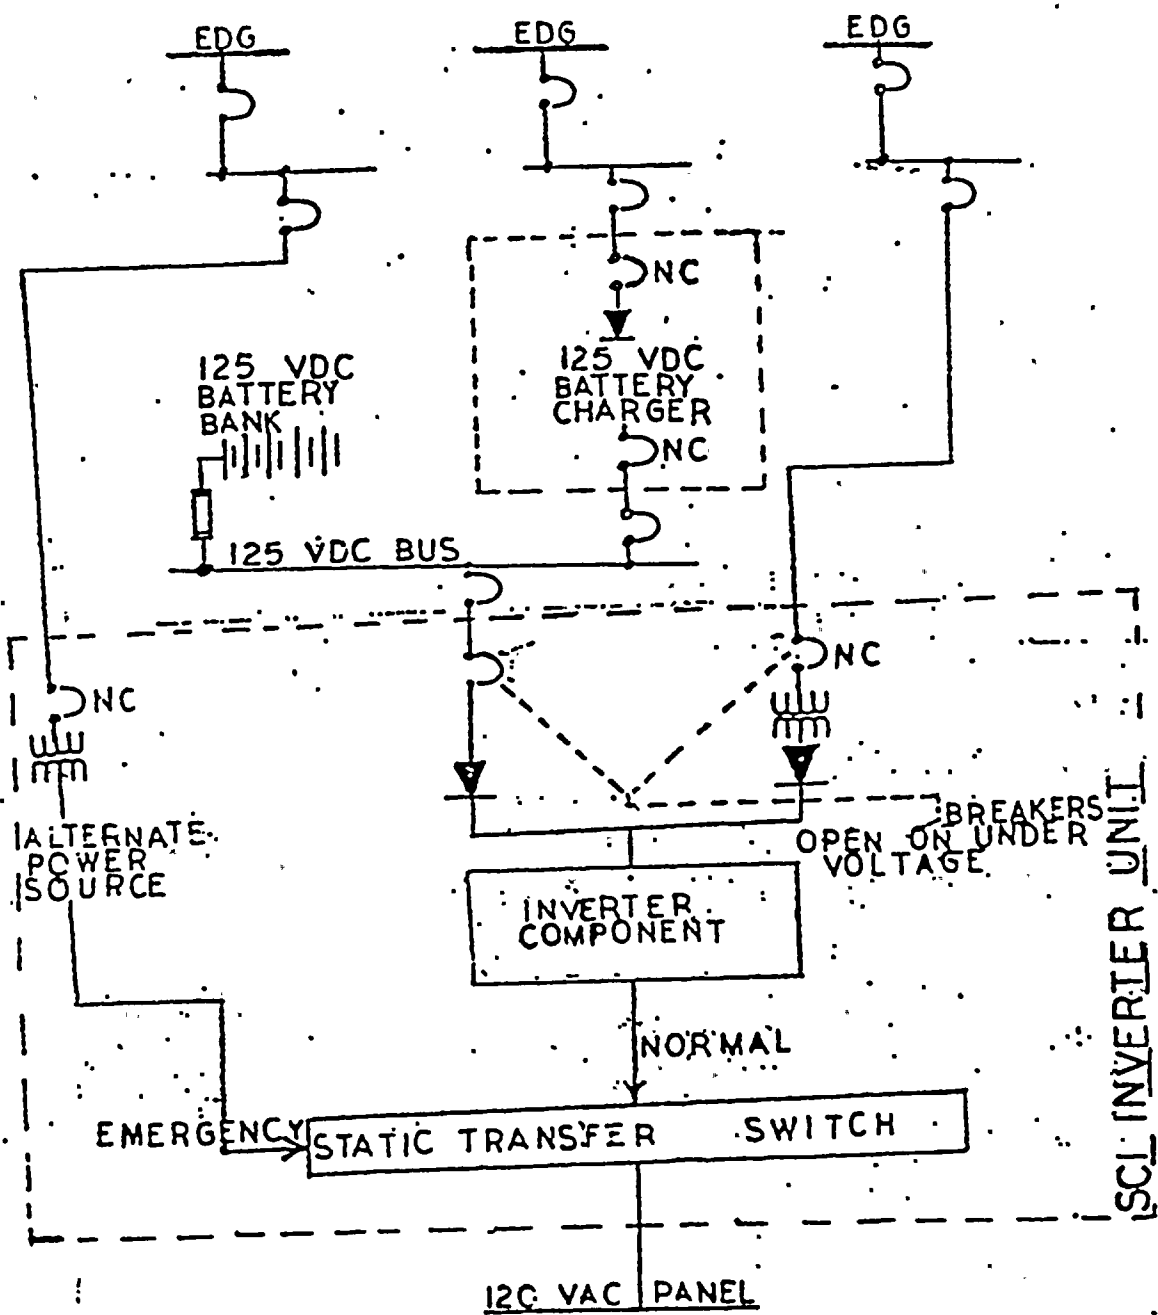
FIGURE 1  
SINGLE LINE DIAGRAM - 120 VAC

On September 16, 1978, Arkansas Nuclear One - Unit 2, while in hot functional testing preceding initial criticality, suffered a degradation of both of the independent off-site power sources. This produced an undervoltage condition on the Engineering Safety Features (ESF) Buses and caused an inadvertent ESF actuation. The licensee determined that the ESF actuation occurred on a loss of at least two of the uninterruptible 120 volt vital AC power sources. Immediate investigation revealed that all four of the Solidstate Controls, Inc., (SCI) inverter static switches had automatically transferred to the alternate power supply (the 120 volt AC being supplied by transformers directly off the ESF buses rather than from the inverter output.) Figure 1 (attached) shows the functional interconnection of the 120 volt AC power supply system.

A single conclusive cause of the undesired SCI inverter static switch transfer could not be identified. However, the following problems were discovered during subsequent investigation.

- (a) The SCI inverters have circuitry to monitor the incoming DC voltage level which, on sensing a low voltage (nominally 104 DC volts for these inverters) will trip both input breakers to the inverter component after an adjustable time delay.

The setting of these time delay relays were not verified during either preoperational testing or subsequent maintenance. The time delay is necessary in order to accommodate transient loading conditions which may be encountered.

- (b) On one SCI inverter, a DC fuse within the inverter component was found blown. The vendor indicated that this fuse will blow due to an excessive DC voltage to the inverter component caused by a transient on the 480 AC input. The licensee has subsequently reset the taps on the 480V to 120V three-phase AC input transformer to limit the DC voltage to the inverter to less than the nameplate maximum rating in the event of a high AC input voltage transient.

- (c) The SCI inverter static switch is designed to transfer to an alternate source on inverter output overcurrent or undervoltage. Initially, these trips were set at 125 percent overcurrent and 80 percent undervoltage. An explanation for the transfer of two of the inverter static switches is that during one of the transfers of site loads, the instantaneous inductive load caused these trip set points to be exceeded. The licensee has subsequently adjusted the transfer sensing circuitry to higher overcurrent and lower undervoltage trip settings to assure that the inverter will maintain load over the widest possible range of voltage and current. (Note that in this case, once the SCI inverter transfers to the alternate source, it will not automatically transfer back to normal source.)

1. Determine whether or not time delay circuitry is used in your inverter units. If so, have they been adjusted to the appropriate set point as required by equipment and the integrated system designs?

2. Determine if the AC input voltage and transformer tap settings are optimized to prevent exceeding the inverter component name-plate maximum rated DC input voltage in the event of a high AC input voltage transient.

3. If an alternate 120 volt source is used in your design, determine if the protection transfer circuitry of the inverter has been optimized within design limits to ensure maximum possible availability of the inverter system during transient loading conditions. An operating history of inexplicable transfers may be indicative of the above.

4. Determine if the administrative controls employed by your facility ensures operability of safety systems after its subcomponents (e.g., time delay relays, switches, etc.) have been subjected to maintenance or testing.
