Interim Construction Deficiency Report

Damage Resulting From Derrick Failure During Hurricane David

Name of Station: St. Lucie Plant - Unit #2
Owner: Florida Power & Light Company .
Architect/Engineer: Ebasco Services, Incorporated
Date of Deficiency: September 3, 1979
Interim Report Filed: October 4, 1979

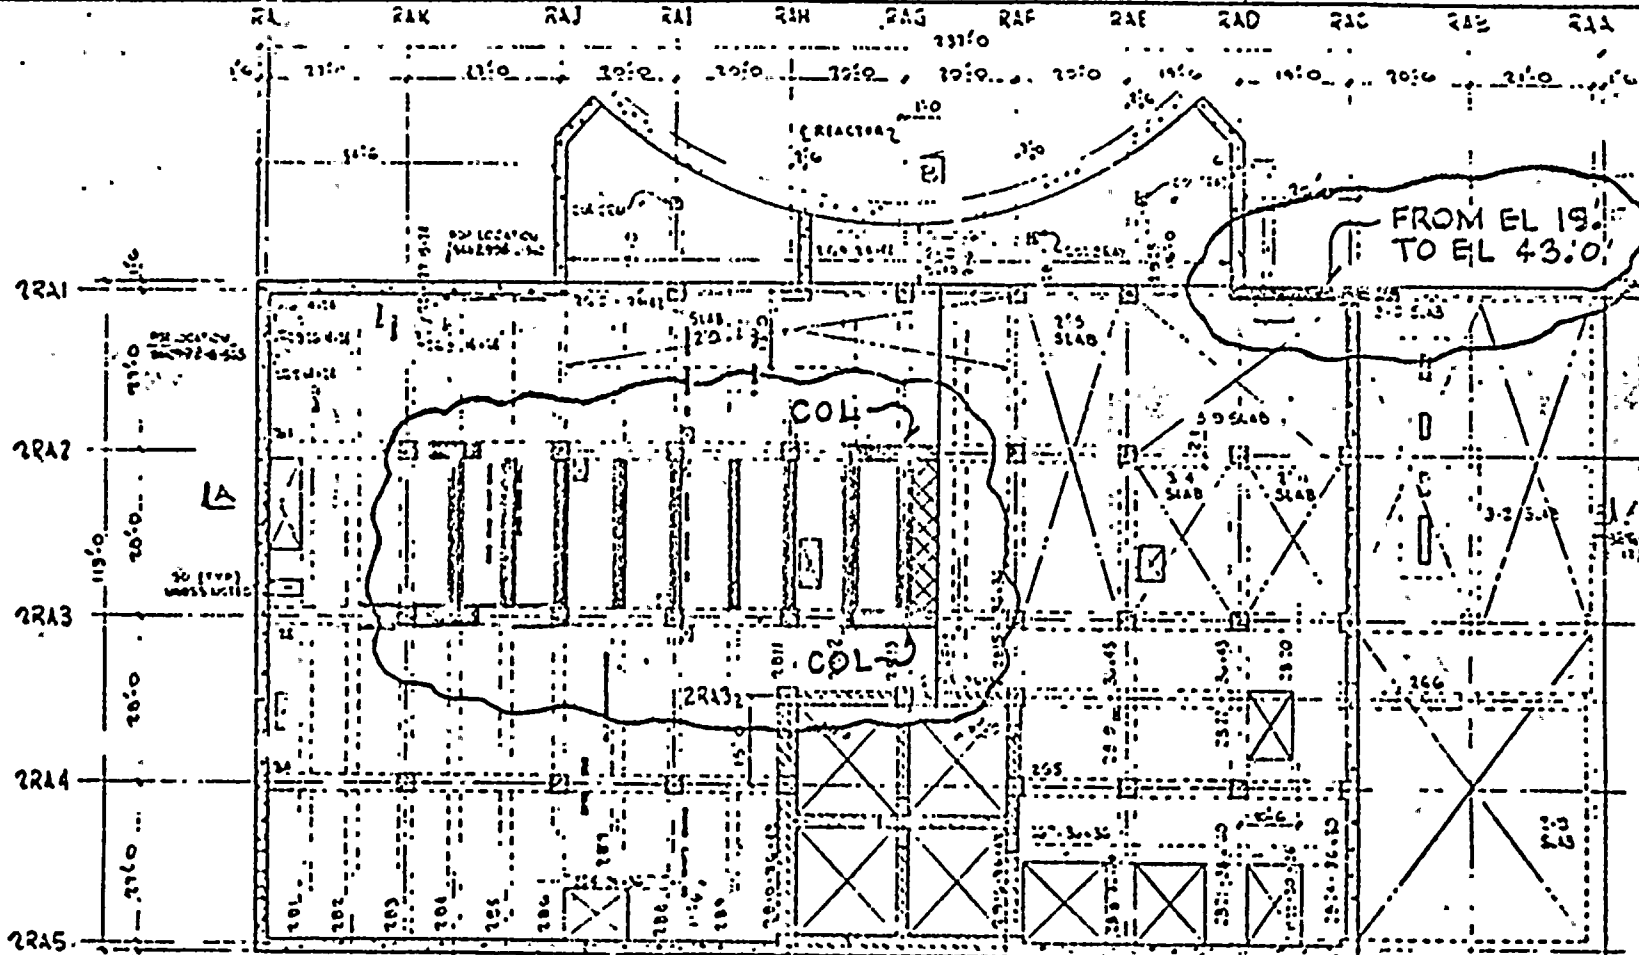
E BASCO SERVICES INCORPORATED		FIG. 1	
DV. _____	DR. _____	APPROVED	REACTOR AUXILIARY BUILDING LOCATION OF PULSE ECHO TESTING
DTE _____	CH. _____		
SCALE _____

The damage within the Reactor Auxiliary Building was extensive and consisted of penetration of floor slabs, shattered floor beam, spalled concrete, and bent and sheared dowels for columns and walls. There is a possibility of some cracking of some floor beams and girders and one exterior wall section. The location of derrick and boom section resting positions, and details of observed damage to the Reactor Auxiliary Building is presented on the enclosed sketches, SK-2998-FG 75.01 to 75.06. In addition to the noted damage on the attached sketches, cracks were observed on the surface of a few elevation +43 feet floor beams. These cracks were chipped back to determine depth and were observed to be only surface shrinkage cracks.

Architect/Engineer has directed Construction to proceed with two testing programs to confirm the extent of damage within the Reactor Auxiliary Building. The first program requires testing of reinforcing steel samples removed from the damaged floor beams and slabs at elevation +62 feet. Test results will indicate if the reinforcing which extends into the surrounding sound concrete had been overstressed during missile impact. The second program requires non-destructive testing of concrete members, 1) adjacent to damaged floor slab areas at elevations +43 feet and +62 feet, including all the beams at elevation +43 feet which were observed to have only surface cracks, and 2) in an exterior wall along the north side of the building which had only five day concrete strength when a section of the derrick hit the top of the wall. The pulse echo method was selected and will be performed by Muenow and Associates of Charlotte, North Carolina. The attached Figures 1 and 2 show the concrete members to be investigated.
