Final Construction Deficiency Report

Damage Resulting From Derrick Failure During Hurricane David

Name of Station:	St. Lucie Plant - Unit #2
Owner:	Florida Power & Light Company
Architect/Engineer:	Ebasco Services, Incorporated
Date of Deficiency:	September 3, 1979
Interim Report Filed:	October 4, 1979
Supplement to Interim Report Filed:	December 7, 1979
Final Report Filed:	February 1, 1980

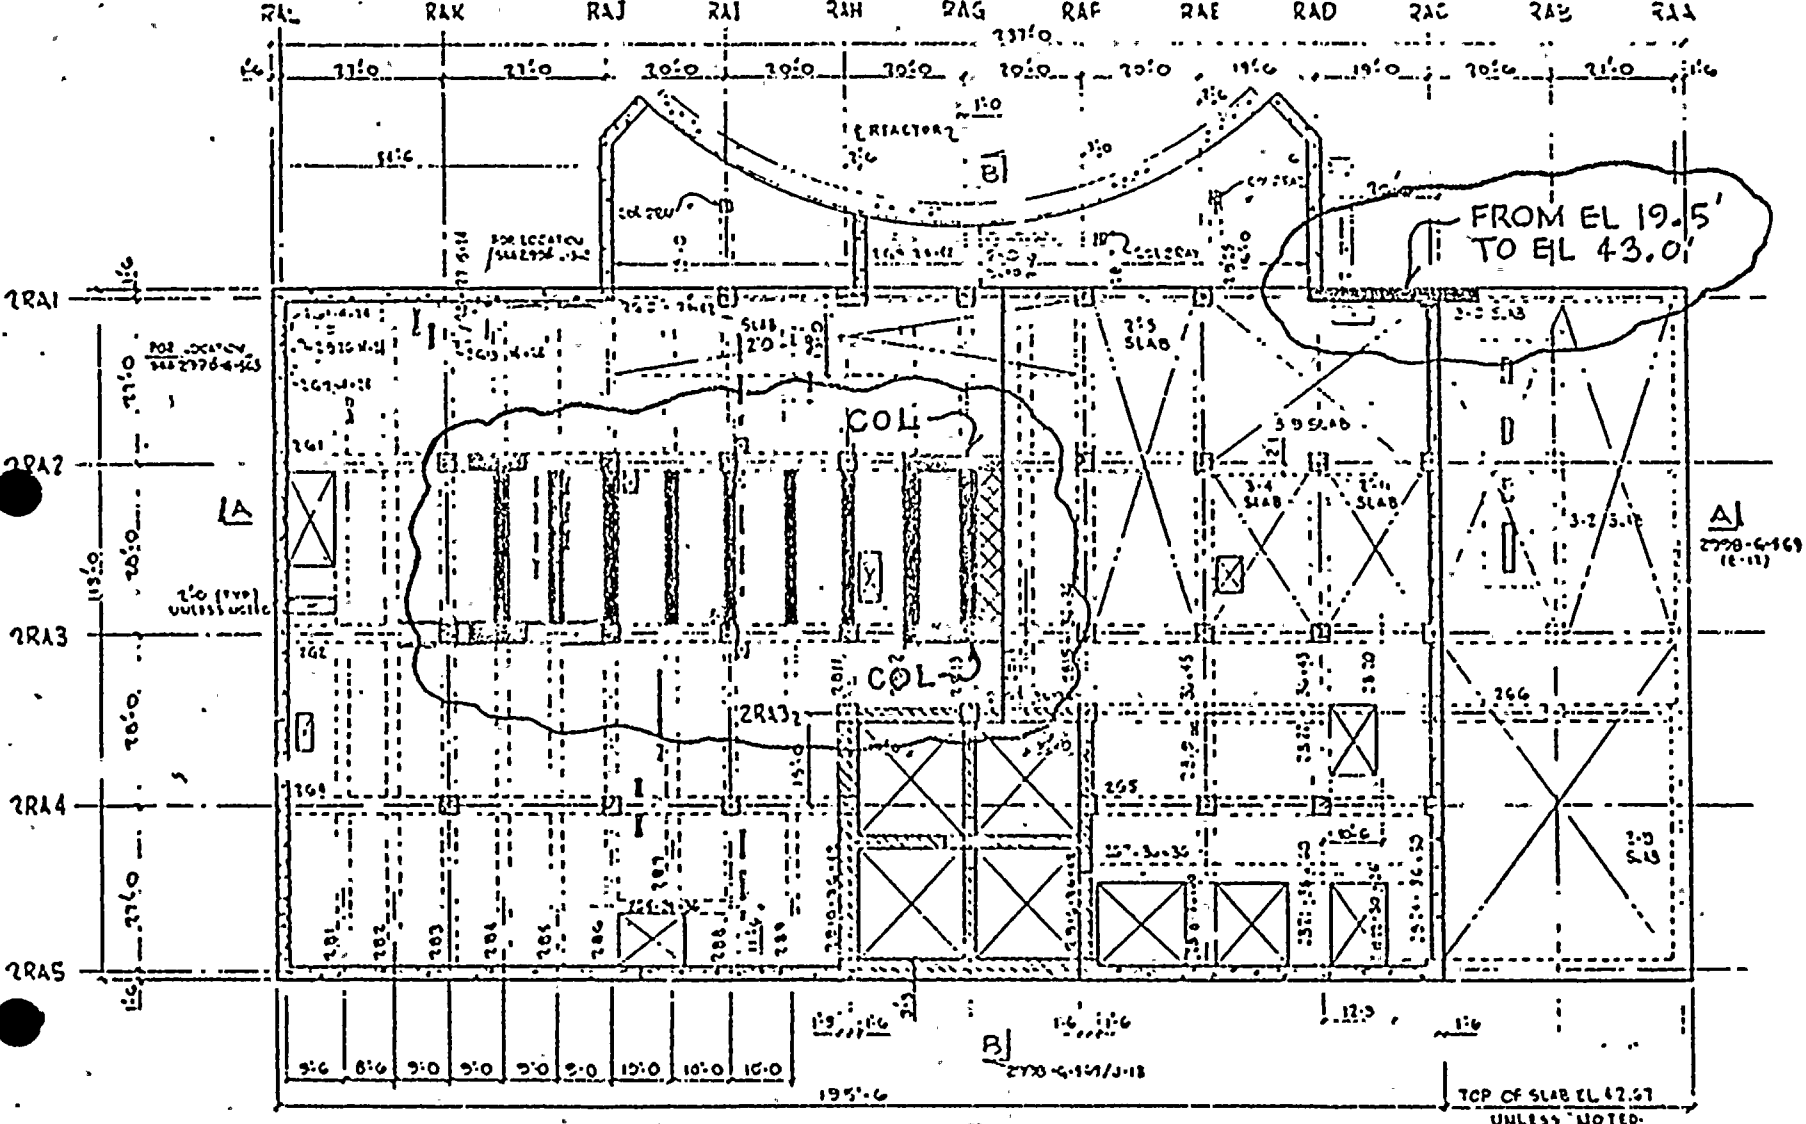
EBASCO SERVICES INCORPORATED		FIG. 1	
DIV. _____ DR. _____	APPROVED _____	REACTOR AUXILIARY BUILDING	
DATE _____ CH. _____	_____	LOCATION OF PULSE	
SCALE _____	_____	ECHO TESTING

The pulse echo method was selected and was performed by Muenow and Associates of Charlotte, North Carolina. The attached Figures 1 and 2 show the concrete members which were investigated.

- Shattered and badly cracked concrete of slab east of column line RAG and between column lines 2RA2 and 2RA3 was removed.
- Samples of exposed slab reinforcing were removed and tested, and were found to meet ASTM minimum requirements.
- Nondestructive testing was performed on all beams on which a portion of the derrick had come to rest and girders and support columns adjacent to the damaged concrete slab (beams 2B4 - 2B13 between columns lines 2RA2 and 2RA3). No microcracks were detected and any visually observed surface cracks were found not to extend beyond two to three inches in depth.

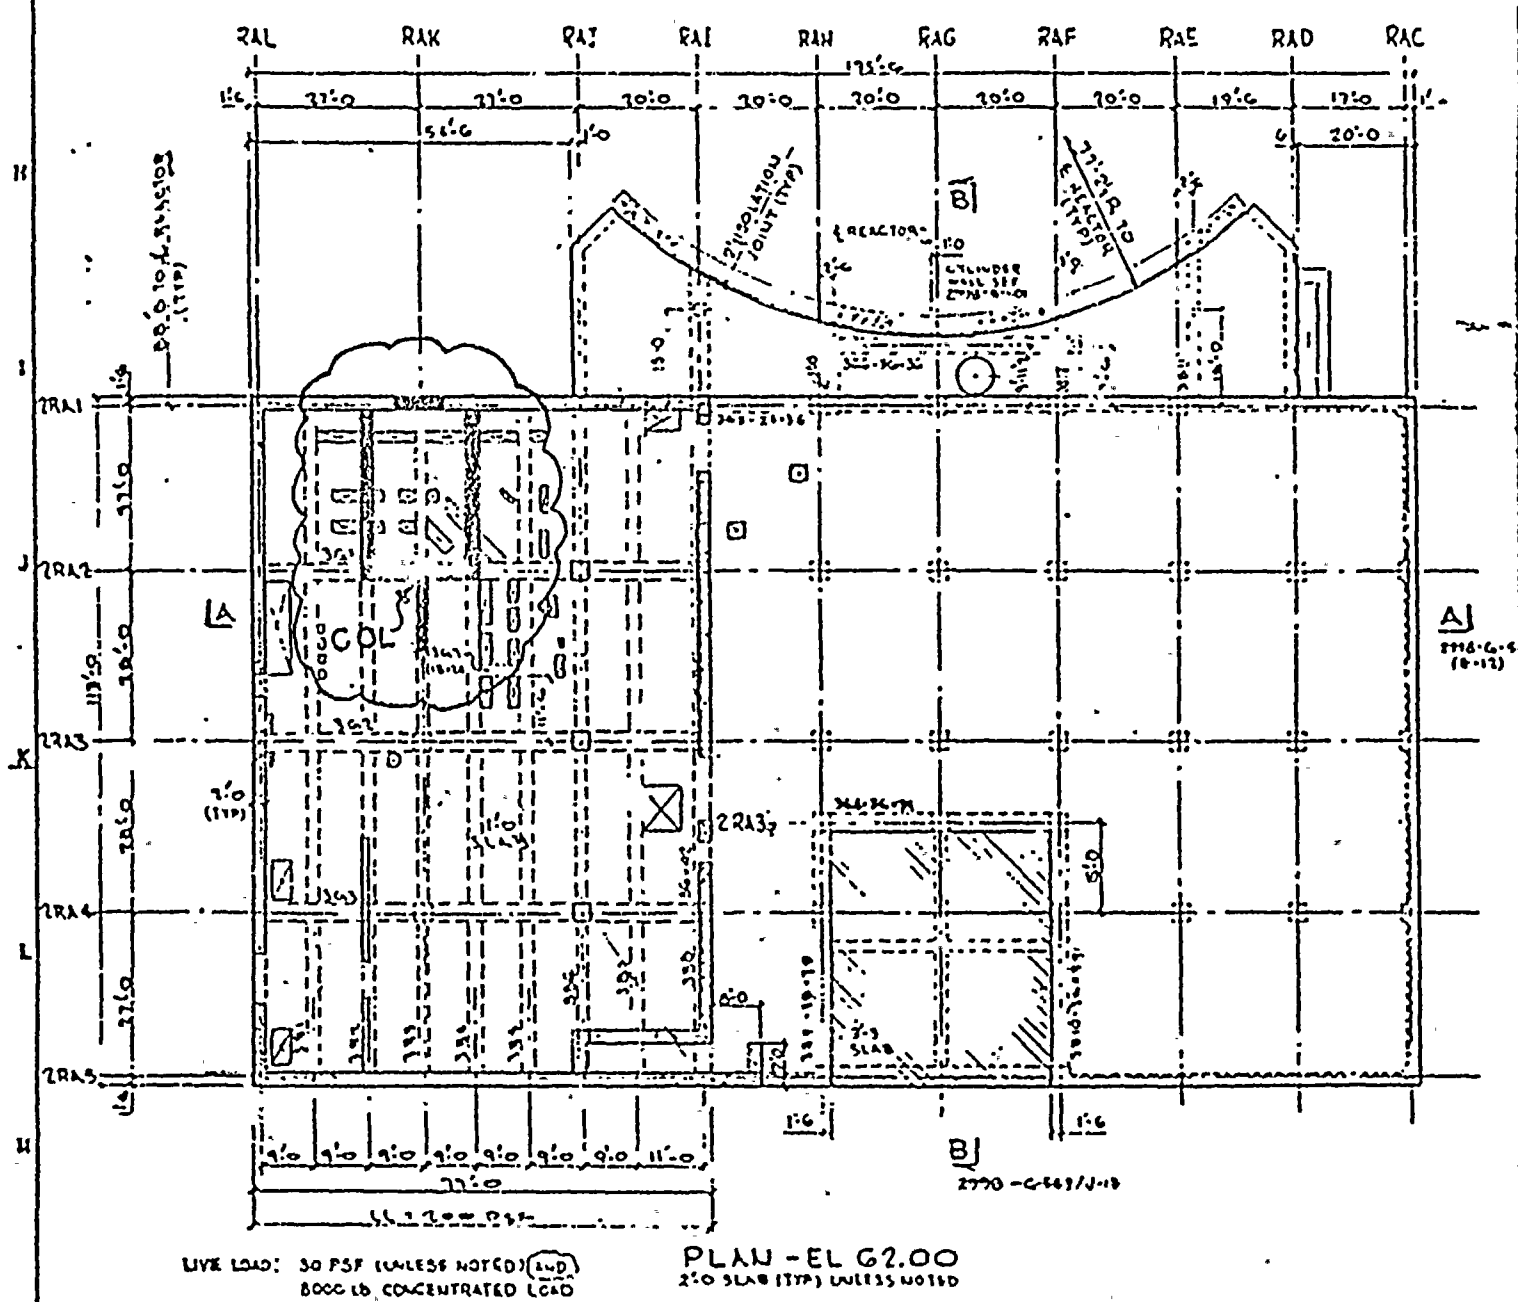
EBASCO SERVICES INCORPORATED		APPROVED	FIG. 2 REACTOR AUXILIARY BUILDING LOCATION OF PULSE ECHO TESTING
DIV. _____	DR. _____		
DATE _____	CH. _____		
SCALE _____

- Nondestructive testing of visually sound concrete members adjacent to the impact area indicated the following:
 - 1) Microcracking and loss of concrete bond to reinforcement in the top four inches of concrete within beams 3B2 and 3B4 adjacent to impacted Beam 3B3, and in Beam 3B3 south of Column Line 2RA2.
 - 2) Microcracking in adjacent slabs through out the one foot depth and for a distance of 3.5 feet past beams 3B2 and 3B4.
 - 3) Microcracking on exterior wall at support point of Beam 3B2 for a depth of less than three inches.
- To document validity of test results, nondestructive testing of concrete members away from the damaged area was also performed and results indicated sound concrete.
