**PRELIMINARY HUMAN ENGINEERING
ASSESSMENT OF THE SAINT LUCIE UNIT 2
NUCLEAR POWER PLANT CONTROL ROOM**

Florida Power & Light Company

June 12, 1981

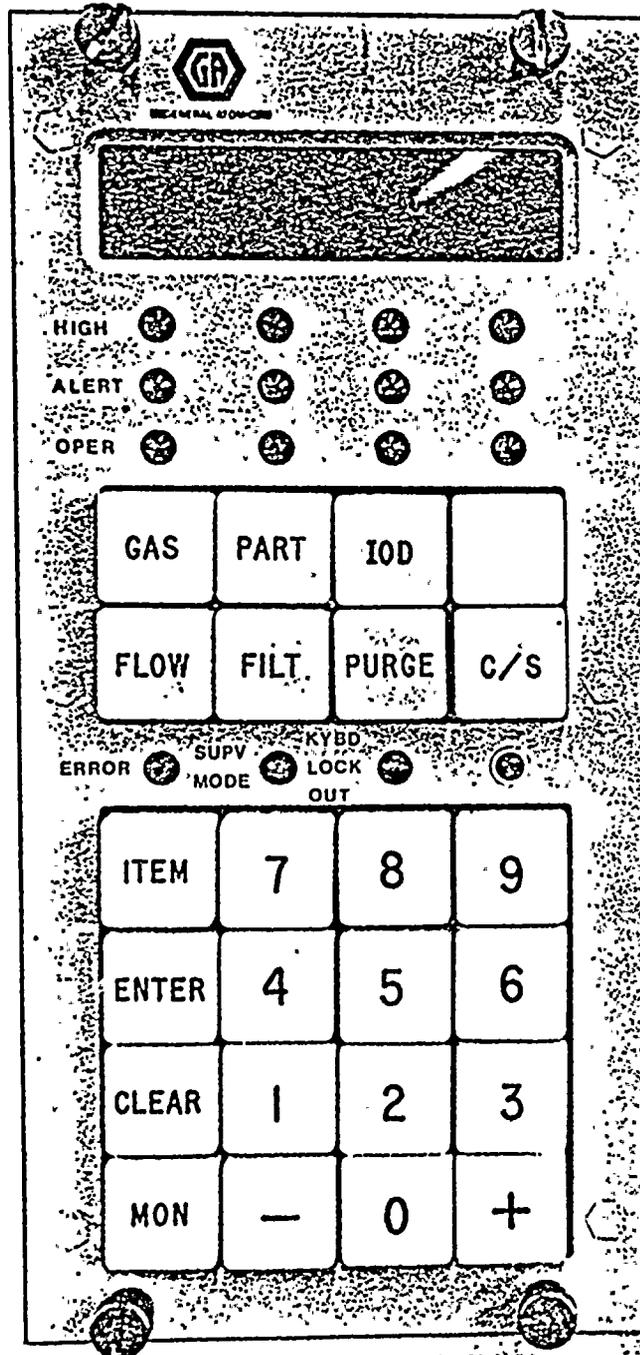
FIGURE 1 - A typical RM-23 module. Labeling of the eight-pushbutton matrix is a client specified option and varies with the desired monitoring function.

2. The "ON", "ALERT" and "HIGH ALARM" lights are very small and not very intense. This makes them difficult to detect under normal illuminance conditions. These should be enlarged and their intensity increased if there is any possibility that they must function as primary displays (i.e., primary radiation annunciators).

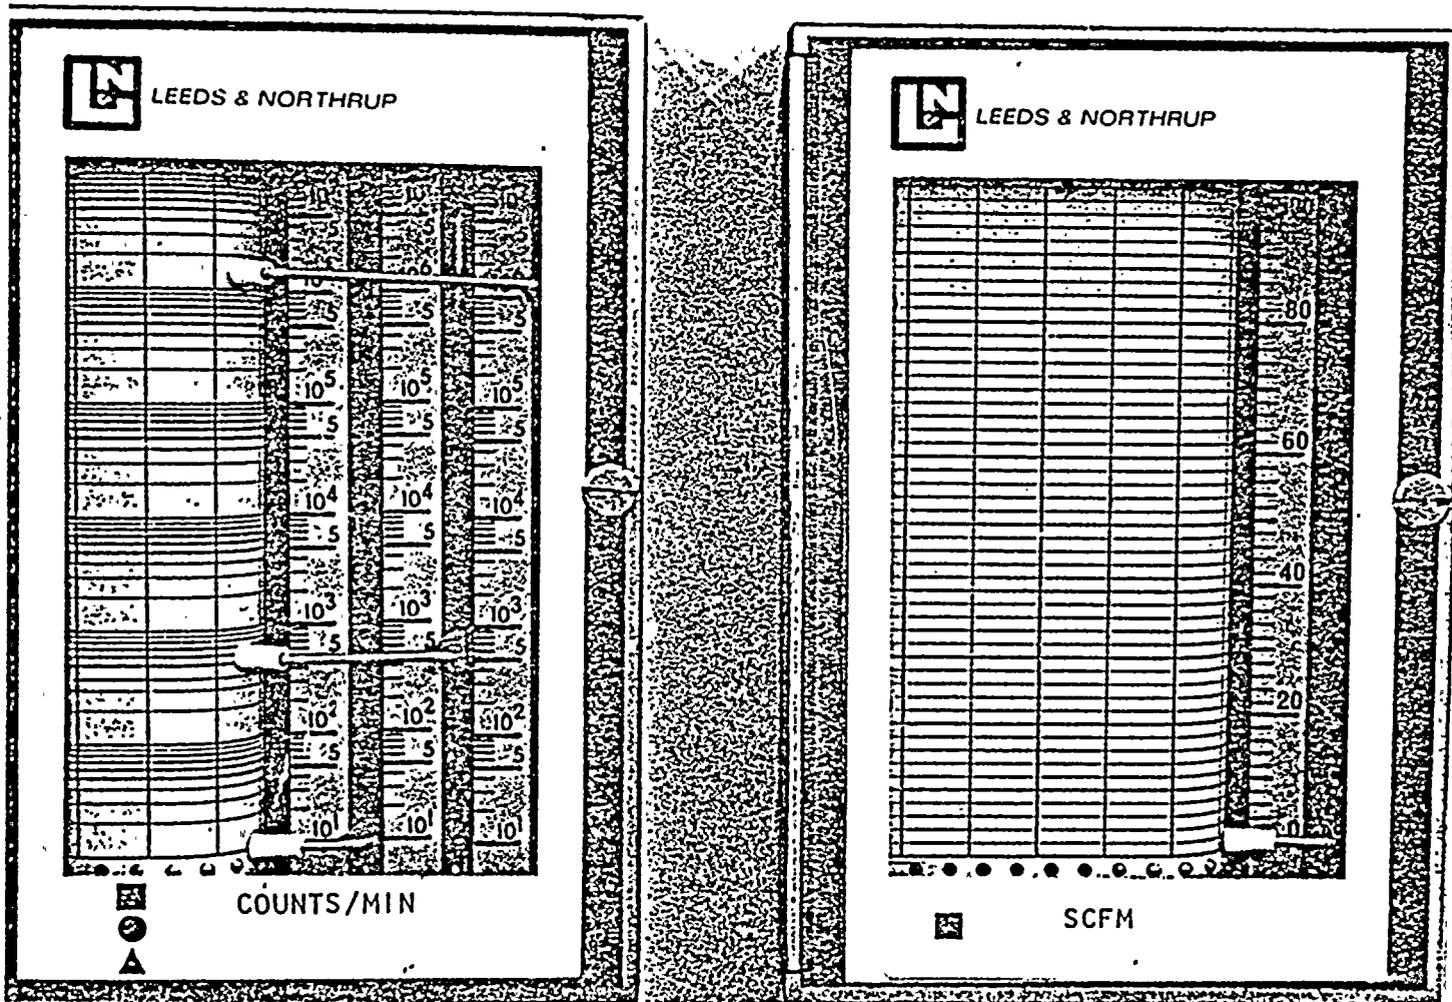
Figure 3 - Examples of the Leeds and Northrup strip chart recorders. Number of pens and linear vs. logarithmic scales are dependent upon client requirements.

4. The strip chart recorders must be read up close. Beyond four feet an observer cannot determine if they are standard scale or log scale.
5. There is no alarm mechanism to notify the operator of strip chart failure, paper running out, or exhausted ink supply.

7. The pen/channel to color on these Leeds and Northrup recorders are different from the majority found in NPP CRs. Based upon a previous recommendation, it is suggested that the sequence be changed to the following:

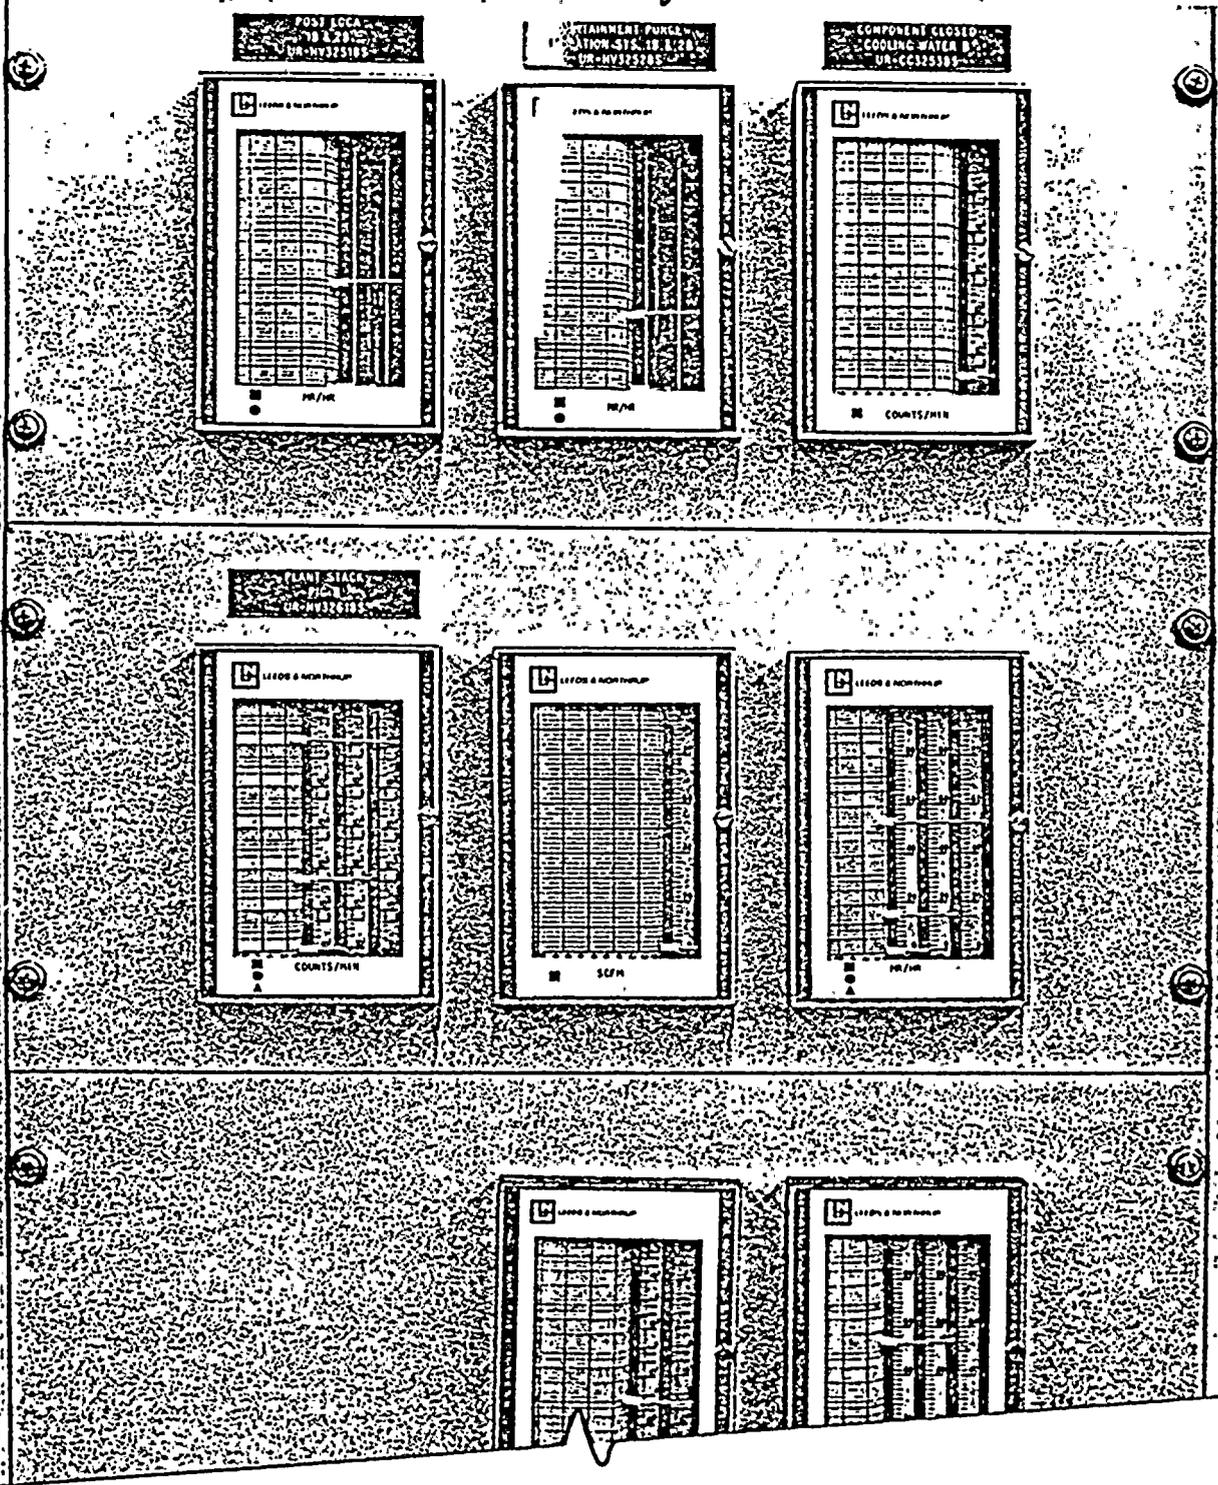
Figure 4 - Examples of the L&N strip chart recorder installation in the RM-23 cabinet. Locations, labels, and number of recorders are dependent upon client requirements.

6. The strip chart recorders can be fully removed from the cabinet once the retainers are loose. Locks should be installed such that they cannot be inadvertently pulled all the way out and dropped when changing ink and paper.

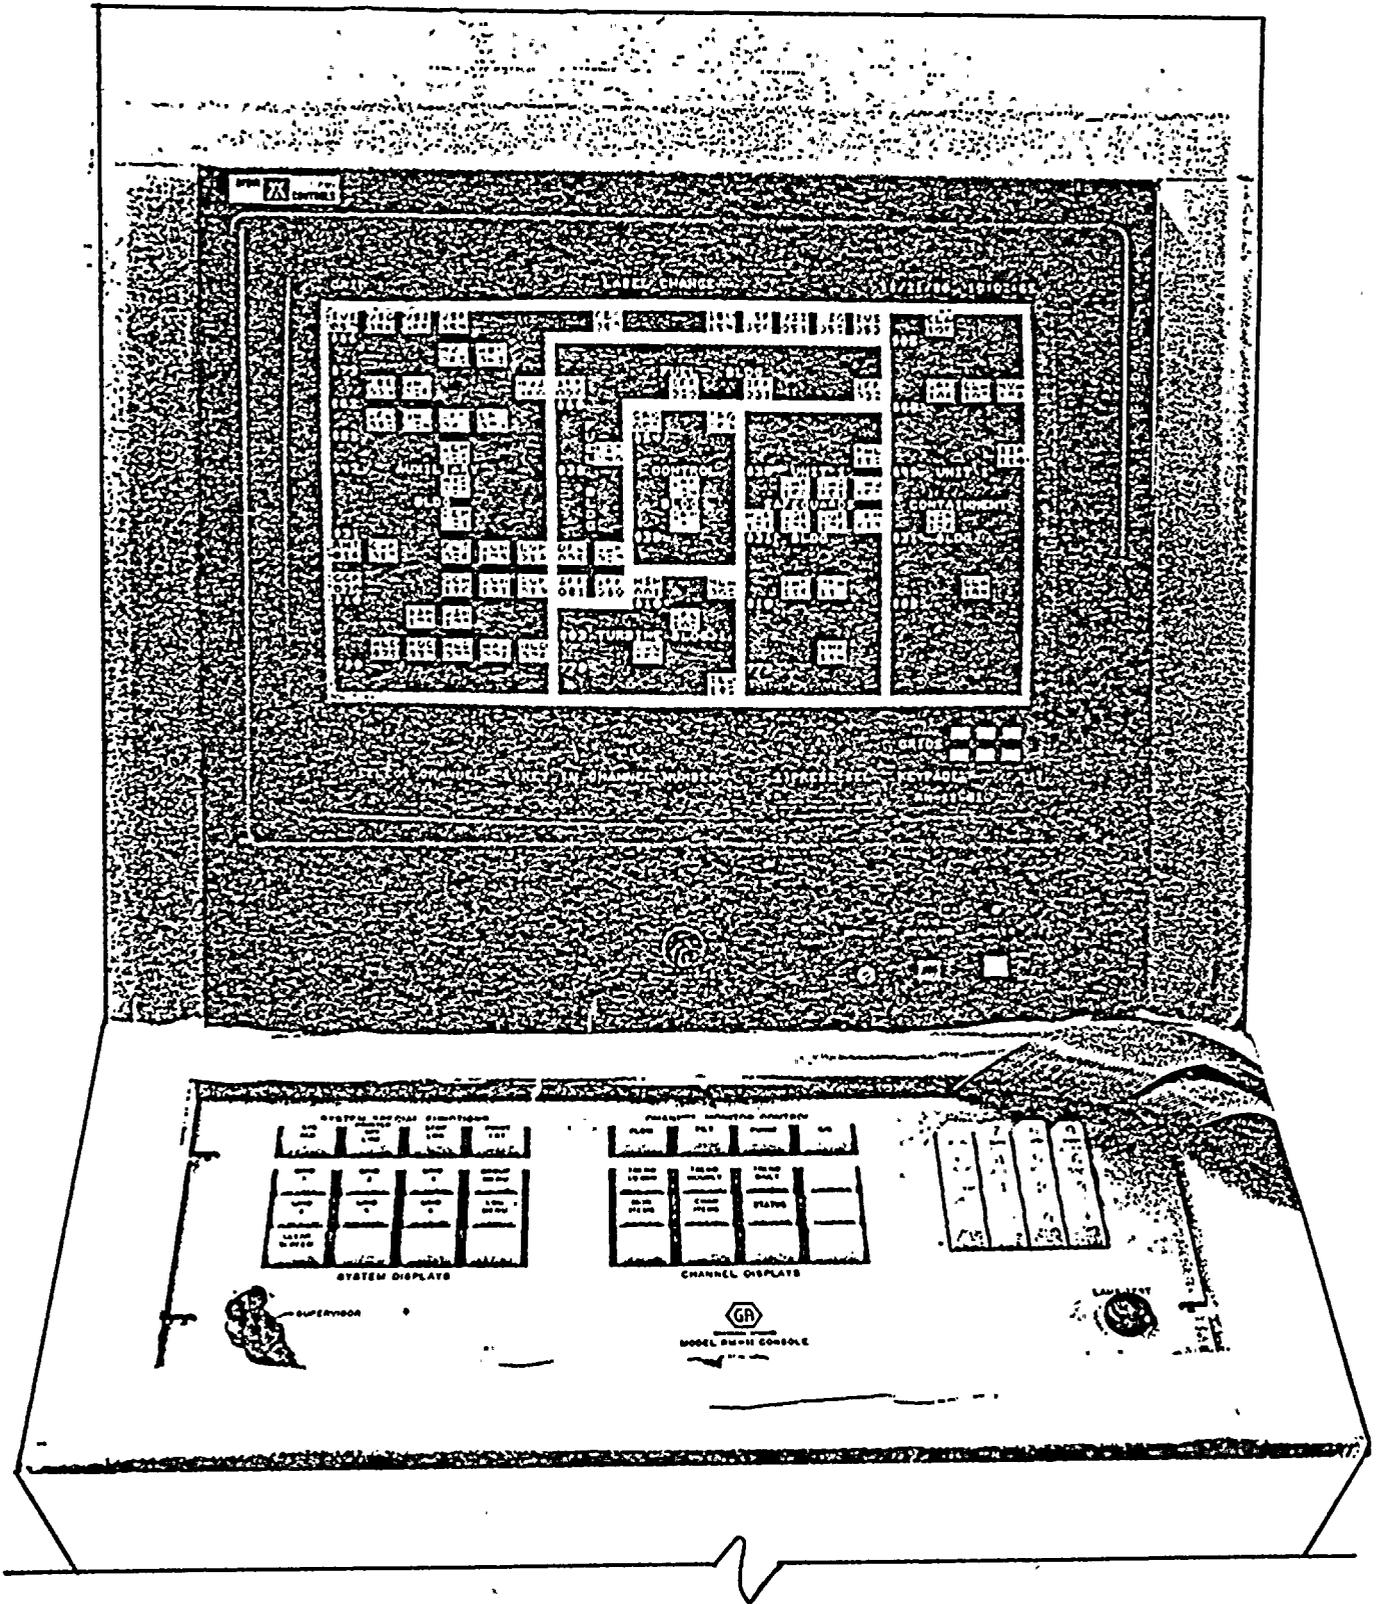
Figure 5 - A typical RM-11 CRT Console (base not shown). Conductor tapes at lower right of CRT are for testing and are not part of the permanent console.

6. The "ENTER" function button is located on the left side of the numeric keyboard, the second in a column of identically appearing buttons and could cause some delay in operating. This is not a time critical system; however, better location of the "ENTER" button could improve operator performance.

9. The "LIT" button converts all function keys to alphabetical keys for system programming. This capability imposes the requirement for a number of buttons that are not used by Control Room Operators. This could cause some confusion; however, this is not a time critical system. It is recommended that this label be changed to one more descriptive of its function such as "NOR/ALPHA" for normal or alphabetic. Additionally, all function keys should carry a double label indicating function (under normal conditions) and the alpha character (when programming function is on).
