Docket No. 50-335

LICENSEE: Florida Power & Light Company (FPL)
FACILITY: St. Lucie Unit 1
SUBJECT: MEETING SUMMARY - ST. LUCIE UNIT 1 STEAM GENERATOR TUBES

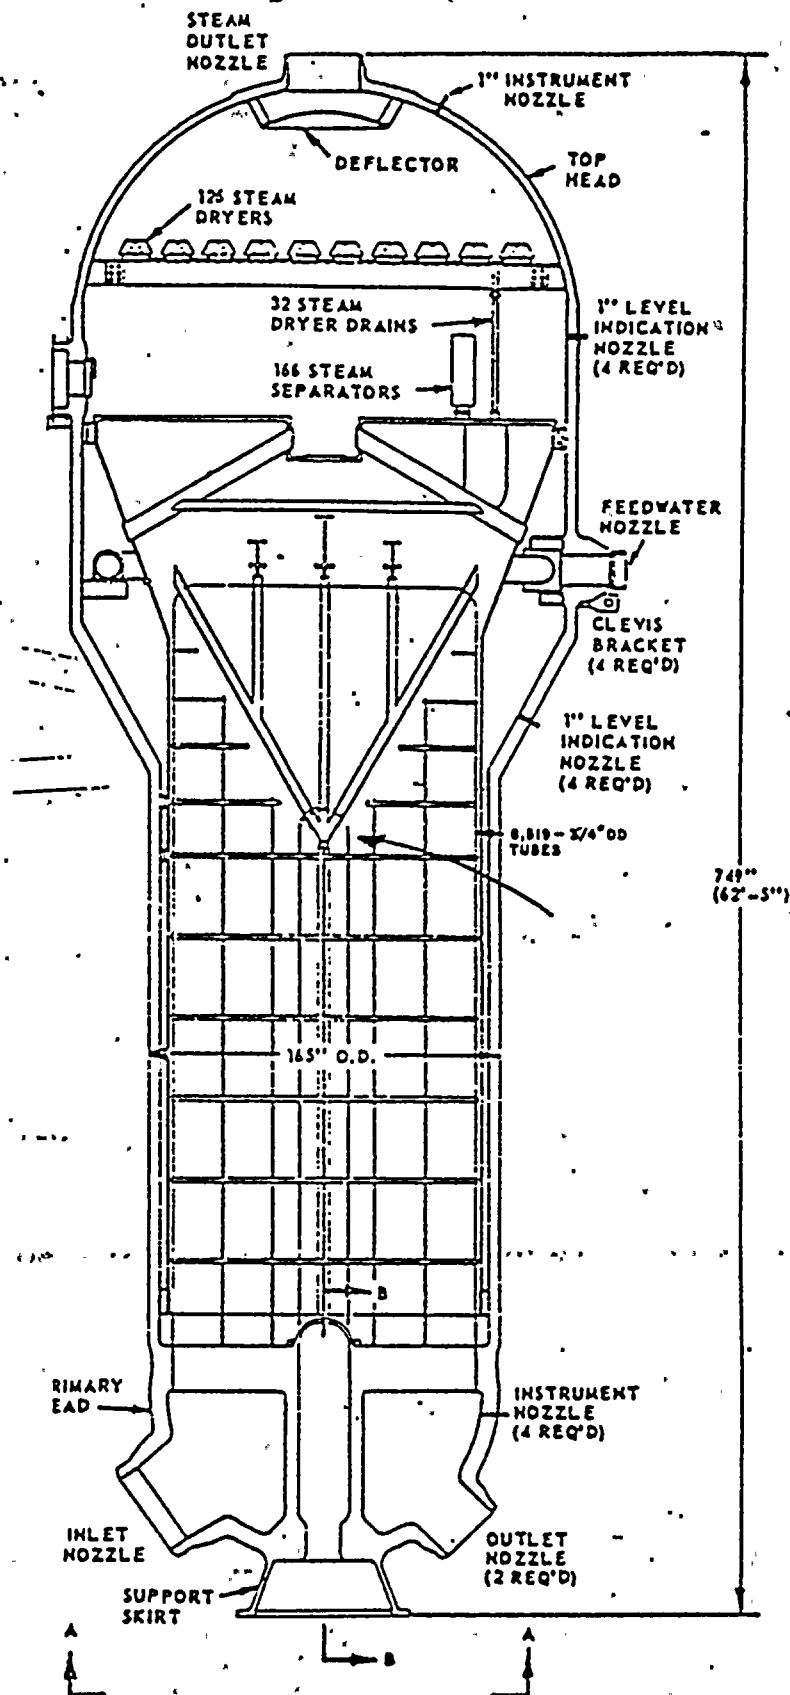
FIGURE 1

Two CE SGs are in service at the plant. Primary coolant passes through U-tubes which serve as both a boundary and a heat transfer medium between the primary and secondary fluids. There are about 8500 tubes in each SG. Tubes in rows 1-18 (inner rows) have a single 180° U-bend. The remaining tubes have two 90° bends and a length of horizontal tube. As illustrated in Figure 1 the SG design includes a V (batwing) support structure.
