SUBJECT: Forwards modified responses to Items A.1.3, A.3.1, A.4.10, A.5.8, A.5.9 & A.6.11 of App C, Suppl 1 to NUREG-0843 re control room design, per 821227 telcon. Updated Section 3.1 of "Near-Term OL Summary Human Engineering Rept..." also encl.

Re: St. Lucie Unit No. 2
Docket No. 50-389
FPL/NRC December 27, 1982 Telecommunication
on Control Room Design Review
Supplement 1 of NUREG-0843

NTOL SUMMARY HUMAN ENGINEERING REPORT ON ST. LUCIE UNIT NO. 2
 CONTROL ROOM (Supplement #1) Update of Section 3.1

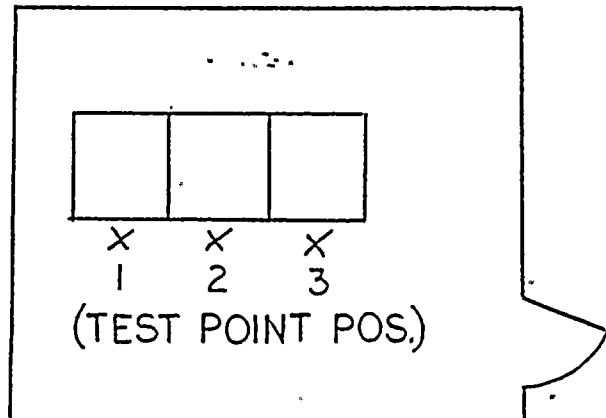
LIGHT SURVEY FOR REMOTE SHUTDOWN PANEL ROOM

A light survey of the normal AC and emergency D.C. light levels in the Remote Shutdown Panel area was completed on November 3, 1982. Light levels were measured at three levels of each vertical panel. The data are presented below:

Remote Shutdown Panel Room Diagram: *NOTE: Readings taken at (3) different positions directly in front of the panel and at (3) verticle points: 30", 50", 74" for each position. Measurements readings in ft.-candles.

Light levels in the Remote Shutdown Panel room will be reduced for conditions 2 and 4 above by reducing the incandescent lamp size. Verification testing will be complete after installation of the two control relays which are scheduled for installation during the second week of February, 1983.

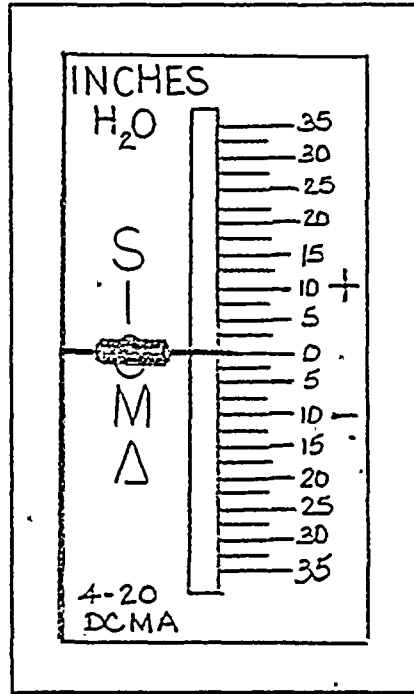
FIGURE NO. 1

During a field review of this item with NRC Field Inspector, Mr. Steve Elrod, it was agreed that the major thick marks on sigma meters did not pose any confusion to the control room operator. Where indicators display positive and negative values the scales are conspicuously marked indicating positive and negative values. Major graduation on sigmas are consistently marked as per the attached Figures 1 & 2. Figure 1 depicts a typical sigma scale showing a negative to positive value scale and Figure 2 depicts a typical sigma scale showing zero to positive values.

"The marks viewed as being minus (-) signs by the field inspection team pose no significant interpretation problem to the control room operator. The subject sigma meter graduations are consistently presented. Where negative and positive values are displayed by indicators minus (-) and plus (+) signs are conspicuously placed on indicator scales. FP&L intends no further action on this item."

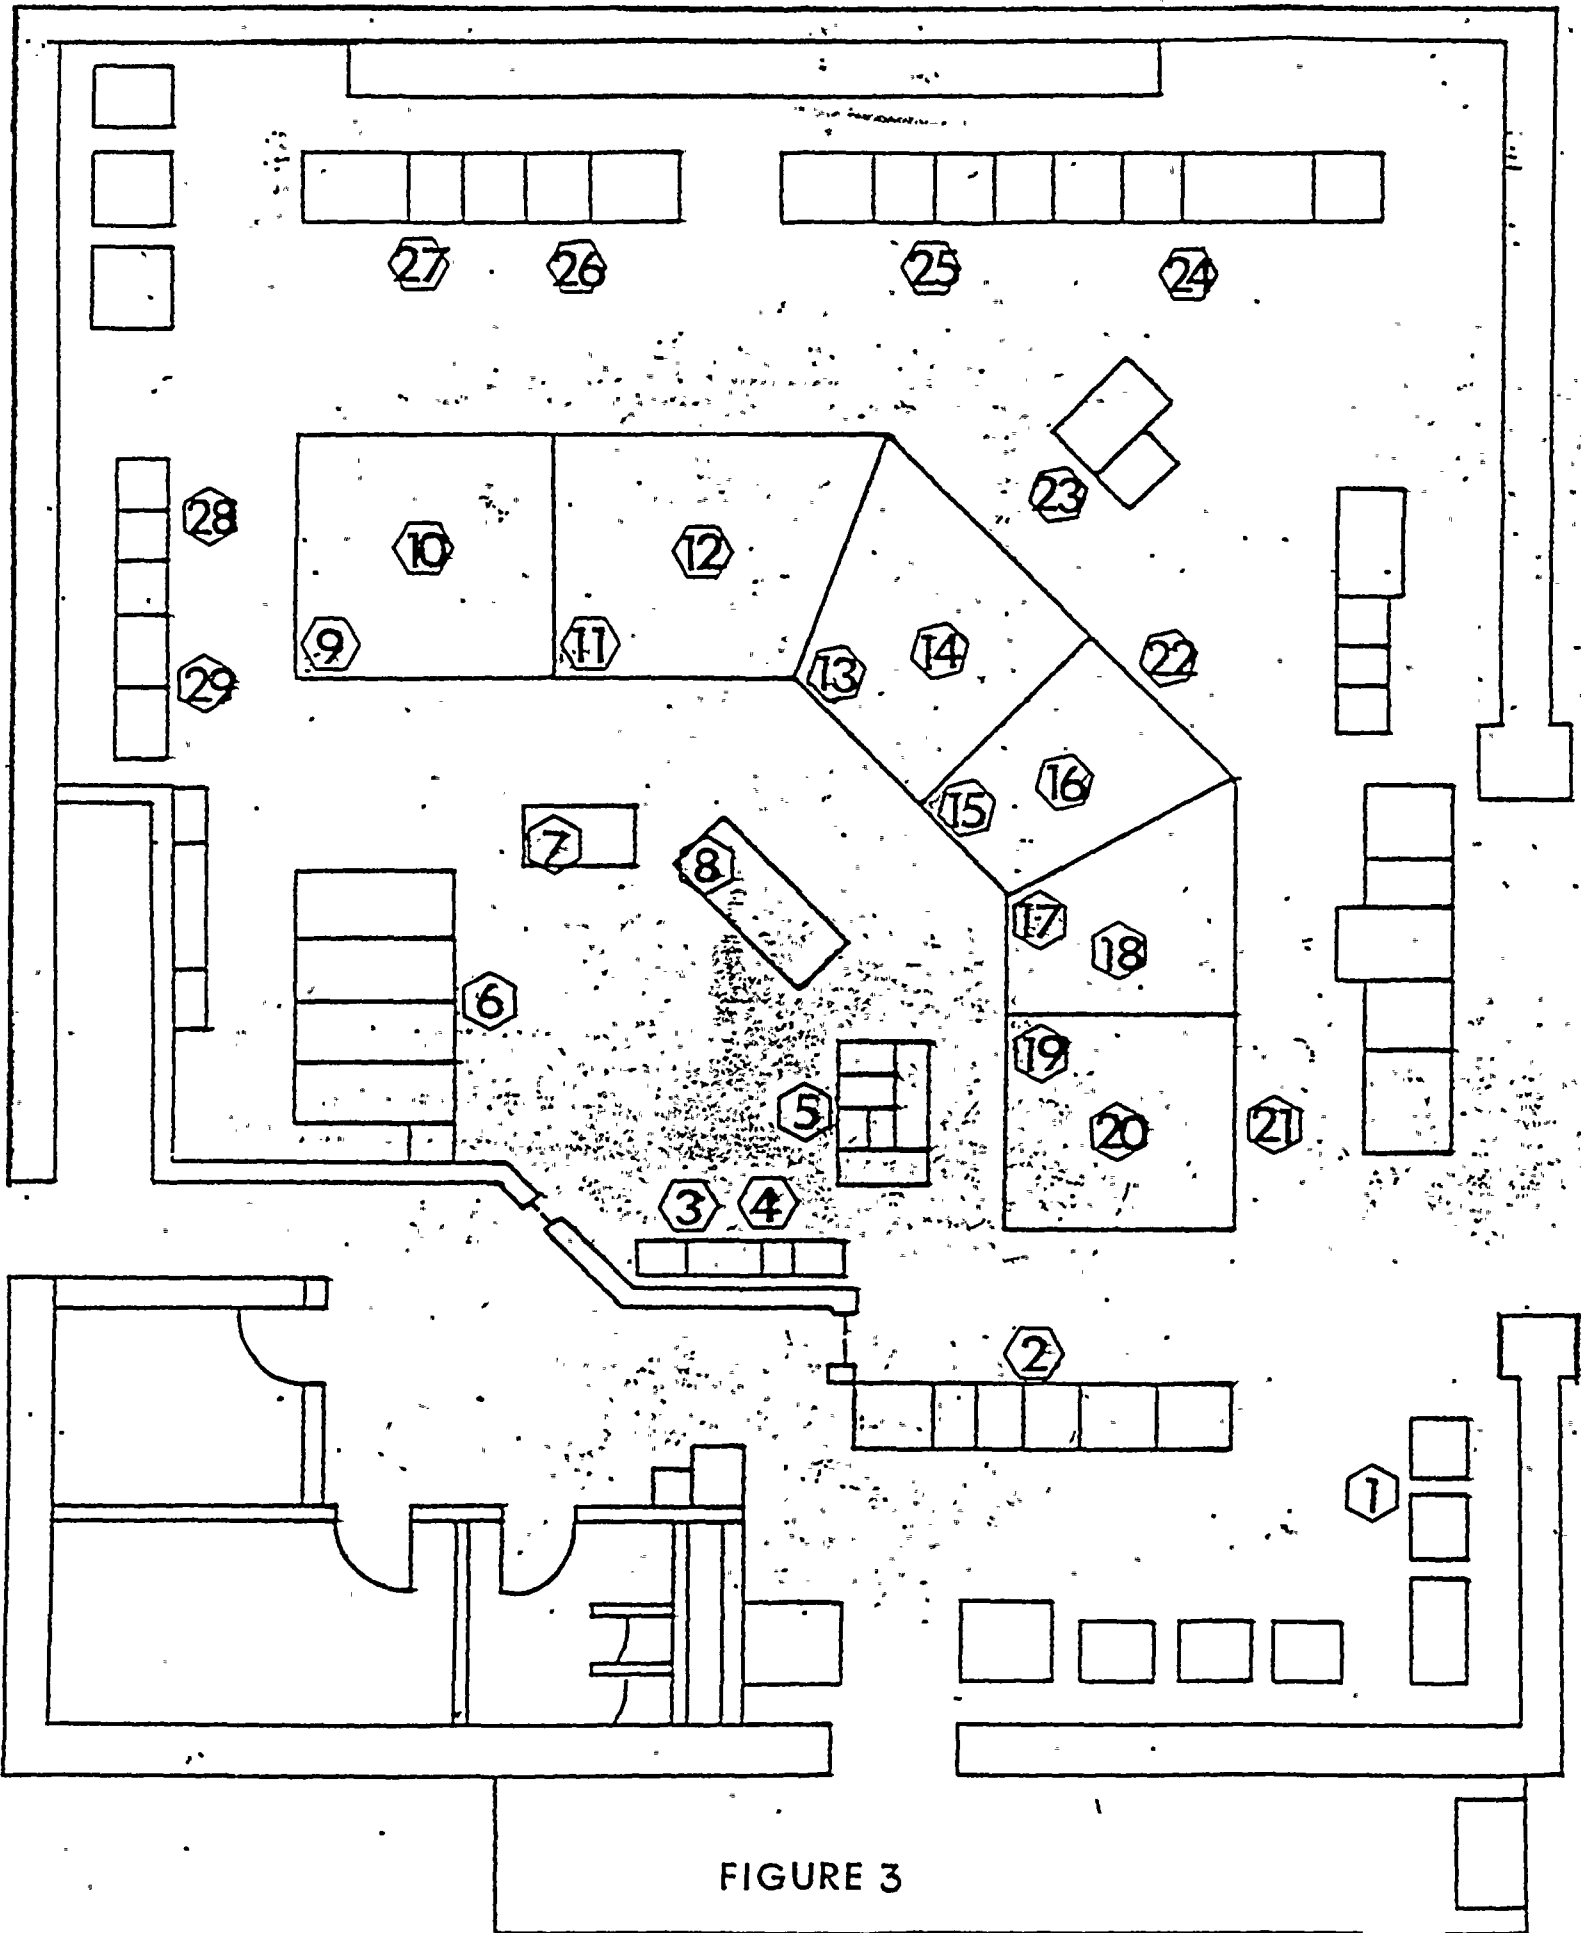
FIGURE 3

A light survey was conducted January 7, 1983 after normal light levels were reduced. The normal AC light levels were reduced to acceptable levels such that emergency light levels remain unaffected. The normal AC light levels as tested are presented in Figure 3 and table 3.1. It should be noted that where control panels have vertical and horizontal work areas light levels were measured on both planes.

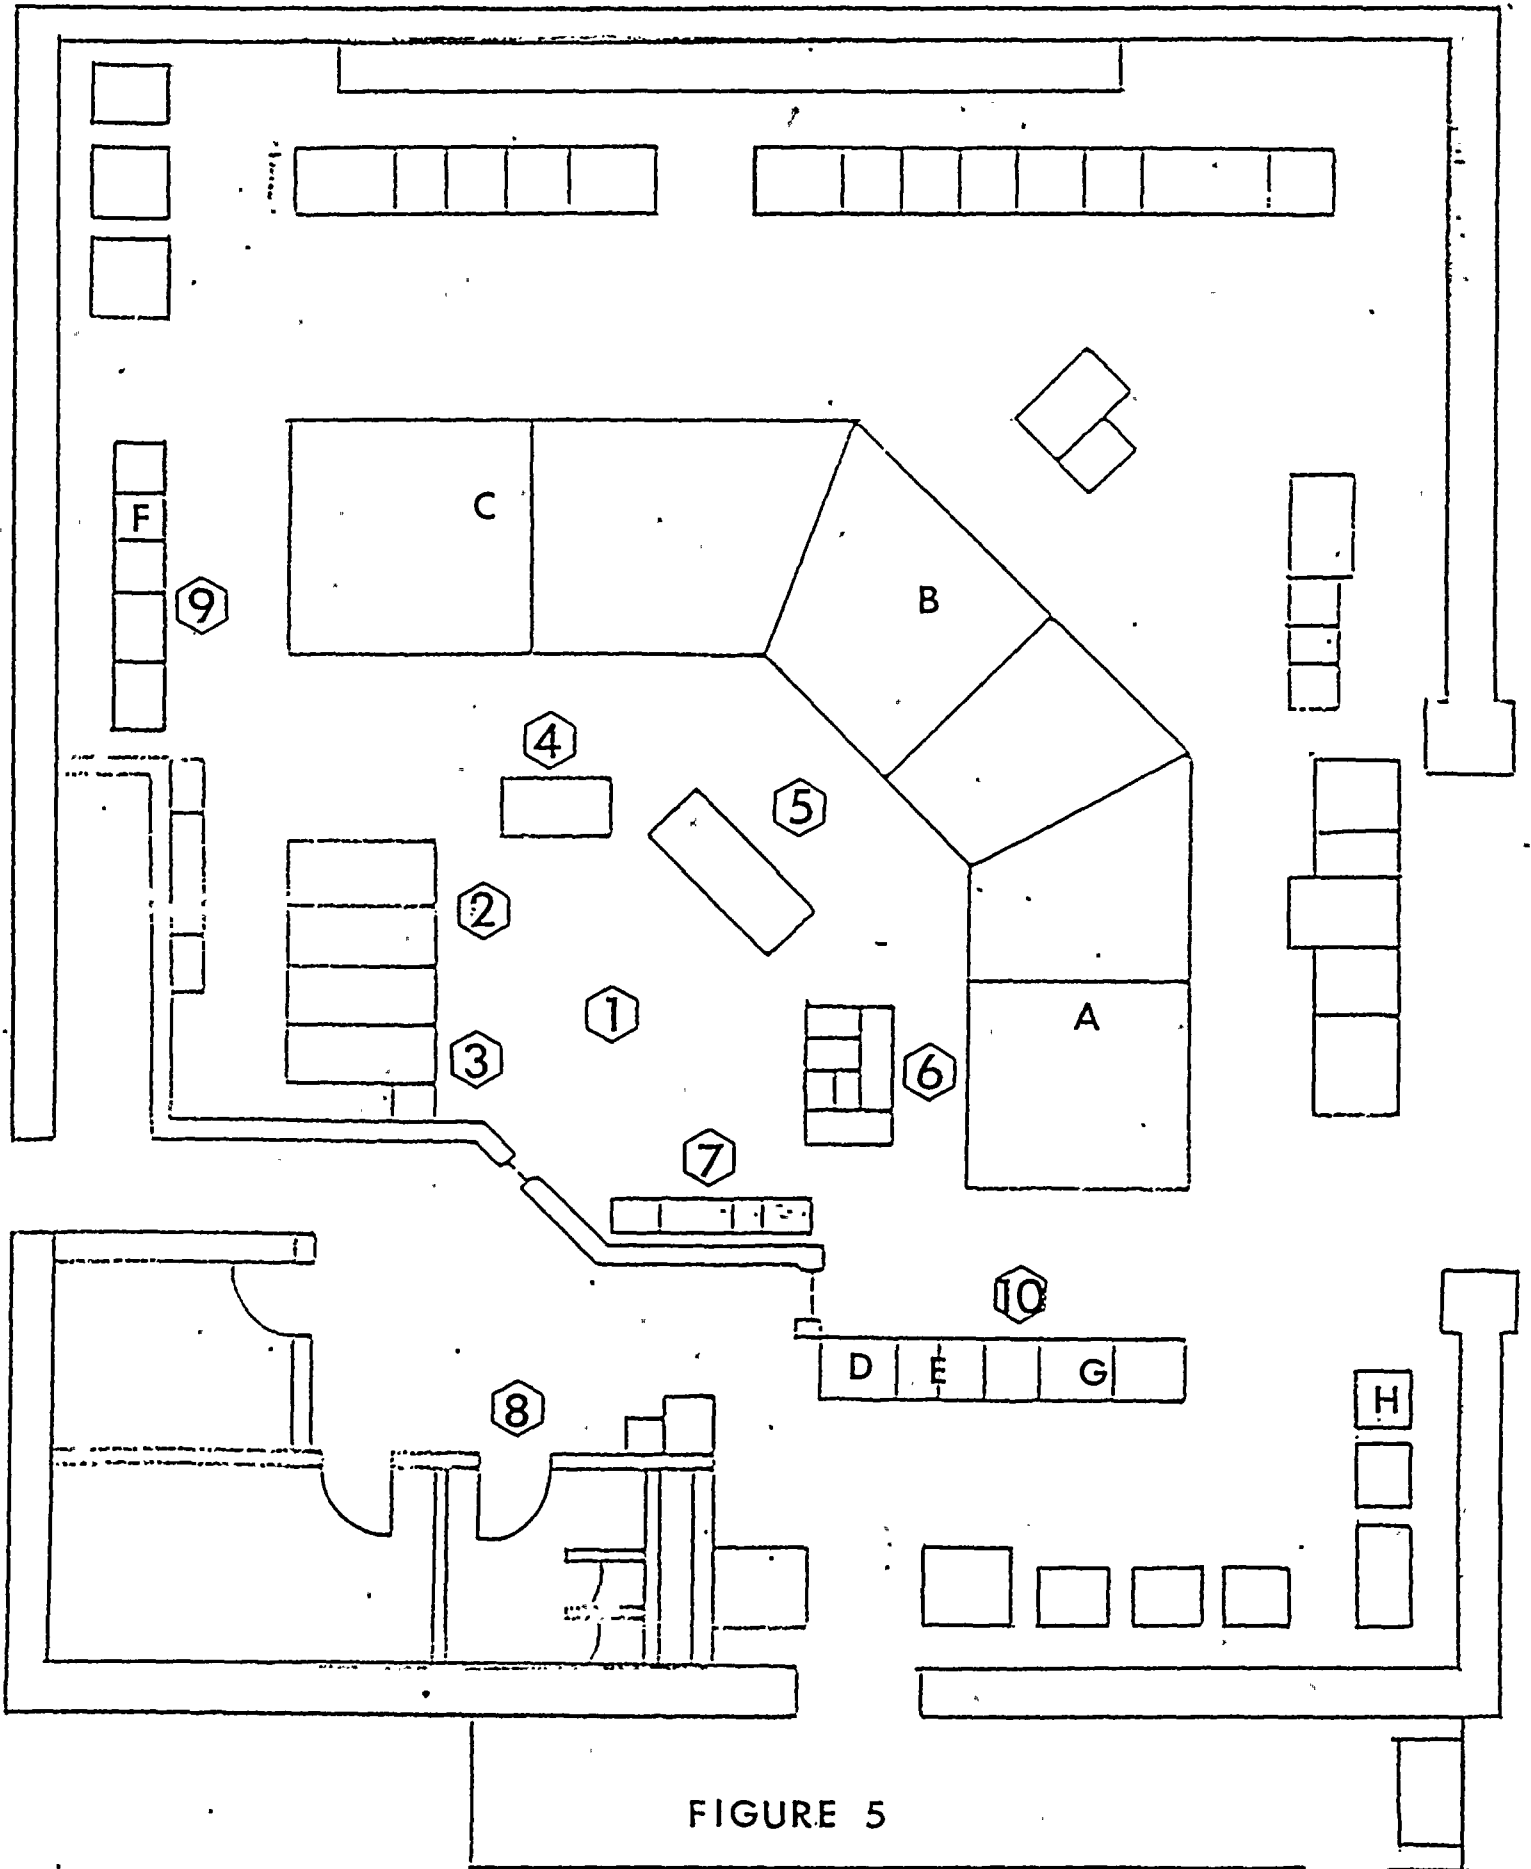
FIGURE 5

A noise survey of the St. Lucie Unit No. 2 control room was conducted on December 30, 1982. Figure 5 shows the control room locations where sound measurements were taken. Table 5.1 lists the background levels and Table 5.2 lists the panel annunciator levels as measured, at position 1 of Figure 5.

It was determined that the 8 Reactor Protection System cooling fans were the major contributing factor to the observed background noise levels. A second survey was conducted with only 4 of the subject fans running. By reducing the number of cooling fans by half, an approximate 3dbA reduction in background noise level was achieved.

Presently FP&L is reviewing the redesign of the air supply to the reactor protection system and will implement the necessary system design changes to reduce the noise contributed by the subject cooling fans during the first refueling outage.

FP&L will install carpeting in the control room which is expected to help reduce background noise levels. The carpeting will be installed after construction activity in the control room is complete.

FP&L considers the control room sound survey to be complete. The presently installed annunciator sound devices are adjustable and will be raised to 10 dbA above background.
