**RADIOLOGICAL SURVEY REPORT
OF THE FORMER LUX CLOCK COMPANY
BUILDING, WATERBURY, CT**

**FOR
MOLL INDUSTRIES, INC.
WATERBURY, CT**

May, 1999

CoPhysics Corporation
1242 Route 208
Monroe, NY 10950

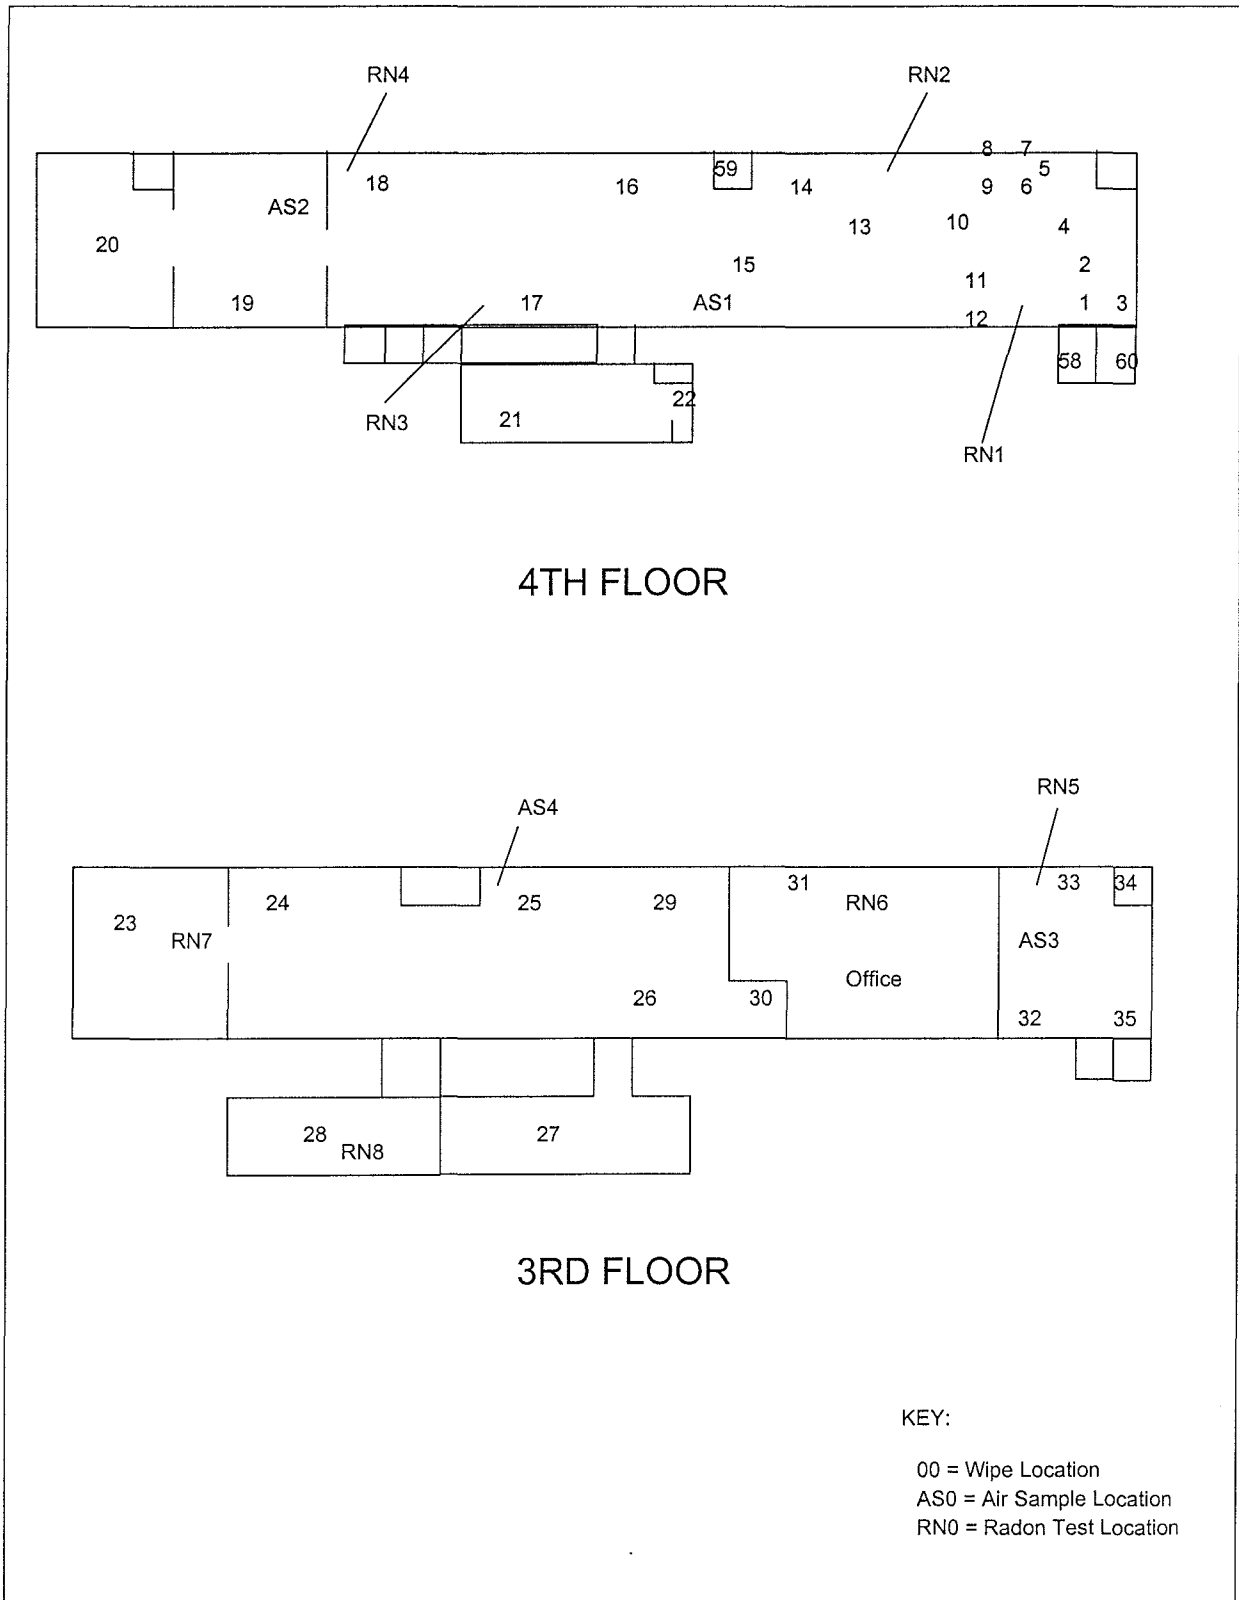
Figure 1 - Sample Locations

Locations of samples collected are shown in Figure 1. Areas of elevated radioactivity are shown in Figure 2. A discussion of specific measurements performed follow:

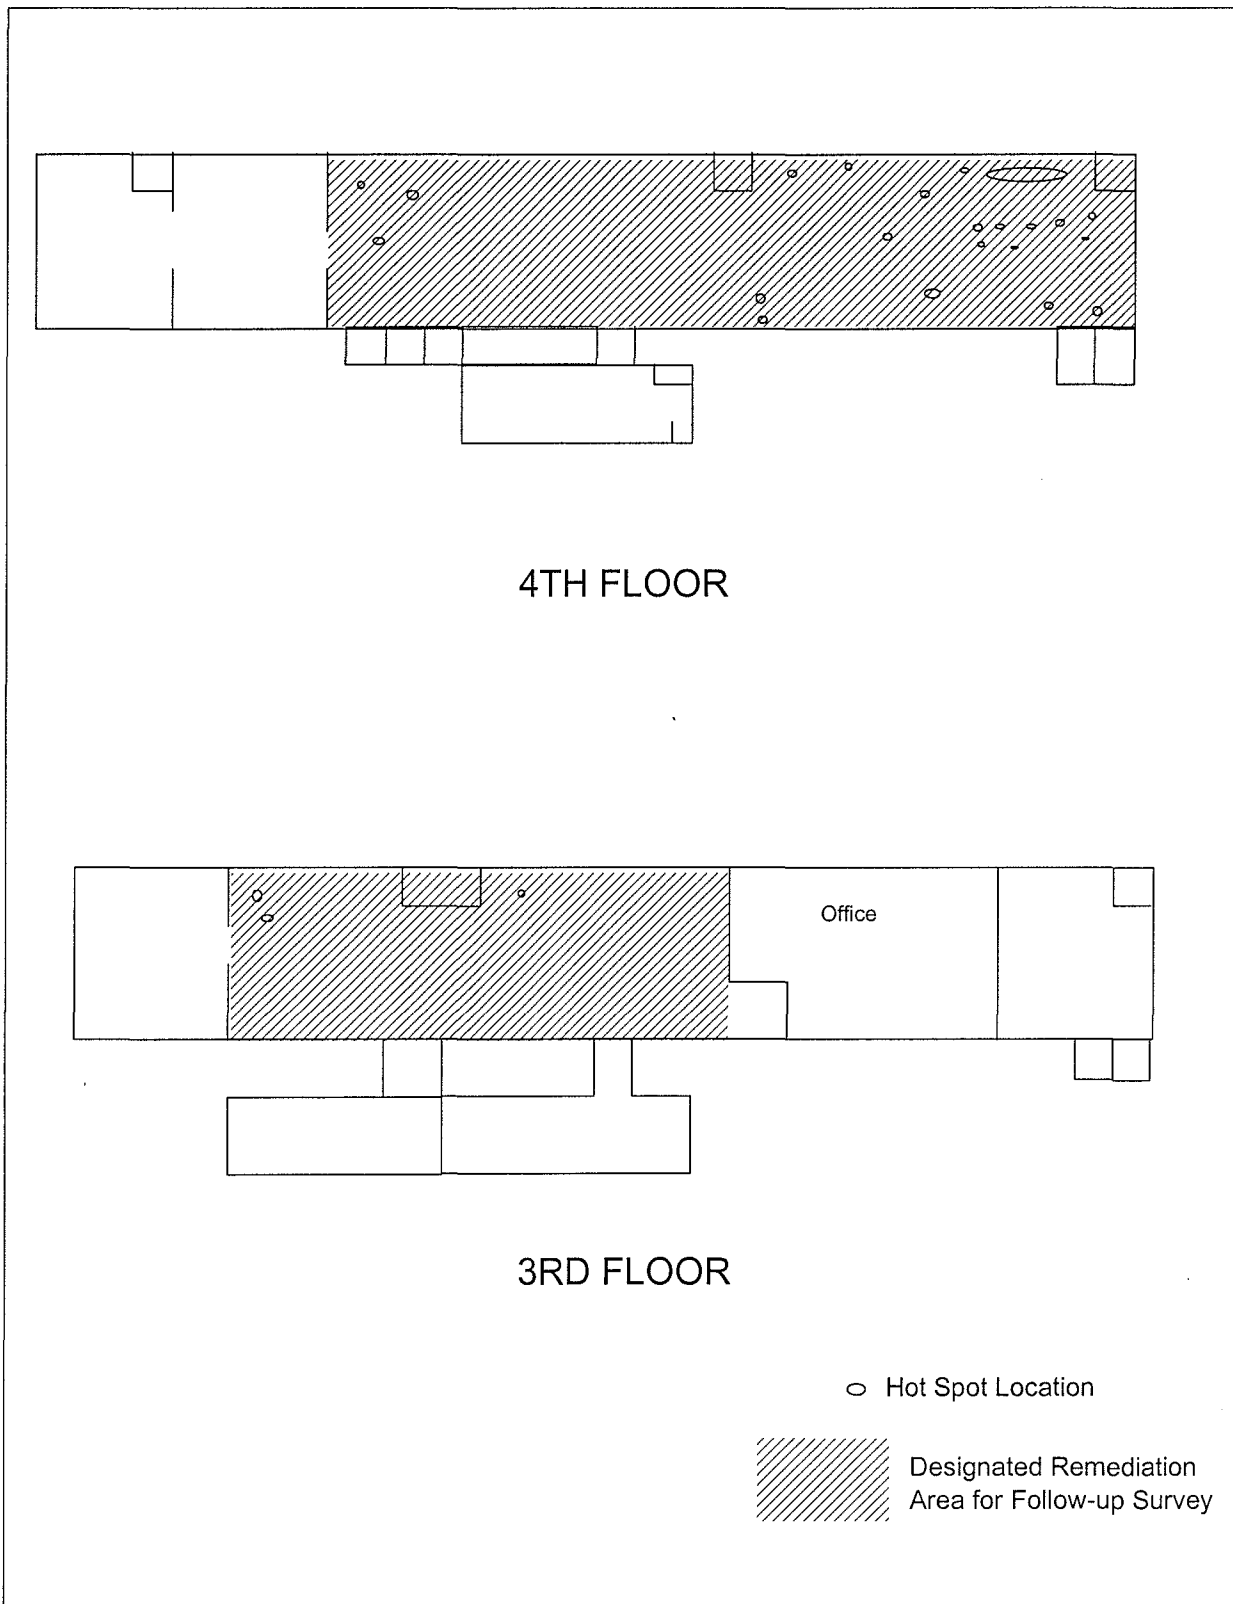
Figure 2 - Approximate Locations of Elevated Beta Readings

Approximately 50 spots of beta radioactivity were found on the 4th floor in the general area of the 3 spots identified by the Ct DEP survey. These spots ranged from 10,000 to 100,000 dpm gross beta and each were less than 100 sq.cm in floor area. Normally, such contamination from radium dial painting shops exists as small radium paint flecks. Readings indicated that the spots consisted of such paint flecks trapped in between floor boards. One spot was further investigated by removing a floor board. Measurements and observations under the board showed that the contamination was indeed in the vertical crack between boards and not under the board. All spots found exceeded Reg Guide 1.86 limits and should be remediated. The spots were identified on the floor with white paint.

On the 3rd floor, 3 spots of slightly elevated activity were found near elevated gamma readings found by the Ct DEP. These spots were barely above background and may have been shielded by overlaying dirt or wood. These spots should be remediated also.

Most of the beta hot spots on the 4th floor showed no alpha readings thus indicating that the radium paint flecks were lodged in the floor cracks and were covered by a layer of clean dirt. A few spots showed up to 5000 dpm alpha.

The spots of contamination found on the 4th floor as well as the suspected spots on the 3rd floor should be remediated. A shrouded router or circular saw coupled to a HEPA vacuum should be able to remove most of the residual radium-bearing paint from the floor cracks. Some floor boards may have to be lifted if the radium paint flecks had worked down under the boards.

A confirmatory survey should be conducted after remediation. The 2 designated remediation areas (shown in Figure 2) are the east side of the 4th floor and the mid to west side of the 3rd floor. Survey activities should include:
