Exelon Insights and Actions

NRC Public Meeting - June 29 2017

LaSalle Unit 2 HPCS Injection Valve - Event Description

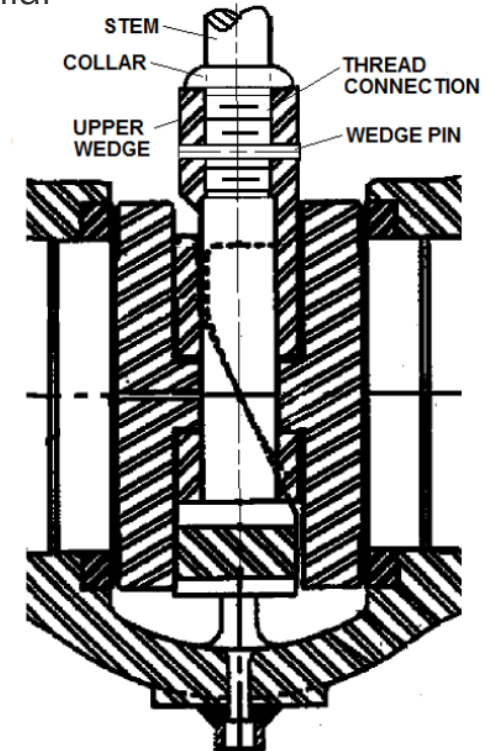
Figure 3: Stem-To-Wedge Connection

- Insufficient load (thrust) carrying capacity of the shrink fit stem collar
- Multiple closing high load cycles (axial thrust and torque)
- Eventual wedge pin shear failure
- Wedge and stem thread wear
 - Adhesive wear (i.e., galling)
 - Aggressive abrasive wear
- Axial shear failure of degraded wedge threads
- Contributing was the lack of pre-load with insufficient capacity of the stem collar and pin assembly

- Vulnerability and risk/consequences of failure should be factored into monitoring and repair plans
- Stem rotation checks should be performed using instruments with sufficient accuracy to support trending
- Trace differences should be thoroughly analyzed based on recent industry experience
- Structural assessment of wedge-pin connection should assume highest applied torque during time in service, which may differ from current set-up
- Weak-Link analyses of Anchor Darling Double Disc Gate Valves should fully assess the stem-wedge assembly including the thrust collar
- Replacement stems should be of the integral one-piece design

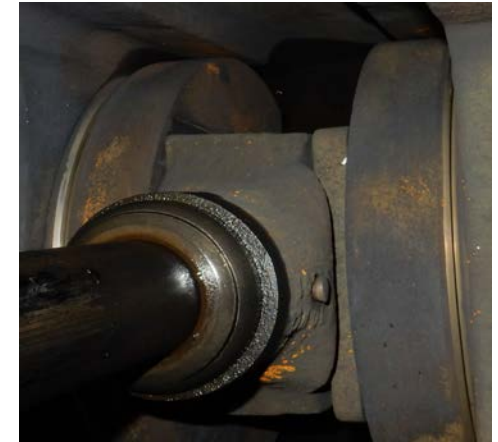
Fig. 4: U1 Internals (As-Found)

- Exelon voluntarily entered into a LaSalle Unit 1 Maintenance Outage on June 22, 2017
- Inspection and Repair of the susceptible Unit 1 High Pressure Core Spray (HPCS) Injection Valve
 - ✓ Prior Diagnostic Trends SAT, No Issues
 - ✓ Prior Stem Rotation SAT, Within tolerance
 - ✓ As-Found Diagnostics SAT, No Anomalies
 - ✓ As-Found Stem Rotation SAT, Within tolerance
 - ✓ In-body Visual Inspection SAT, No Anomalies
 - ✓ Collar – Wedge Gap SAT, No Clearance
 - ✓ Detailed Inspection In Progress
- Internal component replaced with upgraded materials and improved installation practices
 - ✓ Integral One-Piece Stem
 - ✓ Vendor Applied Pre-Torque
 - ✓ High Strength Wedge Pin
- All PMT and Leak-Rate Test SAT
 - ✓ As-Left Diagnostics SAT, No Anomalies
 - ✓ As-Left Stem Rotation SAT, Within tolerance
