**CEN-326 (F)**

**FINAL CORE SUPPORT BARREL  
INSPECTION REPORT  
POST CYCLE SIX  
ST. LUCIE UNIT ONE**

**MARCH 1986**

# St. Lucie Unit 1 Final Core Support Barrel Inspection Report

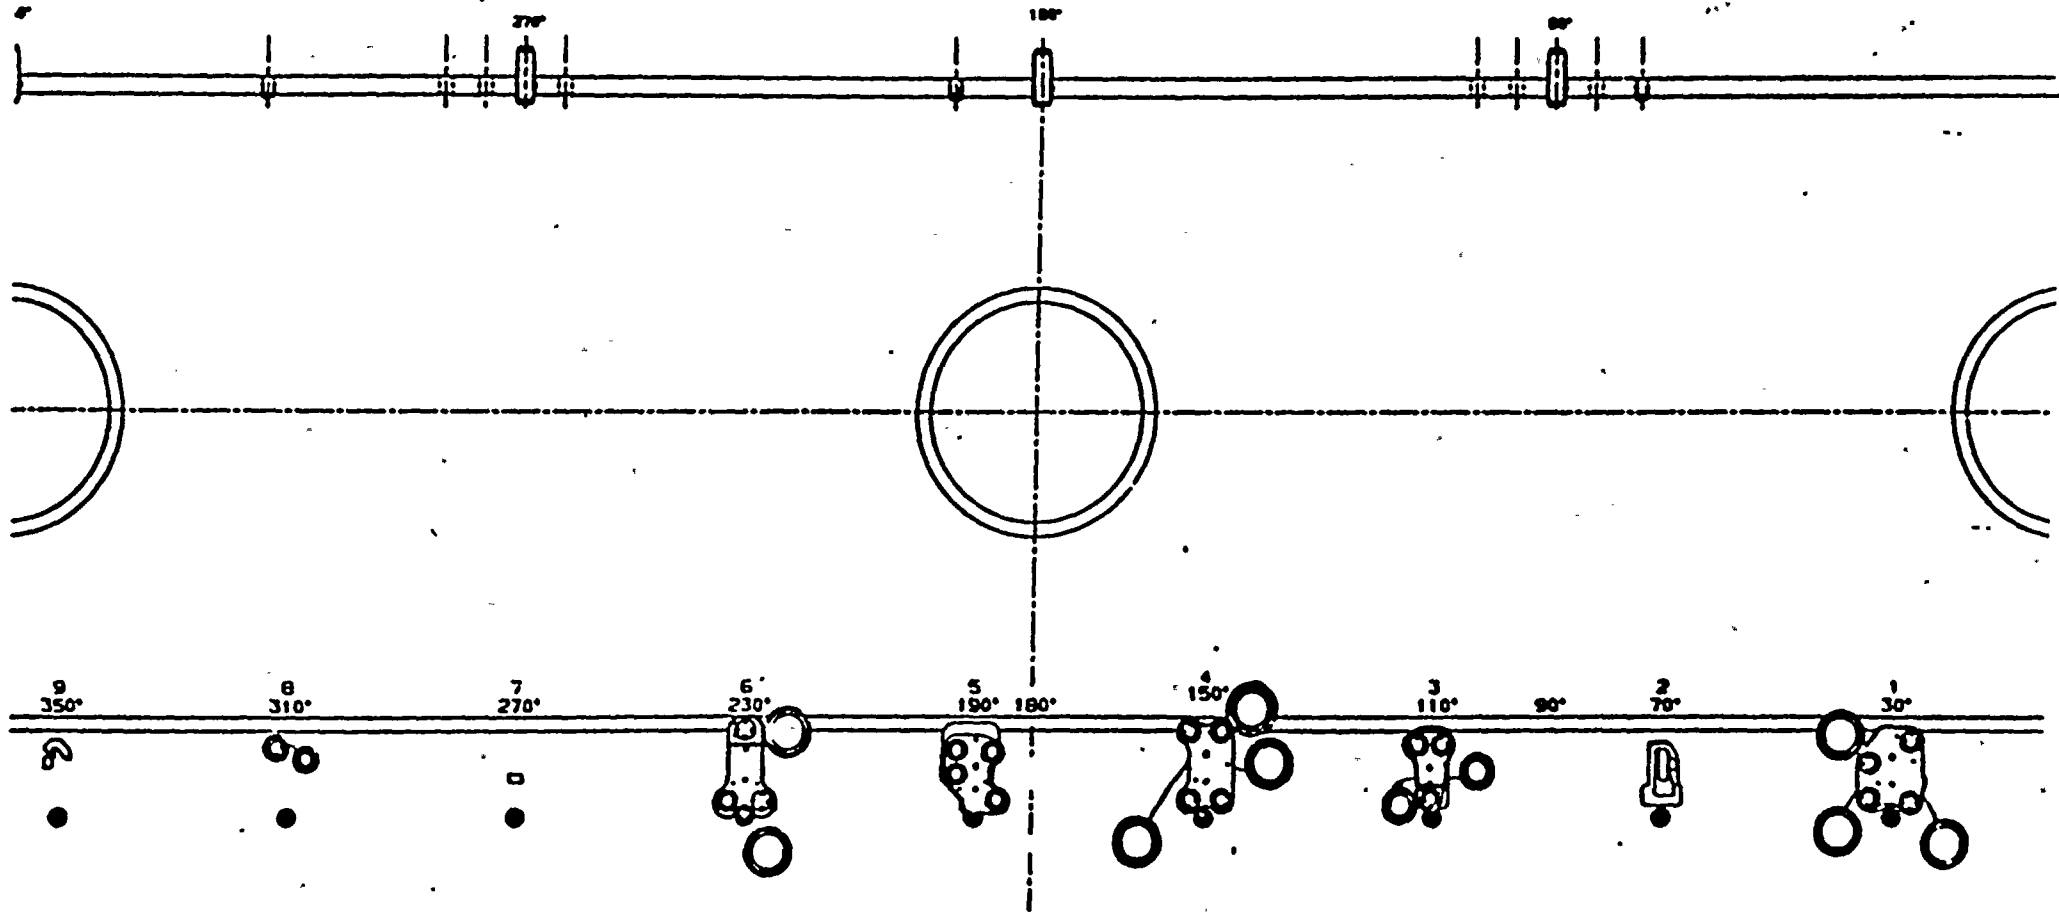
FIGURE 1  
 Repaired Condition of CSB

questions as to the integrity of the repair, a limited visual inspection can be performed without removing the CSB from the reactor vessel by using the surveillance holes in the CSB flange at lug locations 2, 3, 7, 8 and possibly 5 (see Figure 1).

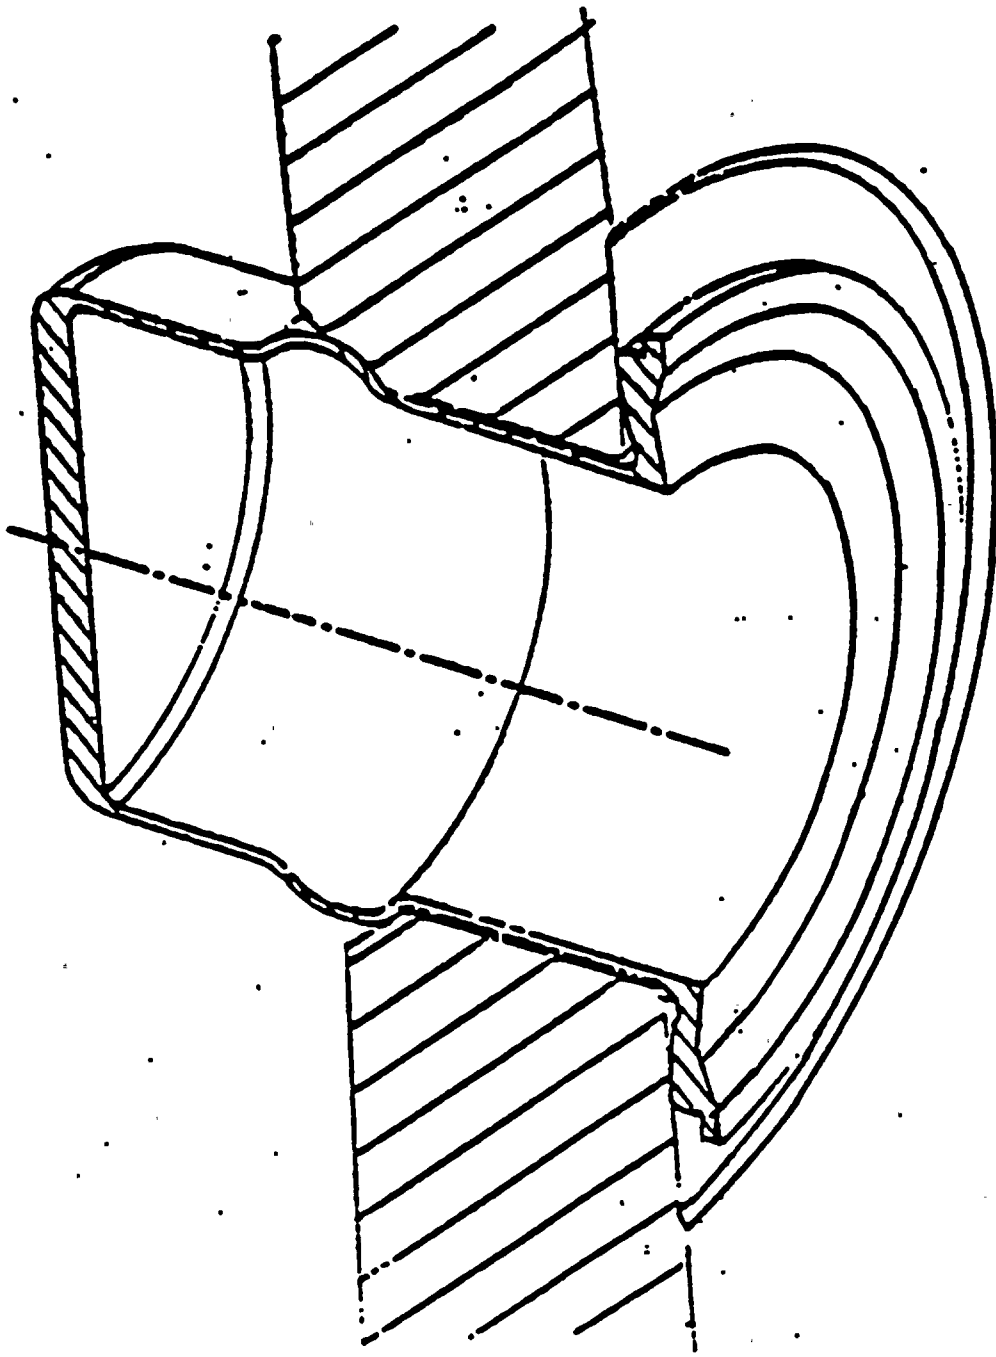
FIGURE 4

Figure 4 shows a cross sectional view of an installed plug. Once the bulge is formed and seated into the back chamfer of the hole in the CSB, the flange is released by the installation tool collet. Some spring-back of the flange occurs, but the bulge contact maintains the plug flange in a deflected configuration, thus preloading the plug into the CSB.
