Florida Power & Light Company

St. Lucie Unit #2

Special Report

EDDY CURRENT EXAMINATION OF  
STEAM GENERATOR TUBING  
DURING OCTOBER, 1987

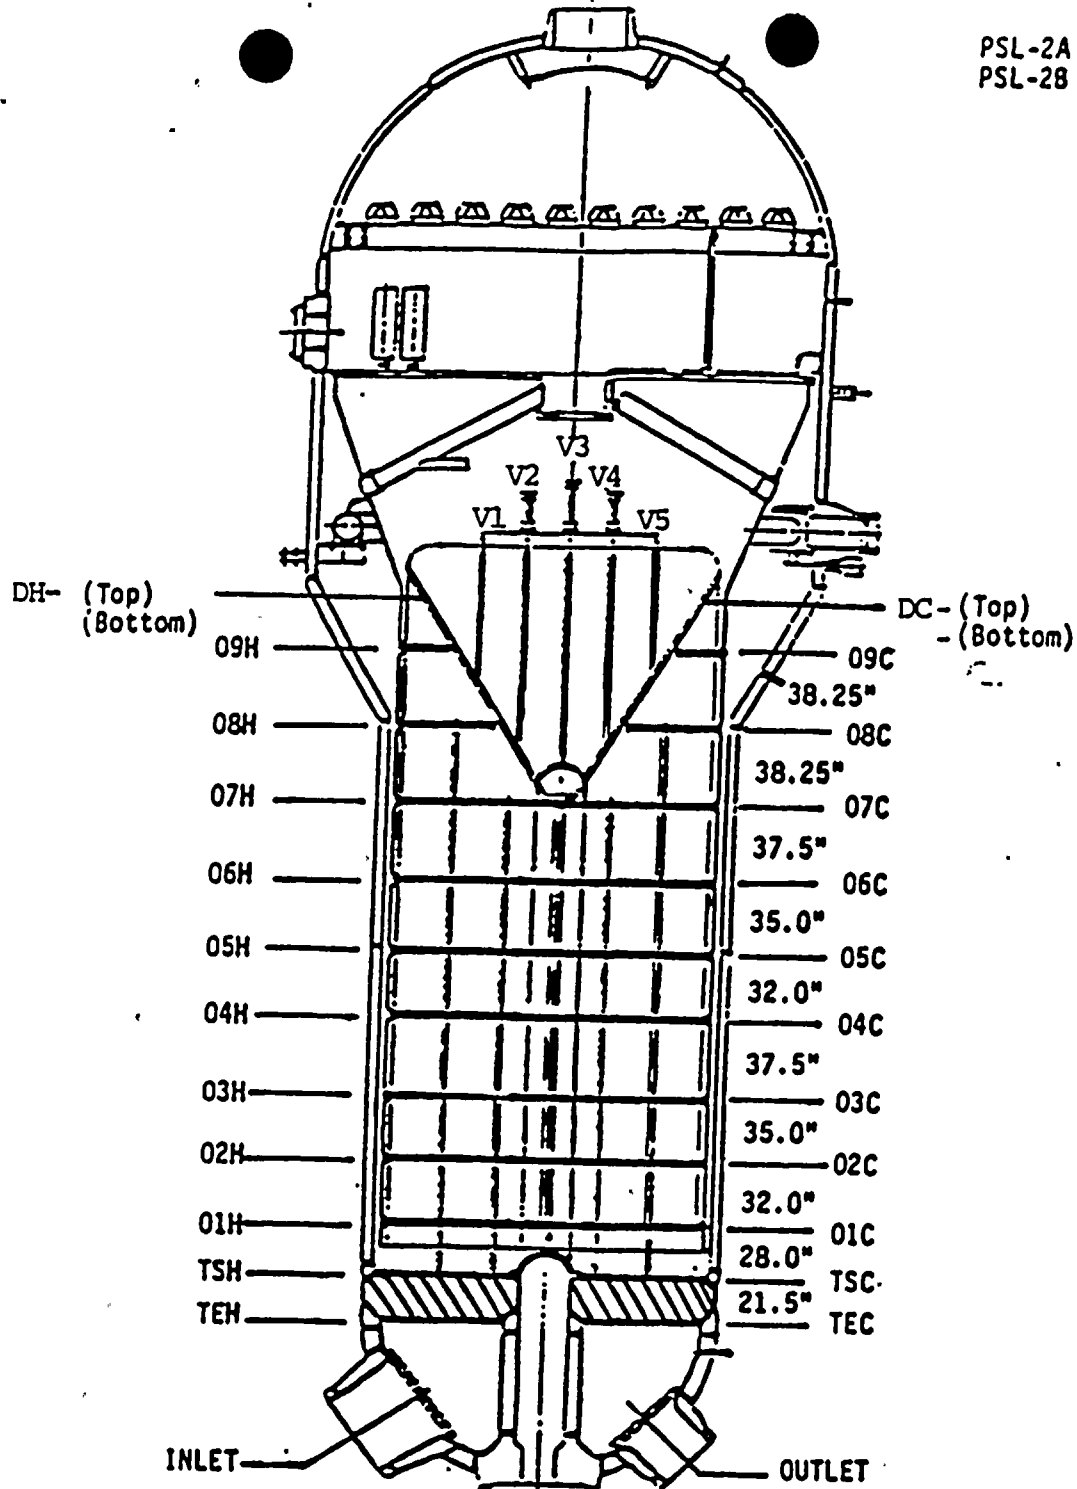
Figure 1

Egg Crates = Elev. 1 to 7  
Drilled Supports = Elev. 8 & 9

STEAM GENERATOR ARRANGEMENT

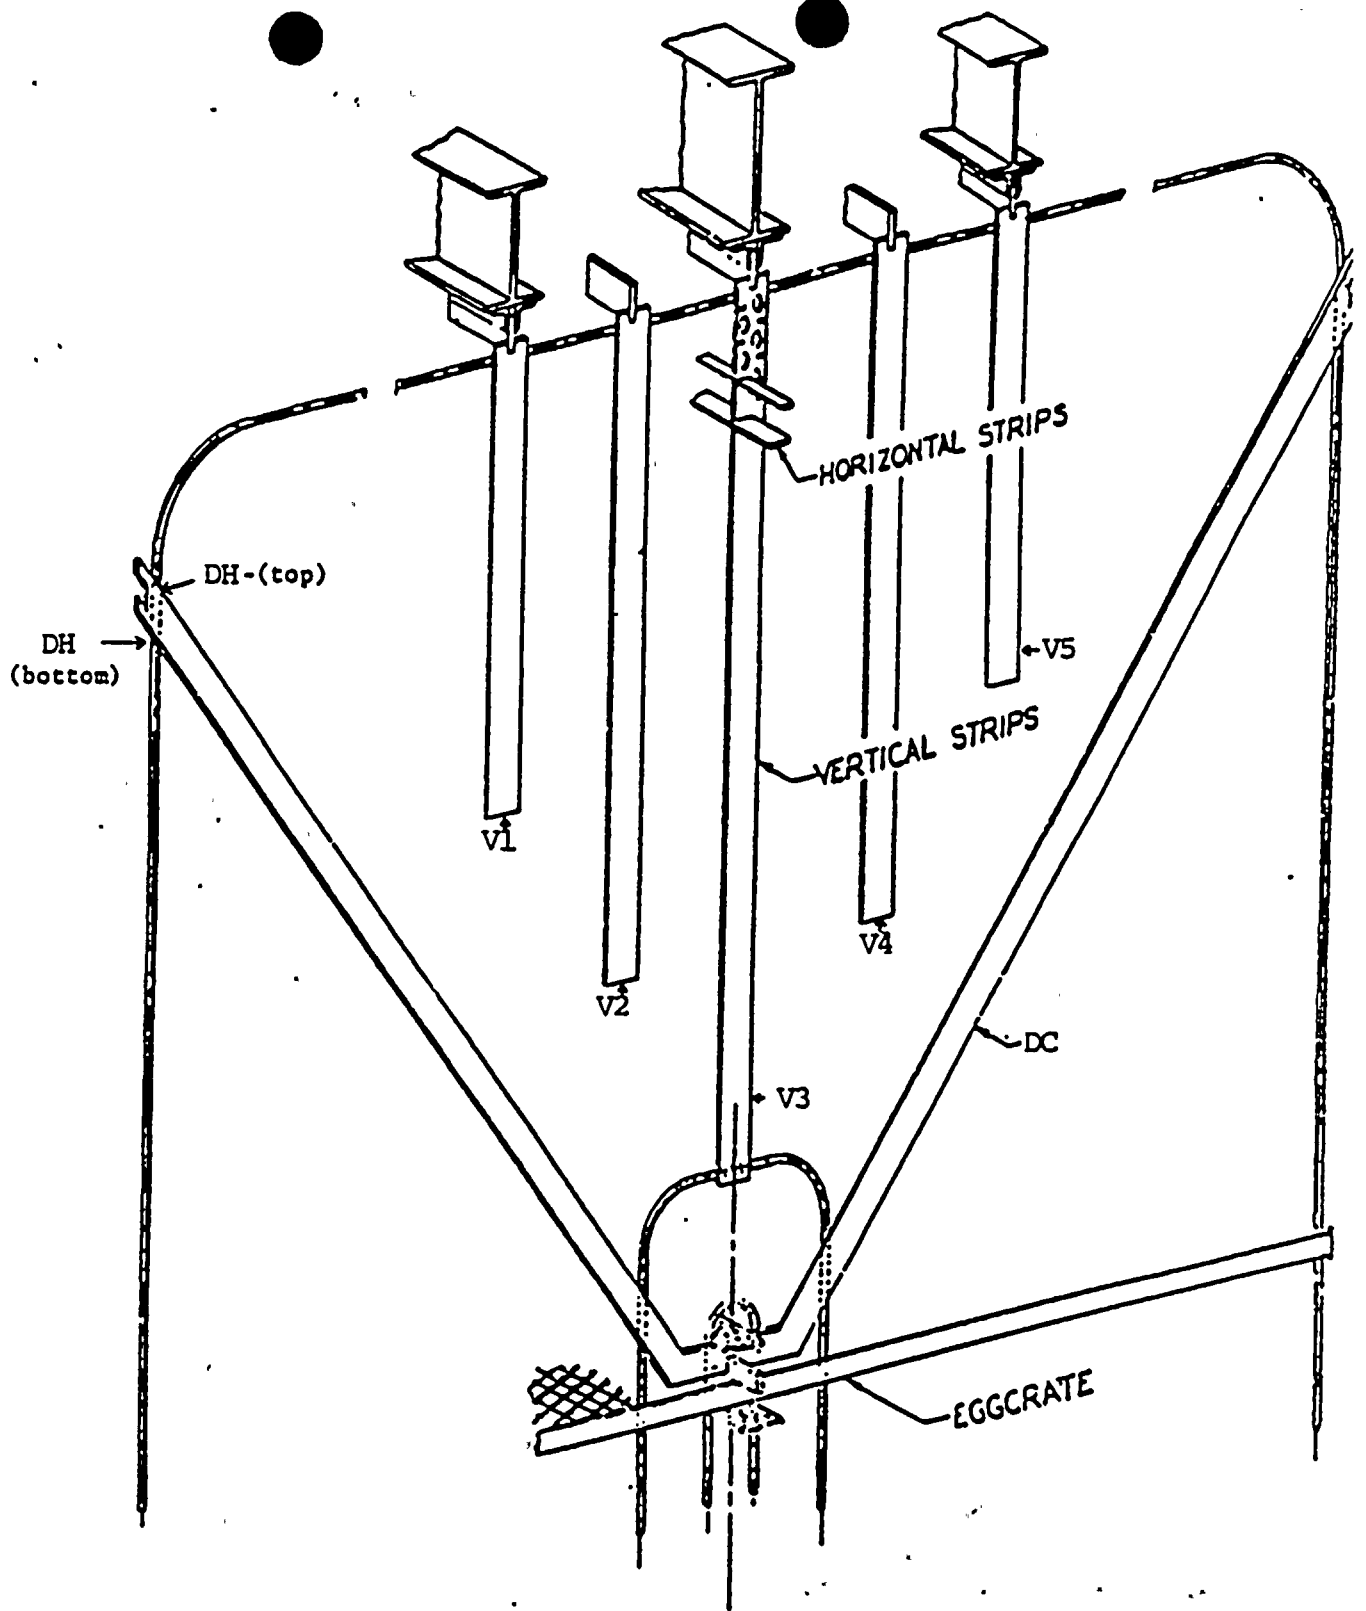
Figure 2

BEND REGION TUBE SUPPORTS
