SUBJECT: Part 21 rept re radiator fan shaft bearing failure.

Subject: Potential 10CFR21 Finding  
Radiator Fan Shaft Bearing Failure  
Standby Diesel-Generators

COMPONENT - RADIATOR FAN SHAFT BEARING FAILURE

LOCATION - FLORIDA POWER & LIGHT COMPANY  
ST. LUCIE #2 NUCLEAR PLANT  
STANDBY DIESEL-GENERATORS

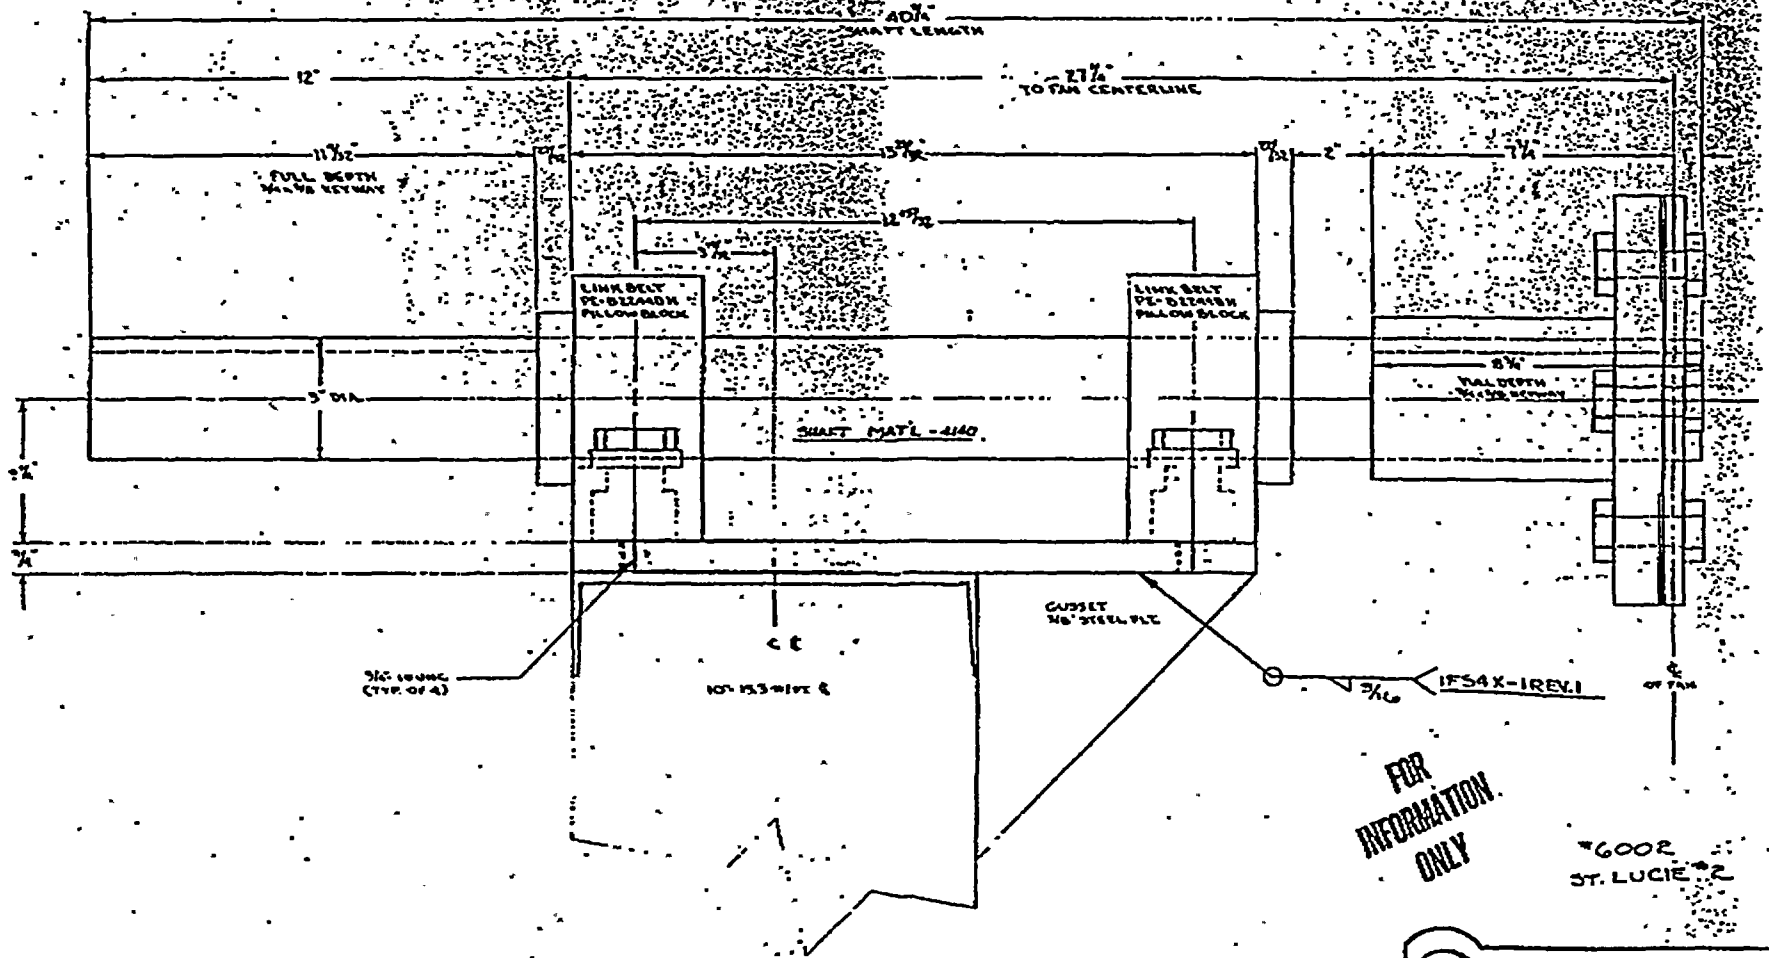
FAN BEARING DETAIL  
 Scale as 10180

The standby diesel-generators at the St. Lucie #2 Nuclear Plant are radiator cooled. The fans that push air through the radiator are engine driven by a shaft drive including sheaves and belts. The fan is mounted on a support that is part of the radiator structure. The fan is mounted on a shaft supported by two bearings. (Drawings 10179 Sheet 3 of 7). A sheave is mounted on the opposite end and is driven by belts off the engine drive line.

I note that the 27 1/4" dimension on drawings 10179 and 10180 should be 26 1/4" to the centerline of the fan. The 12" end dimension should be 13".

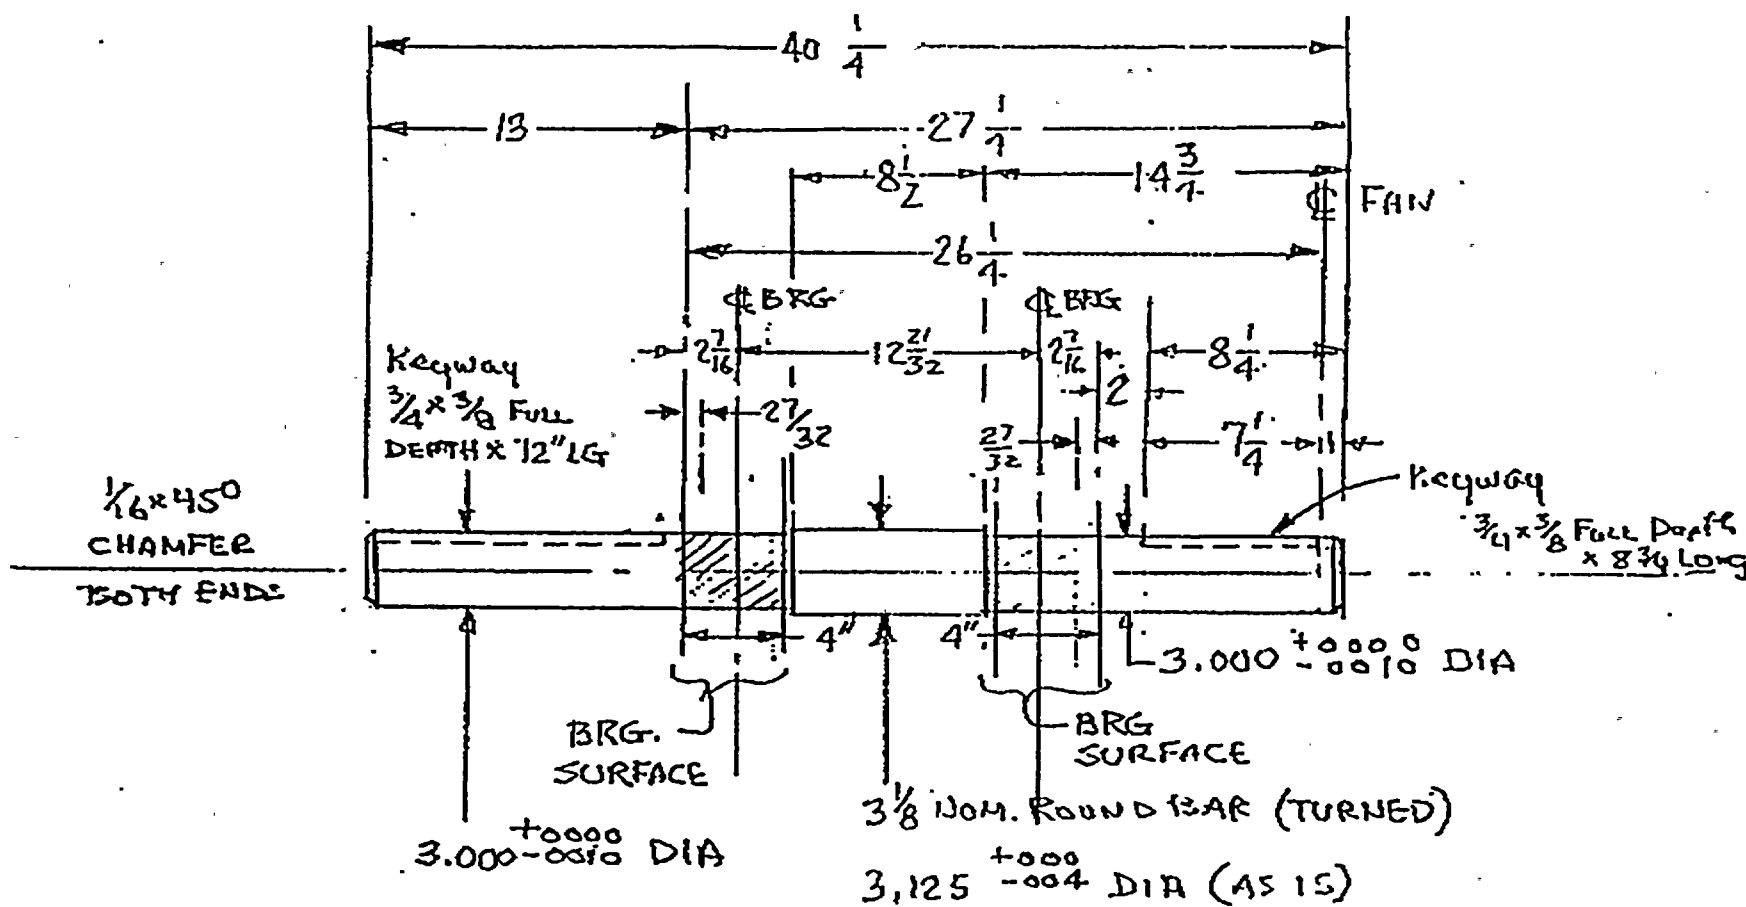
DESCRIPTION: OEM DWG 10179 SH3 & 10180 SH3 SHEET NO. 6002 SK-1

On June 5, 1989, I had a call from Mr. Phil Barnes of the St. Lucie #2 Nuclear Plant (407-468-4236). He explained that they lost a bearing on the radiator shaft. The Florida Power and Light analysis concluded that the bearing failed because the fit on the shaft was too loose. The component was designed and furnished by the O & M Manufacturing Company of Houston, Texas as part of the radiator assembly.

The radiator fan shaft was 3" round stock. I discussed this with Mr. Rich Rouner of the O & M Manufacturing Company who believed it was round stock (Turned). I found that 3" round stock (Turned) had a tolerance of +000/-004. The bearings used are Link-Belt Pillow Block P/N PE-B22448H. The shaft tolerance required for a 3" shaft is +.000/-.001. To meet this tolerance, 3-1/8" diameter round stock is required for machining to the proper tolerance. I have developed a sketch of the replacement shaft 6002SK-1.

The radiator shaft bearings failed. Florida Power & Light Company analysis of the failure attributed the failure to loose bearing fit. A crack developed under the locking collar in the set screw area.

I believed the 3" diameter shaft was cold rolled turned stock with a tolerance of +.000 to -.004. If it was ground stock, the tolerance was +.000 -.002. The bearing PE-B22448 (3") requires a shaft tolerance of 3" +.000 to -.001. To get this a 3-1/8 round bar would have to be used then machined to 3.000+.000/-.001 diameter.

I discussed this further with Phil Barnes in the late afternoon of June 6, 1989. Florida Power and Light has taken corrective action and replaced the fan shaft with one of the proper tolerance.

MATERIAL  $3 \frac{1}{8}$  DIA ROUND  
BAR-TURNED  
COLD ROLLED  
SAE 4140
