SUBJECT: PRAIRIE ISLAND NUCLEAR GENERATING PLANT, UNITS 1 AND 2—NRC  
INTEGRATED INSPECTION REPORT 05000282/2017002 AND  
05000306/2017002

Inspection Report 05000282/2017002, 05000306/2017002; April 1, 2017, through June 30, 2017; Prairie Island Nuclear Generating Plant, Units 1 and 2. Operability Determinations and Functionality Assessments; Correction of Emergency Preparedness (EP) Weaknesses and Deficiencies; and, Identification and Resolution of Problems.

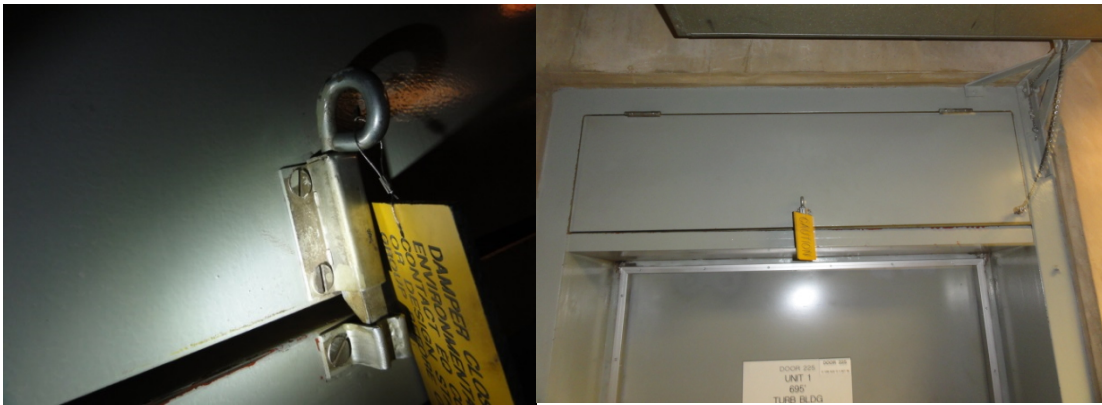
Description: On January 24, 2017, while performing a fire protection inspection walk down in the 11 battery safeguards room, the inspectors noted that the latch assembly on the transom above Door 225 had approximately 1/16<sup>th</sup> inch engagement (pictured below). Door 225 separates the 11 battery room from the Unit 1 turbine building area.

Based on prior knowledge of the Prairie Island USAR and ongoing HELB analysis reconstitution project, the inspectors recalled that the 11, 12, 21, and 22 safeguard battery systems and AFW pump rooms had low margin to humidity and temperature rise limits during and following a postulated HELB event in the turbine building. Additionally, the inspectors confirmed with engineering that the current HELB analyses had not accounted for any steam leakage through the transom (pictured above) into the battery and AFW rooms. The inspectors immediately presented their observation to the Shift Manager (SM) and CAP 1548470 was generated. In response, the licensee initiated work request (WR) 130746 to address the inspectors' observation. Subsequent review of the WR was performed by the WR screening team, forwarded to the FIN SRO and processed as a minor WO.

Prior to beginning work, the maintenance crew communicated to the FIN SRO that they planned to increase the engagement of the latch assembly (pictured above). In response, the SRO communicated to the crew that the transom was a steam exclusion barrier and should remain closed during maintenance. The crew specified that the transom would be held closed by hand during the maintenance repair. However, the crew did not communicate that the lower latch assembly would be entirely removed during the maintenance window. Consequently, on February 3, 2017, maintenance workers removed and replaced the latch as a minor work activity without a steam exclusion barrier permit in place and unbeknownst to the SM and engineering. A few days later on February 6, during a subsequent plant tour, the inspectors identified the latch had been adjusted and they communicated their observation to engineering who informed operations and then initiated CAP 1549724. Initial review of this issue by the

SM on February 6 determined that the transom steam exclusion barrier remained functional by crediting a maintenance worker's hand on the transom as an adequate measure to mitigate a HELB event. However, after a subsequent challenge by the inspectors on February 7, in regard to the transom configuration, a past operability review was initiated. Specifically, the inspectors noted that the transom opened into the 11 battery room and therefore holding the door closed by hand during a postulated HELB event would have been unlikely.

The licensee completed the past operability review on March 20, and concluded that the 11, 12, 21, and 22 safeguards batteries and AFW systems and Unit 1 safeguards bus rooms were inoperable during the approximate five minute maintenance window on February 3, and represented an unanalyzed condition that significantly degraded plant safety. In the absence of existing HELB analyses for the impact on the batteries and AFW systems during a postulated HELB event, the licensee performed several GOTHIC model analyses that were completed and approved on April 5; concluding that only the 11 battery system would have been considered inoperable during the maintenance activity. In their review, the inspectors requested support from a Region III inspector who specialized in GOTHIC modelling to assist in evaluating and confirming adequacy of the licensee's final determination of past operability for the affected systems. In conclusion, the inspectors determined the analyses performed adequately limited postulated HELB impact to the 11 battery and therefore safety functions were not impacted during the maintenance activity.

Corrective actions for this issue included completing a past operability review, an apparent cause evaluation, and communicating lessons learned to the operations and maintenance departments focusing on the potential consequences of communications without the appropriate level of technical information and working within the bounds of the minor maintenance program. Because this violation was of very low safety significance and was entered into the licensee's Corrective Action program as CAPs 1548470 and 1549724, this violation is being treated as an NCV, consistent with Section 2.3.2 of the U.S. Nuclear Regulatory Commission (NRC) Enforcement Policy. **(NCV 05000282/2017002-01, Failure to Properly Implement the Minor Maintenance Process During Door 225 Transom Maintenance).**
