ACCELERATED DISTRIBUTION DEMONSTRATION SYSTEM

SUBJECT: LER 91-008-00: on 911110 & 11, containment integrity not in compliance w/Tech Specs during core alterations. Caused by personnel failing to follow approved procedure. Containment integrity reestablished & personnel counseled. W/911209 ltr.

Re: St. Lucie Unit 1
Docket No. 50-335
Reportable Event: 91-08
Date of Event: November 10, 1991
Core Alterations Performed With Containment
Integrity Not in Compliance with Technical
Specifications due to Personnel Error

TITLE (4) Core Alterations Performed With Containment Integrity Not in Compliance With Technical Specifications due to Personnel Error

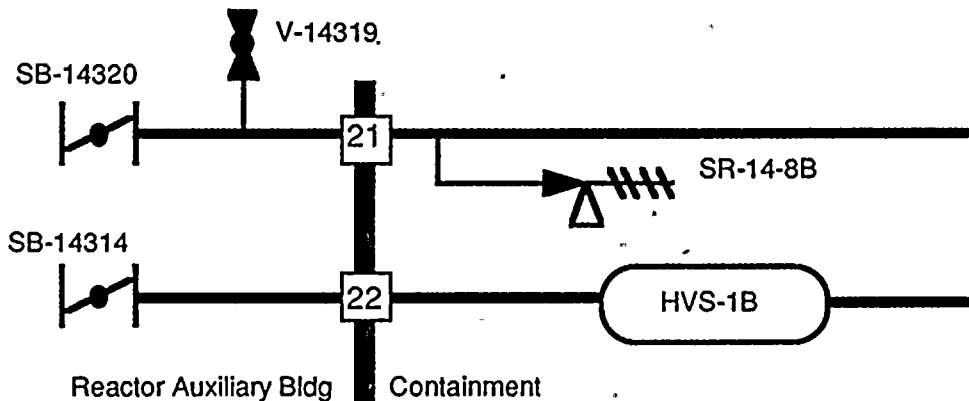
Nuclear Plant Work Order (NPWO) 3836 was written to remove a one-inch Component Cooling Water (CCW) (EIS:CC) safety relief valve, SR-14-8B, to implement a plant modification. The NPWO was planned November 4, 1991. The NPWO package contained instructions for work performed in the maintenance shop on the new valve and for work performed in the Reactor Containment Building to remove the old valve. Work was started in the maintenance shop on November 7. On November 9, clearance 1-11-113 was authorized and hung to support removal of SR-14-8B. The clearance closed SB-14314 and SB-14320, inlet and outlet CCW isolation valves for the 1B Containment Cooler (HVS-1B)(EIS:BK), and opened drain valve V-14319 to remove water from the system. The drain valve is located outside containment between Penetration 21 and isolation valve SB-14320.

On November 10, 1991, fuel assemblies were being moved in the reactor core. A utility maintenance worker was assigned to work NPWO 3836. He entered containment and removed SR-14-8B at about 1430. Since shop preparation work for the NPWO had been in progress for a few days, the worker mistakenly believed all approvals had been previously acquired. The foreman had signed onto the clearance earlier but had not brought the NPWO to the Control Room to obtain permission to start work. Administrative Procedure 0010432, "Nuclear Plant Work Orders," states that the approval of the Nuclear Plant Supervisor (NPS), Assistant Nuclear Plant Supervisor (ANPS), or Nuclear Watch Engineer (NWE) is required prior to starting work. The NPWO was turned over to the next shift who brought it to the Control Room for approval. The ANPS reviewed the NPWO and did not approve it, realizing that the removal of the relief valve with the drain valve open should not be permitted. However, he was informed that the valve had already been removed. The ANPS then directed a nonlicensed operator to close the drain valve. Complete containment integrity was restored at 0210 on November 11, 1991.

Technical Specification 3.9.4, "Refueling Operations: Containment Penetrations," requires each penetration to be closed during core alterations. The removal of SR-14-8B with open drain valve V-14319 created a flow path across Penetration 21 from about 1430 on November 10, 1991, to 0210 on November 11, 1991. Eleven fuel moves were performed in the reactor core during this time interval. This event is reportable per 10 CFR 50.73.a.2.i.B, any condition or operation prohibited by Technical Specifications. Containment integrity is required during fuel movement to restrict radioactive material released from a fuel element rupture. No failures of fuel elements occurred during the time interval containment integrity was breached. In the event of a fuel element rupture, the amount of radioactive material released through a 1" line would be minimal. This is due to the lack of a pressurization potential associated with a refueling accident. Any material released would enter the Reactor Auxiliary Building, not the environment. Therefore, the health and safety of the public was not at risk during this event.

- (1) Operations closed the drain valve and restored containment integrity.
- (2) The responsible foreman was counseled on his failure to follow procedures, i.e., failure to obtain the proper authorization prior to beginning work on plant systems. The event was also discussed with all Mechanical Maintenance crews.
- (3) A task team, lead by Operations, is reviewing the clearance procedure. Any necessary changes to the procedure related to this event will be made.
- (4) The event will be included as part of In House/Industry Events training, performed every quarter with journeymen, during the first quarter of 1992.
- (5) The Training Department will incorporate this event into the Licensed Operator Requalification Program.
- (6) An INPO Human Performance Enhancement System evaluation of this event was performed and its conclusions agree with this report.
