RE: St. Lucie Unit 2  
Docket No. 50-389  
Event Date: April 21, 1992  
Turbine Trip Failure

**ST. LUCIE PLANT  
IN HOUSE EVENT REPORT 92-023**

**TURBINE GENERATOR FAILED TO TRIP FOLLOWING MANUAL REACTOR TRIP**

**UNIT: 2**

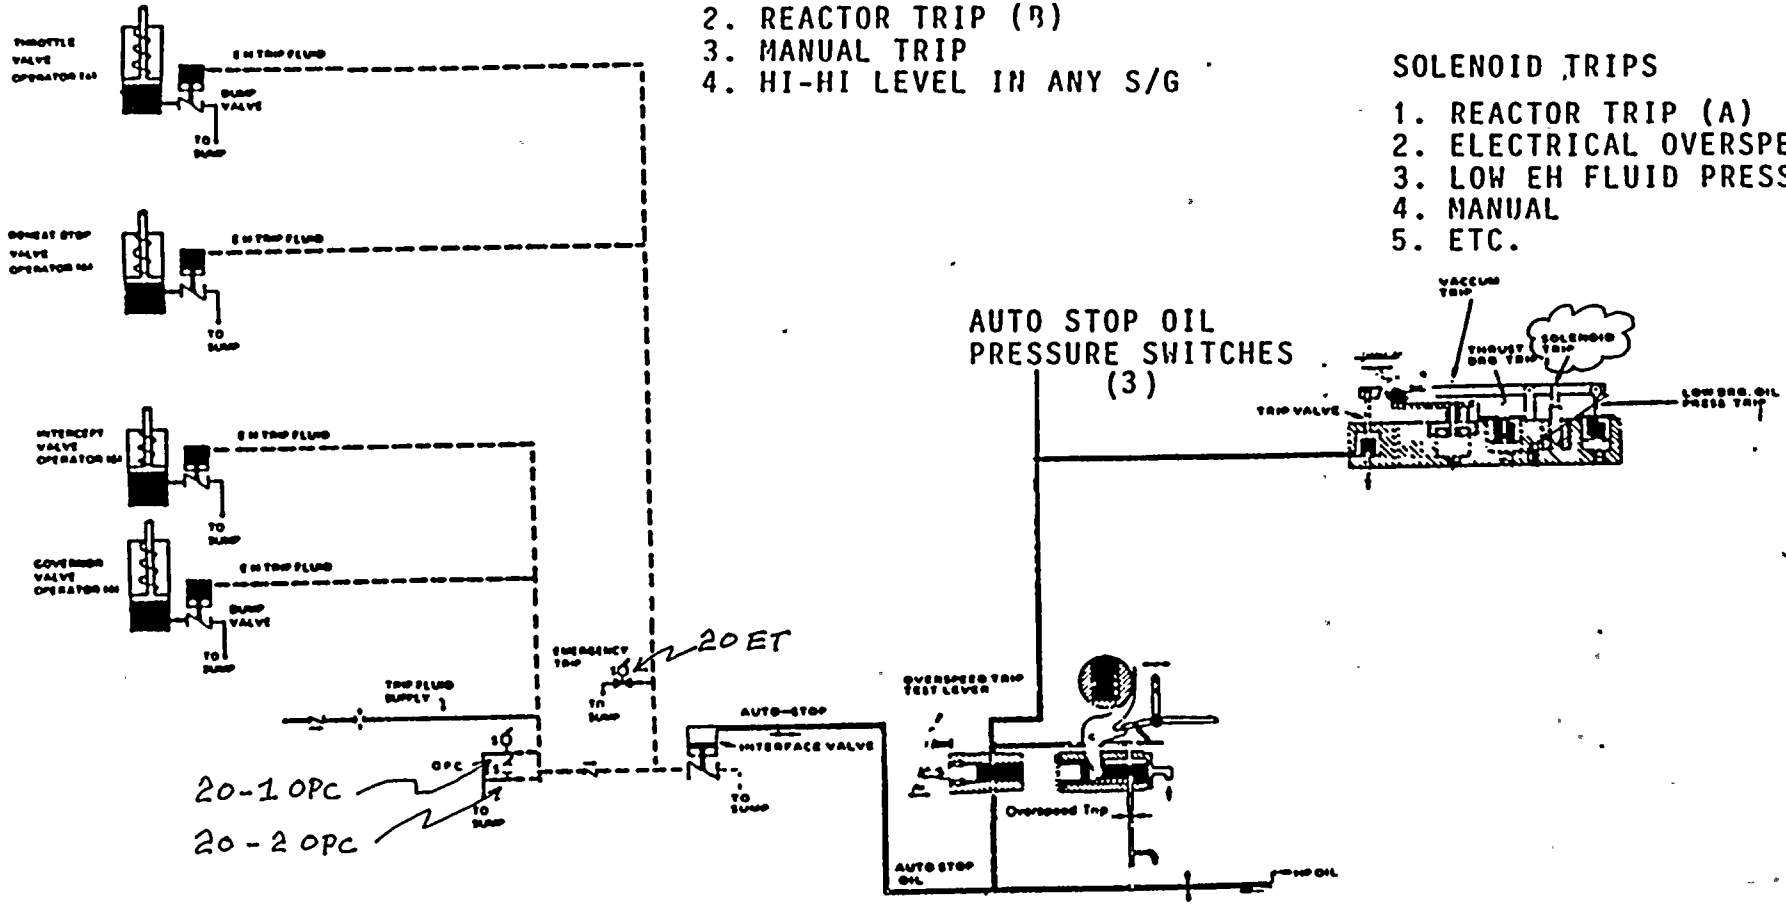
ATTACHMENT # 1, IHE # 92-023  
SHEET 1 OF 1

The plant response to this event was as expected with the exception of the failure of the turbine to trip. Upon the reactor trip signal, the four Control Element Drive Mechanism (CEDM) Bus undervoltage relays should de-energize. This should energize (open) the 20 ET solenoid valve and drain the electro-hydraulic fluid from the emergency trip header ( See attachment #1). The 20 AST trip solenoid coil should simultaneously energize, pull down the mechanical trip lever, and dump the auto-stop oil header. Decreasing auto stop oil pressure allows the Interface valve to open and dump the electro-hydraulic fluid emergency trip header. When auto stop oil pressure decreases to 45 psi, pressure switches 63-1 AST and 63-2 AST should lock in, actuating a generator primary lockout which trips the generator output breakers. The same result should be obtained when attempting to trip the turbine via the Turbine Trip Pushbutton. A multi-discipline team is investigating to determine why the turbine failed to trip when the trip signals were initiated.

Testing of the 20 ET Trip solenoid, 20 AST solenoid valve, and the 20 OPC 1 and 2 solenoid valves was performed in accordance with 2-LOI-T-67. The results of this evaluation are as follows:

**1) 20 ET Solenoid valve**

The original solenoid valve was removed to preserve the "as found" condition of the valve. A new solenoid valve was installed and tested satisfactorily. This verified the 20 ET electrical circuits did not contribute to the failures.

**2) 20 AST Trip Solenoid**

The solenoid was tested numerous times with two of the tests indicative of intermittent circuit problems. A loose connection was found on relay 62 ASTX / pin 6. This connection is in the circuit for all 20 AST trip functions. Further troubleshooting is continuing.

**3) 20 OPC 1 and 2 Solenoid Valves**

One OPC solenoid valve was removed prior to testing for potential failure mode analysis. Testing of one original and one replacement OPC solenoid valve indicated acceptable operation of the OPC circuits.

# WESTINGHOUSE ELECTRO-HYDRAULIC CONTROL SYSTEM AND AUTO-STOP OIL SYSTEM

- 1. The original 20 ET, 20 OPC-1 and 20 OPC-2 Solenoid valves have been removed and were sent to an independent laboratory for analysis.**
- 2. Maintenance is continuing to investigate the root cause of the intermittent electrical problems of the 20 AST Trip Solenoid. The circuits of the 20 ET and 20 OPC 1 and 2 Solenoids are also being evaluated to ensure similar problems do not exist.**
- 3. Nuclear Fuels is evaluating additional guidance for ASI control at the end of core life.**
- 4. Operations is evaluating additional guidance for EOP-1, "Standard Post Trip Actions", on actions to take for a reactor trip with no subsequent turbine trip.**
