ACCESSION NBR: 9208110304 DOC. DATE: 92/08/07 NOTARIZED: NO DOCKET #
 FACIL: 50-389 St. Lucie Plant, Unit 2, Florida Power & Light Co. 05000389
 AUTH. NAME AUTHOR AFFILIATION
 SIENKIEWICZ, S. Florida Power & Light Co.
 SAGER, D.A. Florida Power & Light Co.
 RECIP. NAME RECIPIENT AFFILIATION

Re: St. Lucie Unit 2
Docket No. 50-389
Reportable Event: 92-005
Date of Event: July 10, 1992
Reactor Trip from 100% power on (Loss of Load)
caused by a design error in the
Turbine Trip Testing on-line modification

TITLE (4) Reactor trip from 100% power on (Loss of Load) caused by a design inadequacy in the on-line testing modification of the turbine trip control system

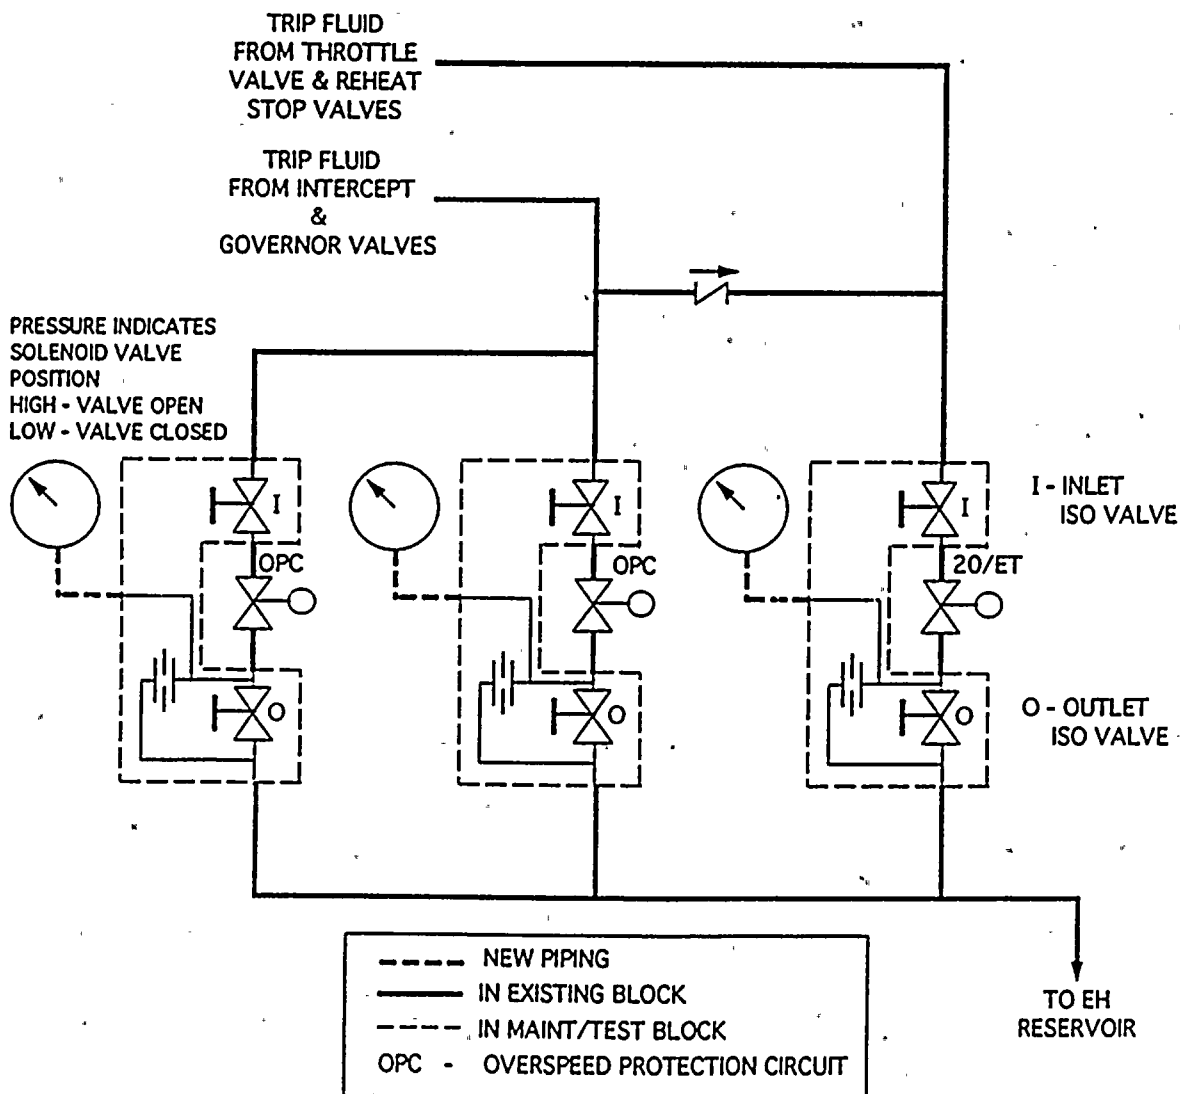
FIGURE #1

On July 10, 1992 at 1018 hours with St. Lucie Unit 2 in mode 1 at 100% power, the reactor automatically tripped on Loss of Load while performing turbine trip solenoid device tests using newly installed on-line testing circuitry. The sequence for testing this valve (see figure #1) and the subsequent trip is as follows:

- 1) 20/ET test block outlet isolation valve was closed.
- 2) Per the procedure the pressure gauge was verified as having no indicated pressure.
- 3) Valve 20/ET was opened.
- 4) When valve 20/ET was opened, it induced a pressure transient which was picked up by the Loss of Load Reactor Protection System (RPS) pressure switches due to their close proximity to valve 20/ET.
- 5) The RPS tripped the reactor on Loss of Load which subsequently tripped the turbine.

The cause of the subsequent reactor trip was an unforeseen and previously undetected pressure transient imposed on the turbine generator hydraulic control oil system during on-line turbine trip testing with the modification installed. The pressure transient had not been identified during extensive post modification testing and was not detectable with the normally installed instrumentation. Sensitive test instrumentation revealed a very rapid 0.020 second pressure transient which interacted with the Reactor Protection System pressure switches that are activated above 15% power. The pressure pulse was most probably caused by filling the very small void between 20/ET, outlet isolation valve and the orifice when valve 20/ET was opened. Previous design experience had not suggested such a phenomenon, and the reactor trip occurred the first time the modification was tested above 15% power.

In summary the root cause of the reactor trip was design inadequacy. The lack of experience in the industry in regard to on-line testing of the turbine trip solenoid valves contributed to the design inadequacy. A contributing factor is that the post modification testing did not detect the pressure transient.

- 1) The on-line testing of the turbine trip solenoid valves (20 /ET, 20-1/OPC, 20-2/OPC) has been suspended.
- 2) Testing of the "Loss of Load" trip signal was conducted while Unit 2 was shutdown due to the trip. The results of the testing validated the cause of this event as described in this LER.
- 3) Further evaluation of the solenoid valve test modifications will be performed prior to the next Unit 1 refueling outage.
- 4) Pre-installation testing will be performed for the Unit 1 solenoid valve test modifications.
- 5) Unit 1 post modification testing will be performed prior to start up, utilizing the lessons learned from Unit 2.
- 6) Perform the same solenoid valve test modifications on Unit 2, during the next scheduled refueling outage.
