Re: St. Lucie Unit 2  
Docket No. 50-389  
Reportable Event: 93-07  
Date of Event: May 21, 1993  
Manual Reactor Trip After the Simultaneous Dropping  
of Control Element Assemblies due to Equipment Failure

FACILITY NAME (1) <b>St. Lucie Unit 2</b>	DOCKET NUMBER (2) <b>05000389</b>	PAGE (3) <b>1 OF 5</b>
--	--------------------------------------	---------------------------

TITLE (4) **Manual Reactor Trip After the Simultaneous Dropping of Control Element Assemblies due to Equipment Failure**

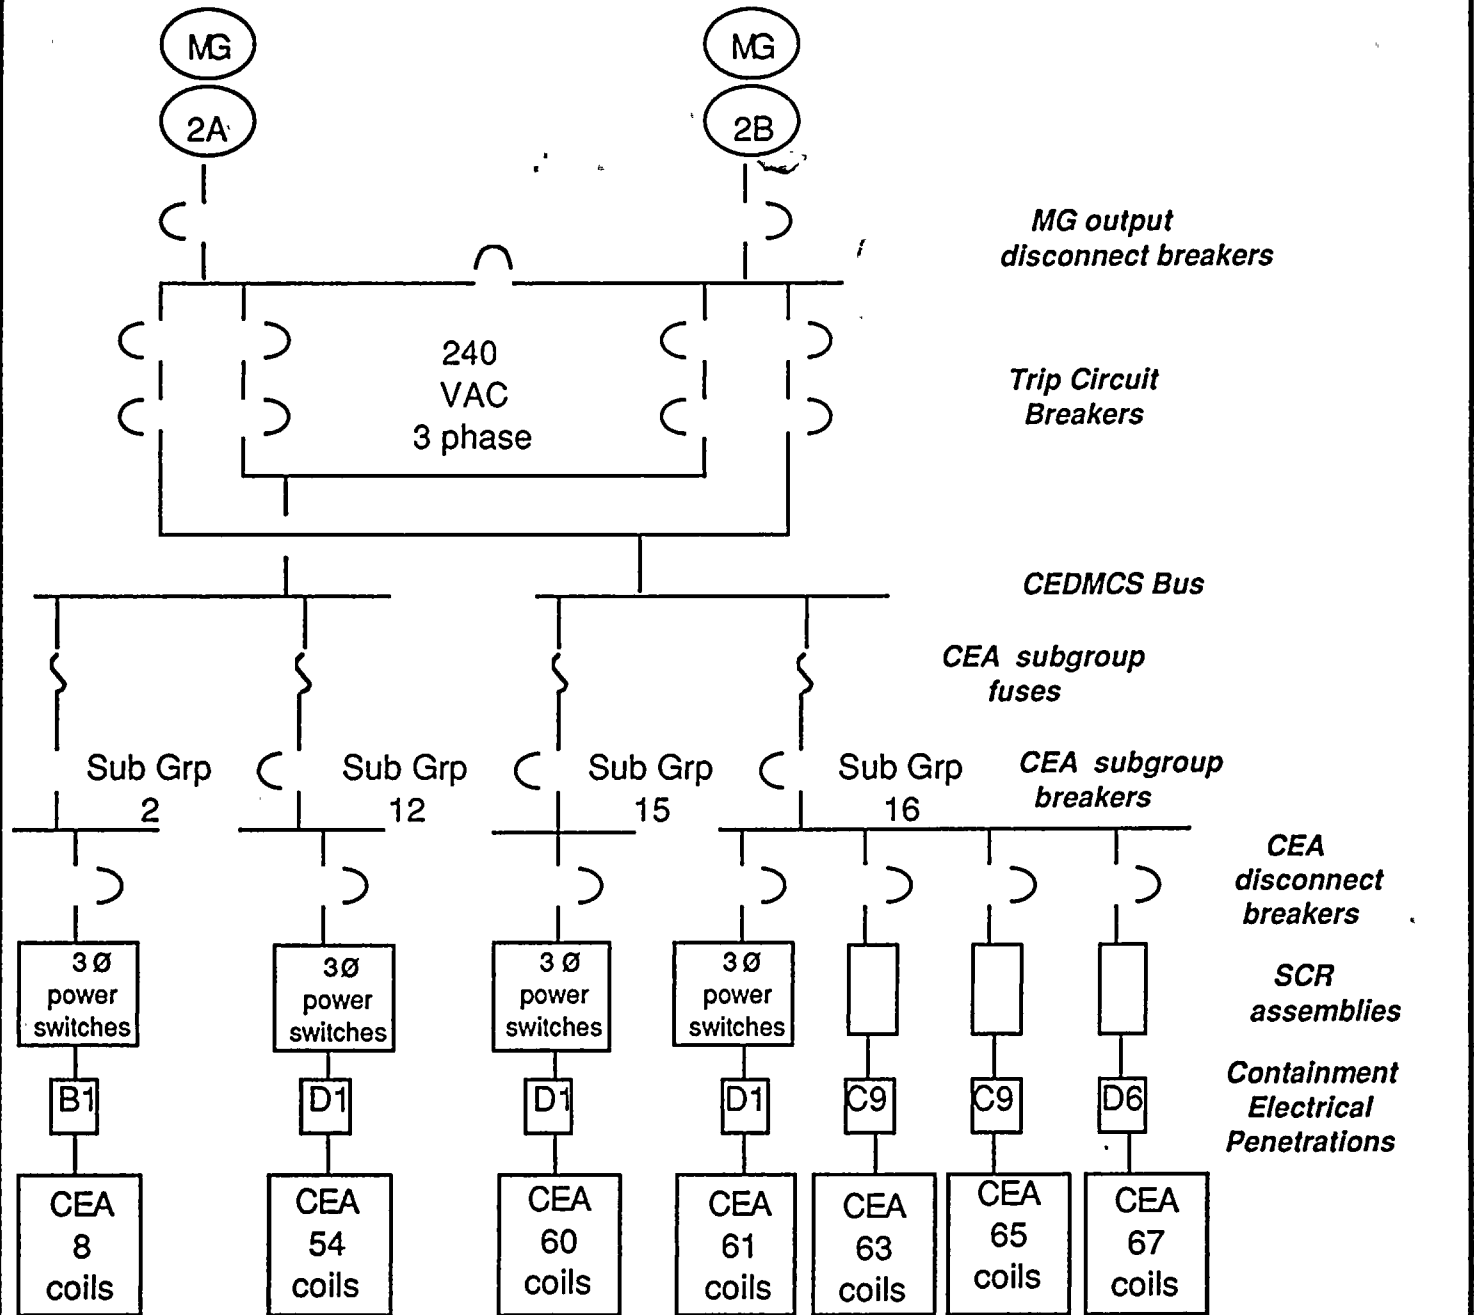
**FIGURE ONE - CEA POWER DISTRIBUTION**

On May 21, 1993, while Unit 2 was at 72% power steady state operation, control room operators observed the indication of multiple dropped Control Element Assemblies (CEA's) (EIS : AA) on the Core Mimic Display and the CEA Display Panel accompanied by the simultaneous annunciation of alarm K-23 "CEDMCS (Control Element Drive Mechanism Control System) (EIS : AA) Trouble". Subsequently, a decrease in Tave was observed. The Digital Data Processing System indicated that the seven dropped CEAs were numbers 8, 54, 60, 61, 53, 65 and 67. Approximately 10 seconds after the CEA's dropped, operators manually tripped the reactor and the turbine in accordance with the immediate operator actions of the CEA Off-Normal procedure, ONOP 2-0110030. Emergency Operating Procedure (EOP) One, "Standard Post Trip Actions", was implemented immediately post-trip. The Steam Bypass Control System (EIS: JI) operated properly to reduce Tave to 532 degrees Fahrenheit. The Steam Generators (SG's) (EIS: AB) were supplied post trip via the Steam Generator Feed Pumps (SGFP) (EIS: SJ) and the 15% feedwater bypass valve. After the successful implementation of standard post trip actions by two Reactor Control Operators, an uncomplicated reactor trip was diagnosed and the Senior Reactor Operator directed the crew to exit EOP-1 and enter EOP-2, "Reactor Trip Recovery". After the completion of EOP-2, the unit was maintained in Mode 3 for the post trip review and event investigation. Subsequent examination of the CEDMCS revealed the following conditions for the seven dropped CEA's: (See Figure One for an abbreviated schematic of the CEA power system)

- CEA 8, Regulating Group 5 - disconnect breaker was not tripped, no Subgroup fuses blown.
- CEA 54, Shutdown Group A - disconnect breaker was tripped.
- CEA 60, Regulating Group 3 (Subgroup 15) - disconnect breaker not tripped, no Subgroup fuses blown.
- CEA 61, Regulating Group 3 (Subgroup 16) - A&B phases of disconnect breaker tripped, 2 Subgroup fuses blown.
- CEA 63, Regulating Group 3 (Subgroup 16) - disconnect breaker closed, 2 Subgroup fuses blown.
- CEA 65, Regulating Group 3 (Subgroup 16) - disconnect breaker closed, 2 Subgroup fuses blown.
- CEA 67, Regulating Group 3 (Subgroup 16) - disconnect breaker closed, 2 Subgroup fuses blown.

The CEA power distribution system utilizes a 240 VAC three phase system with an ungrounded neutral line. This three phase AC is then rectified and conditioned by the CEDMCS to a nominal 50 VDC which is then supplied to each Control Element Drive Mechanism (CEDM) (EIS: AA) coil stack inside of containment. During steady state conditions, the control room CEDMCS operating panel is switched to "Off", as it was during this event. This results in only the Upper Gripper Coil of each CEA being energized. If the Automatic CEDM Timer Module (ACTM) for a CEA reads an abnormal current condition for the Upper Gripper coil, the CEA will be maintained withdrawn by the ACTM energizing the Lower Gripper Coil. Under normal conditions, this DC power arrangement with an ungrounded neutral line is tolerant of at least one conductor short to ground. Furthermore, as long as the conductor grounds are of the same polarity, multiple conductor grounds on different coil stacks may not affect the system's operability and may go undetected. When a second conductor ground develops on a conductor of different polarity a short circuit develops which may cause CEDM coils to deenergize.

The most probable cause of the drop of seven CEAs is attributable to grounds in the 50 VDC CEDM power system located in an electrical penetration. Testing by the I&C Department revealed that five grounds were present in the Shield Building side of electrical penetration D-1. These conductor to ground shorts resulted in an overcurrent condition that opened the disconnect breaker for CEA 54, several contacts in the disconnect breaker for CEA 61, and the 2 fuses blown on subgroup 16. The two CEAs which did not observe a condition that would permanently interrupt power to the Upper Gripper and Lower Gripper Coils were CEAs 8 and 60. (CEDM 60 was found to have a ground on the neutral phase of its load transfer coil; this condition alone would not cause the CEA to drop. CEDM 8 had no faults identified). The most likely cause for CEA's 8 and 60 to drop during this event was due to a transient induced on the CEDMCS 240 VAC power system when the conductor to ground faults developed. Output monitoring of the 2A Motor Generator (MG) set with a temporary power line monitor during testing of CEA 61 prior to the repairs showed that the grounds were reflected back throughout the CEDMC power system. This disturbance probably resulted in the dropping of CEA's 8 and 60.
