SUBJECT: LER 93-007-00: on 930521, observed indication of multiple
dropped CEA on core mimic display resulting to manual
reactor trip. Caused by equipment failure. LLRT conducted to
verify containment vessel integrity. W/930621 ltr.

Re: St. Lucie Unit 2
Docket No. 50-389
Reportable Event: 93-07
Date of Event: May 21, 1993
Manual Reactor Trip After the Simultaneous Dropping
of Control Element Assemblies due to Equipment Failure

TITLE (4) Manual Reactor Trip After the Simultaneous Dropping of Control Element Assemblies due to Equipment Failure

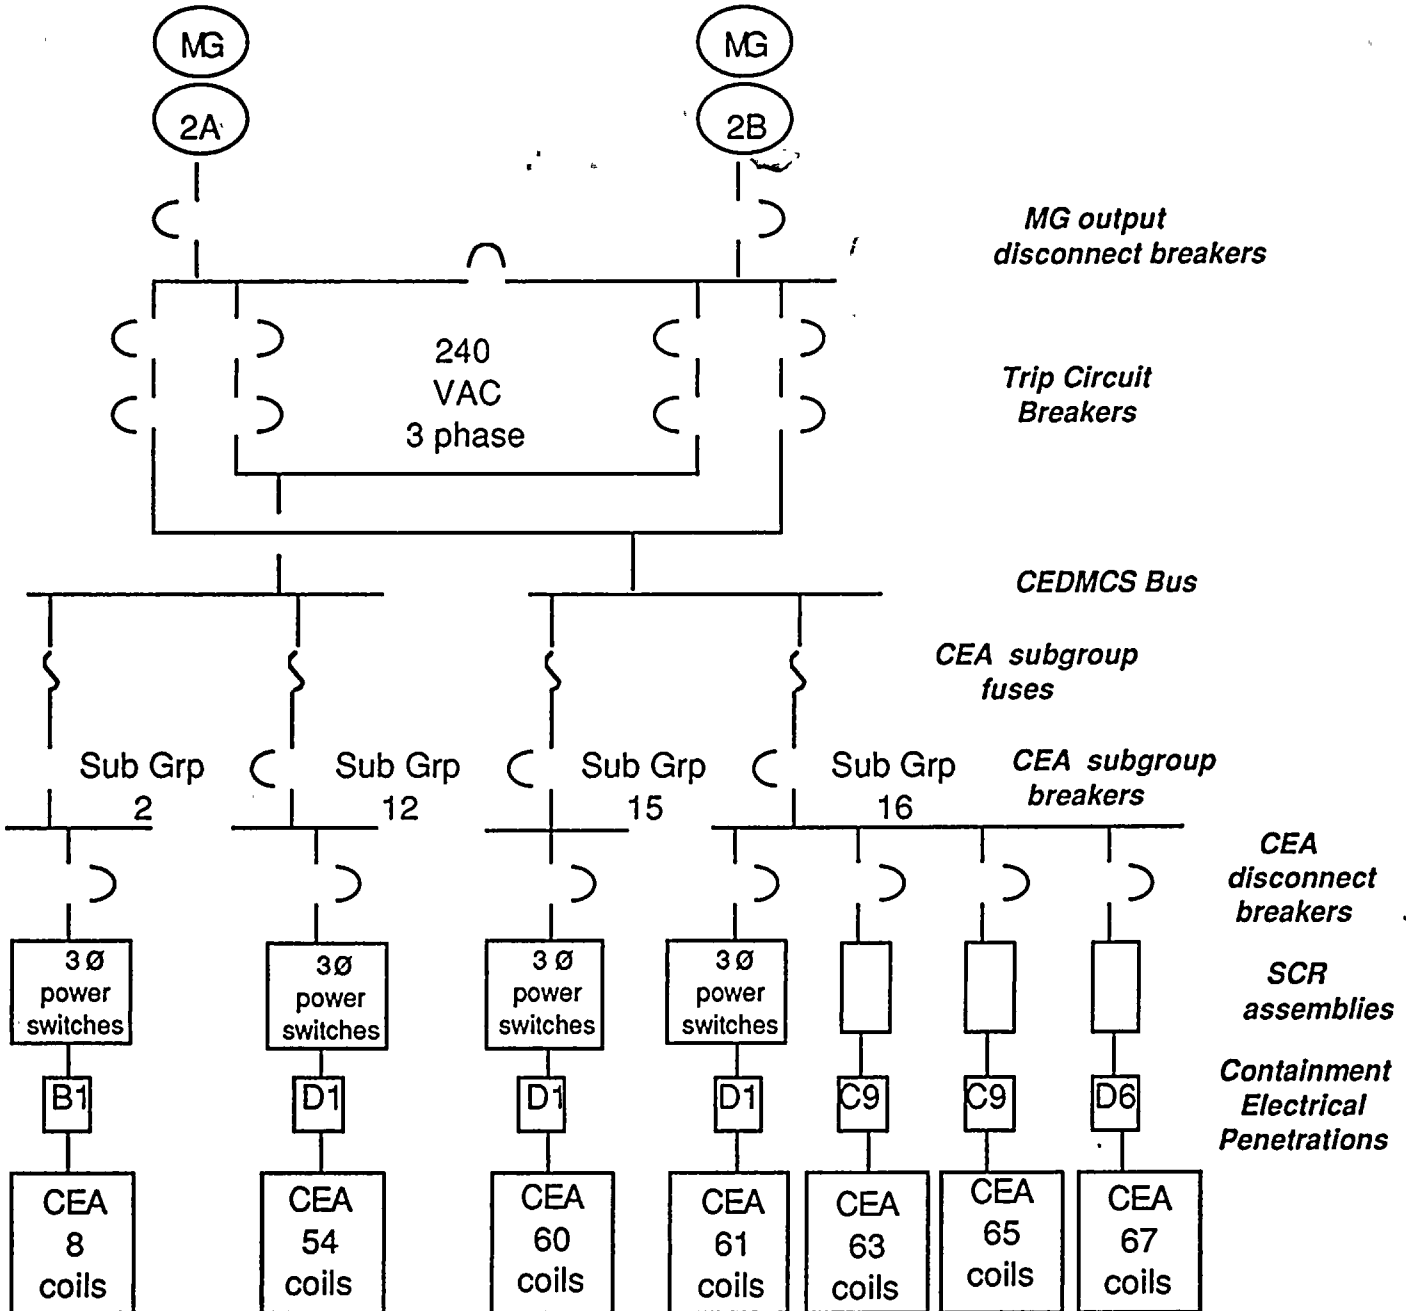
FIGURE ONE - CEA POWER DISTRIBUTION

On May 21, 1993, while Unit 2 was at 72% power steady state operation, control room operators observed the indication of multiple dropped Control Element Assemblies (CEA's) (EIS : AA) on the Core Mimic Display and the CEA Display Panel accompanied by the simultaneous annunciation of alarm K-23 "CEDMCS (Control Element Drive Mechanism Control System) (EIS : AA) Trouble". Subsequently, a decrease in Tave was observed. The Digital Data Processing System indicated that the seven dropped CEAs were numbers 8, 54, 60, 61, 53, 65 and 67. Approximately 10 seconds after the CEA's dropped, operators manually tripped the reactor and the turbine in accordance with the immediate operator actions of the CEA Off-Normal procedure, ONOP 2-0110030. Emergency Operating Procedure (EOP) One, "Standard Post Trip Actions", was implemented immediately post-trip. The Steam Bypass Control System (EIS: JI) operated properly to reduce Tave to 532 degrees Fahrenheit. The Steam Generators (SG's) (EIS: AB) were supplied post trip via the Steam Generator Feed Pumps (SGFP) (EIS: SJ) and the 15% feedwater bypass valve. After the successful implementation of standard post trip actions by two Reactor Control Operators, an uncomplicated reactor trip was diagnosed and the Senior Reactor Operator directed the crew to exit EOP-1 and enter EOP-2, "Reactor Trip Recovery". After the completion of EOP-2, the unit was maintained in Mode 3 for the post trip review and event investigation. Subsequent examination of the CEDMCS revealed the following conditions for the seven dropped CEA's: (See Figure One for an abbreviated schematic of the CEA power system)

- CEA 8, Regulating Group 5 - disconnect breaker was not tripped, no Subgroup fuses blown.
- CEA 54, Shutdown Group A - disconnect breaker was tripped.
- CEA 60, Regulating Group 3 (Subgroup 15) - disconnect breaker not tripped, no Subgroup fuses blown.
- CEA 61, Regulating Group 3 (Subgroup 16) - A&B phases of disconnect breaker tripped, 2 Subgroup fuses blown.
- CEA 63, Regulating Group 3 (Subgroup 16) - disconnect breaker closed, 2 Subgroup fuses blown.
- CEA 65, Regulating Group 3 (Subgroup 16) - disconnect breaker closed, 2 Subgroup fuses blown.
- CEA 67, Regulating Group 3 (Subgroup 16) - disconnect breaker closed, 2 Subgroup fuses blown.

The CEA power distribution system utilizes a 240 VAC three phase system with an ungrounded neutral line. This three phase AC is then rectified and conditioned by the CEDMCS to a nominal 50 VDC which is then supplied to each Control Element Drive Mechanism (CEDM) (EIS: AA) coil stack inside of containment. During steady state conditions, the control room CEDMCS operating panel is switched to "Off", as it was during this event. This results in only the Upper Gripper Coil of each CEA being energized. If the Automatic CEDM Timer Module (ACTM) for a CEA reads an abnormal current condition for the Upper Gripper coil, the CEA will be maintained withdrawn by the ACTM energizing the Lower Gripper Coil. Under normal conditions, this DC power arrangement with an ungrounded neutral line is tolerant of at least one conductor short to ground. Furthermore, as long as the conductor grounds are of the same polarity, multiple conductor grounds on different coil stacks may not affect the system's operability and may go undetected. When a second conductor ground develops on a conductor of different polarity a short circuit develops which may cause CEDM coils to deenergize.

The most probable cause of the drop of seven CEAs is attributable to grounds in the 50 VDC CEDM power system located in an electrical penetration. Testing by the I&C Department revealed that five grounds were present in the Shield Building side of electrical penetration D-1. These conductor to ground shorts resulted in an overcurrent condition that opened the disconnect breaker for CEA 54, several contacts in the disconnect breaker for CEA 61, and the 2 fuses blown on subgroup 16. The two CEAs which did not observe a condition that would permanently interrupt power to the Upper Gripper and Lower Gripper Coils were CEAs 8 and 60. (CEDM 60 was found to have a ground on the neutral phase of its load transfer coil; this condition alone would not cause the CEA to drop. CEDM 8 had no faults identified). The most likely cause for CEA's 8 and 60 to drop during this event was due to a transient induced on the CEDMCS 240 VAC power system when the conductor to ground faults developed. Output monitoring of the 2A Motor Generator (MG) set with a temporary power line monitor during testing of CEA 61 prior to the repairs showed that the grounds were reflected back throughout the CEDMC power system. This disturbance probably resulted in the dropping of CEA's 8 and 60.
