SUBJECT: LER 93-009-00 on 931117, ESF actuation occurred due to subgroup actuation module trip. Cause under investigation. Corrective action: replaced & tested subgroup actuation module & reset actuation components. W/931117 ltr.

Re: St. Lucie Unit 1  
Docket No. 50-335  
Reportable Event: 93-009  
Date of Event: November 17, 1993  
Engineered Safety Features Actuation  
due to Subgroup Actuation Module Trip

FACILITY NAME (1) <b>St. Lucie Unit 1</b>	DOCKET NUMBER (2) <b>05000335</b>	PAGE (3) <b>1 OF 4</b>
TITLE (4) <b>Engineered Safety Features Actuation due to Spurious Subgroup Actuation Module Trip</b>

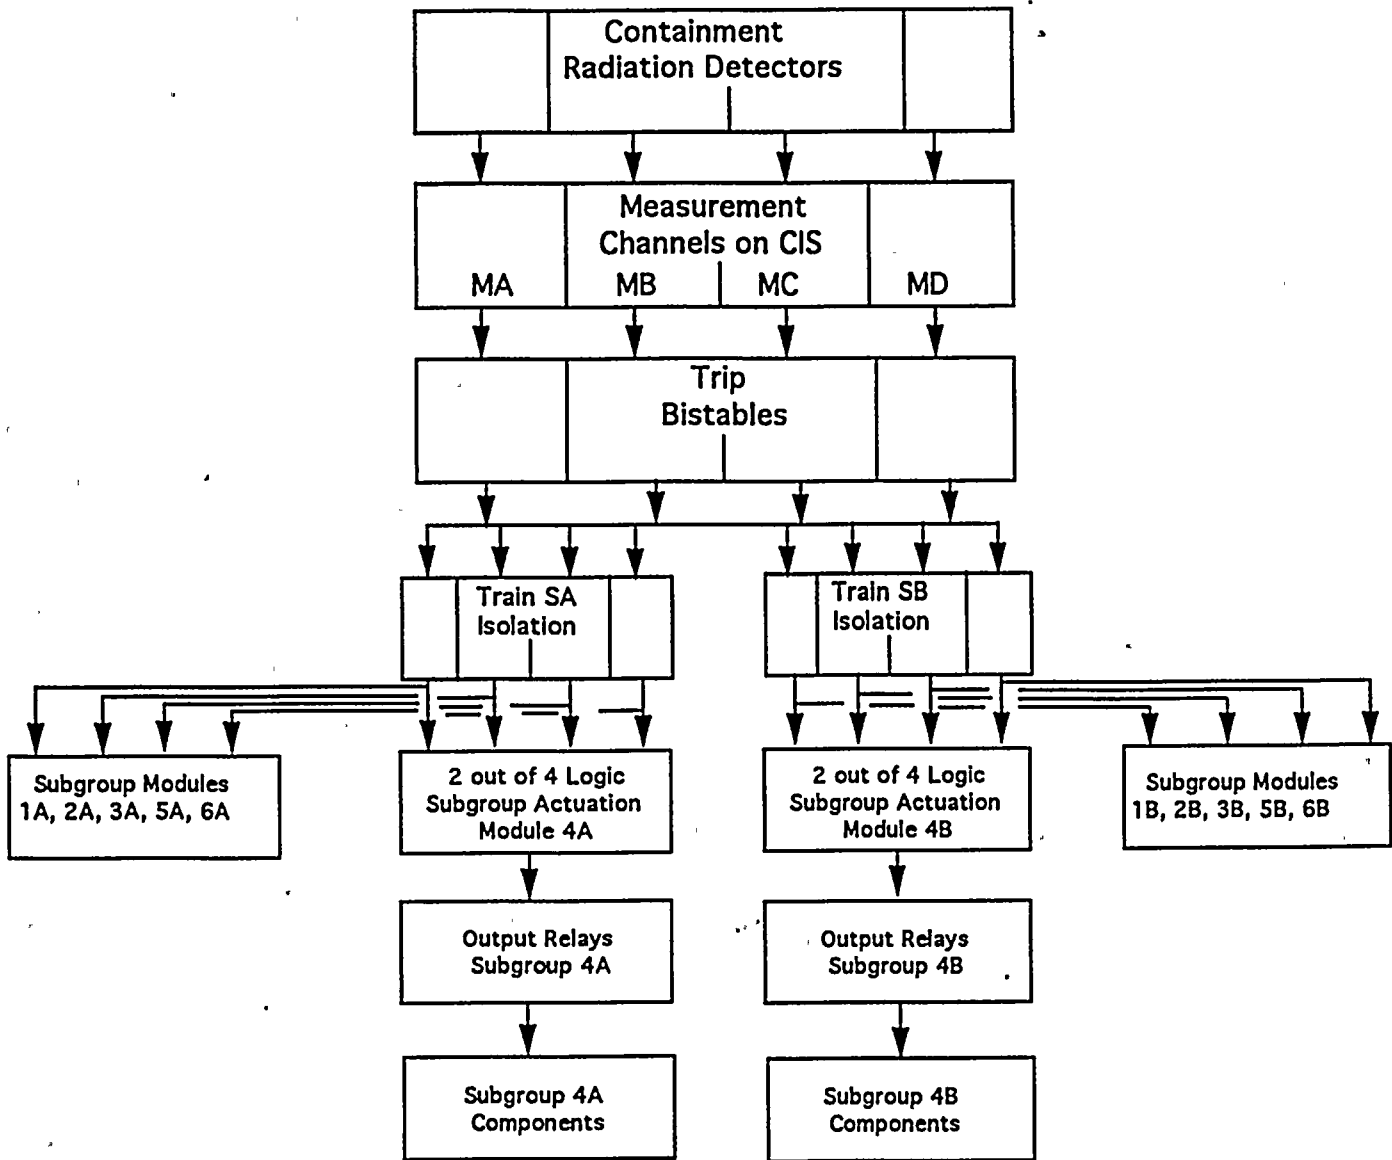
FIGURE ONE - CONTAINMENT ISOLATION SYSTEM

On November 17, 1993, St. Lucie Unit 1 was in mode 1 at 98% steady state power. The Engineered Safety Features Actuation System (ESFAS) (EIIS:JE), which normally requires two of four channels in trip for actuation, was in one out of three logic for the containment isolation system (CIS) (EIIS:JM). The MA containment radiation loop was out of service for repair and had been placed in trip per Technical Specification 3.3.2.1. The CIS as actuated by containment radiation consists of four independent measurement channels (MA,MB,MC,MD), each utilizing an independent bistable which passes a trip signal upon the measured parameter reaching its setpoint (See Figure 1). These four bistables are fed to two redundant actuation channels (SA,SB) where the subgroup actuation modules are located. The subgroup actuation modules pass a signal to their respective component actuation relays upon coincident signals from any two of four measurement bistables.

The root cause of the 4B CIS subgroup actuation module trip is under investigation by I&C maintenance. The results of that review will be provided in a supplement to this LER. No maintenance or surveillances were being performed at the time of the event. The CIS was in one out of three logic for containment radiation therefore making this parameter potentially more susceptible to spurious actuation. The 4B CIS subgroup actuation module which was replaced is being sent to the vendor, Consolidated Controls Corp. (C560), for failure analysis. Preliminary field checks and examination by the utility I&C maintenance did not identify any failures.
