# ACCELERATED DISTRIBUTION DEMONSTRATION SYSTEM

SUBJECT: LER 94-001-00: on 940217, pressurizer auxiliary spray declared out of svc. Caused by mispositioned valve due to personnel error. Valve correctly realigned, plant records reviewed & nonlicensed operators counseled. W/940224 ltr.

Re: St. Lucie Unit 2  
Docket No. 50-389  
Reportable Event: 94-001  
Date of Event: February 17, 1994  
Pressurizer Auxiliary Spray Out of Service  
Caused by a Mispositioned Isolation Valve  
Due to Personnel Error

TITLE (4) Pressurizer Auxiliary Spray Out of Service caused by a Mispositioned Isolation Valve due to Personnel Error.

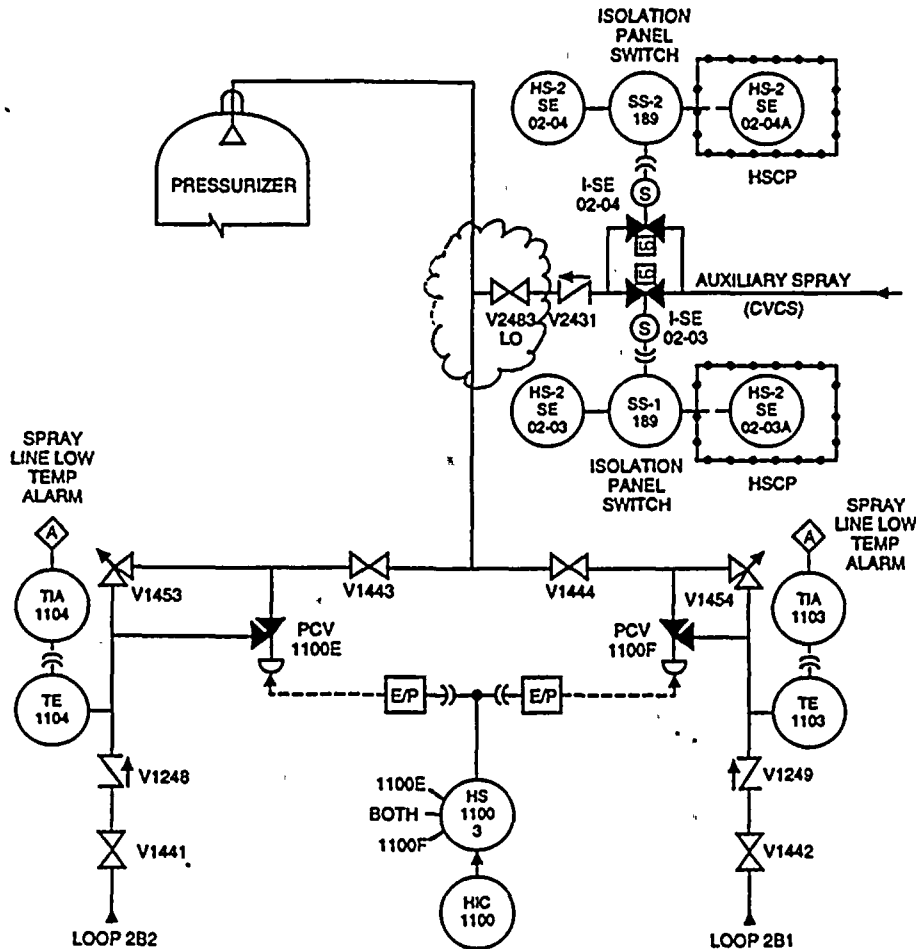
**FIGURE 1 - St. Lucie Pressurizer Spray System**

At 0030 on February 17, 1994, Unit 2 was in mode 5 at the beginning of a refueling outage. Operations, in accordance with Operating Procedure OP 2-0030127 "REACTOR PLANT COOLDOWN - HOT STANDBY TO COLD SHUTDOWN", was attempting to depressurize the Pressurizer (EII:AB) using Auxiliary Spray (EII:AB). When Auxiliary Spray was attempted the utility licensed operators noted that Pressurizer pressure was not decreasing as expected. Subsequent troubleshooting was initiated to verify the valve lineup for the Auxiliary Spray system. During this valve lineup verification process, a utility non-licensed operator found the Auxiliary Spray isolation valve V2483 to be mispositioned, locked closed. Valve V2483 is located in the Pressurizer cubicle and is a manually operated 2 inch gate valve which is normally in the locked open position.

However, Auxiliary Spray is not the only method of achieving Pressurizer pressure control to Shutdown Cooling entry conditions. FSAR Table 9.3-9 mentions the complete loss of Auxiliary Spray with the assumption of simultaneous failure of I-SE-02-03 and I-SE-02-04, Auxiliary Spray control valves (see Figure 1). The compensating action is to repeatedly cool down the Reactor Coolant System (RCS)(EIS:AB) via an available Steam Generator (EIS:AB) with the Atmospheric Dump Valves (ADVs)(EIS:SB) to shrink the Pressurizer level and consequently decrease RCS pressure, and then fill the Pressurizer with cooler RCS water via the surge line with the Charging Pumps (EIS:CB). This technique uses safety grade equipment and is described in FSAR Section 9.3.4.3.1.3.4, "Shutdown Without Letdown and Without Auxiliary Spray." This technique of repeatedly shrinking the Pressurizer level via an intact Steam Generator with the ADVs and refilling the Pressurizer with cooler RCS water would be applicable for a postulated Steam Generator Tube Rupture and Small Break Loss of Coolant Accident. In the case of a Large Break Loss of Coolant Accident, Auxiliary Spray is not required due to immediate RCS depressurization. For any other design basis event with the RCS remaining intact, the only difference is that the Letdown System may be available and can be utilized to drain down the Pressurizer. The method of repeatedly shrinking and filling the Pressurizer is referenced in Combustion Engineering Emergency Procedures Guidelines, CEN-152. This method is not explicitly described in the St. Lucie EOPs, but the use of charging, letdown and ADVs is listed as a contingency action for RCS pressure control and is considered to be within the knowledge and skills of the operators.
