SUBJECT: LER 93-009-01: on 931117, containment isolation sys subgroup actuation module trip occurred due to spurious signal on one containment isolation sys channel. Module replaced, tested & reset. W/940628 ltr.

Re: St. Lucie Unit 1
Docket No. 50-389
Reportable Event: 93-009-01
Date of Event: November 17, 1993
Engineered Safety Features Actuation due to
Spurious Subgroup Actuation Module Trip

TITLE (4) **Engineered Safety Features Actuation due to Spurious Subgroup Actuation Module Trip**

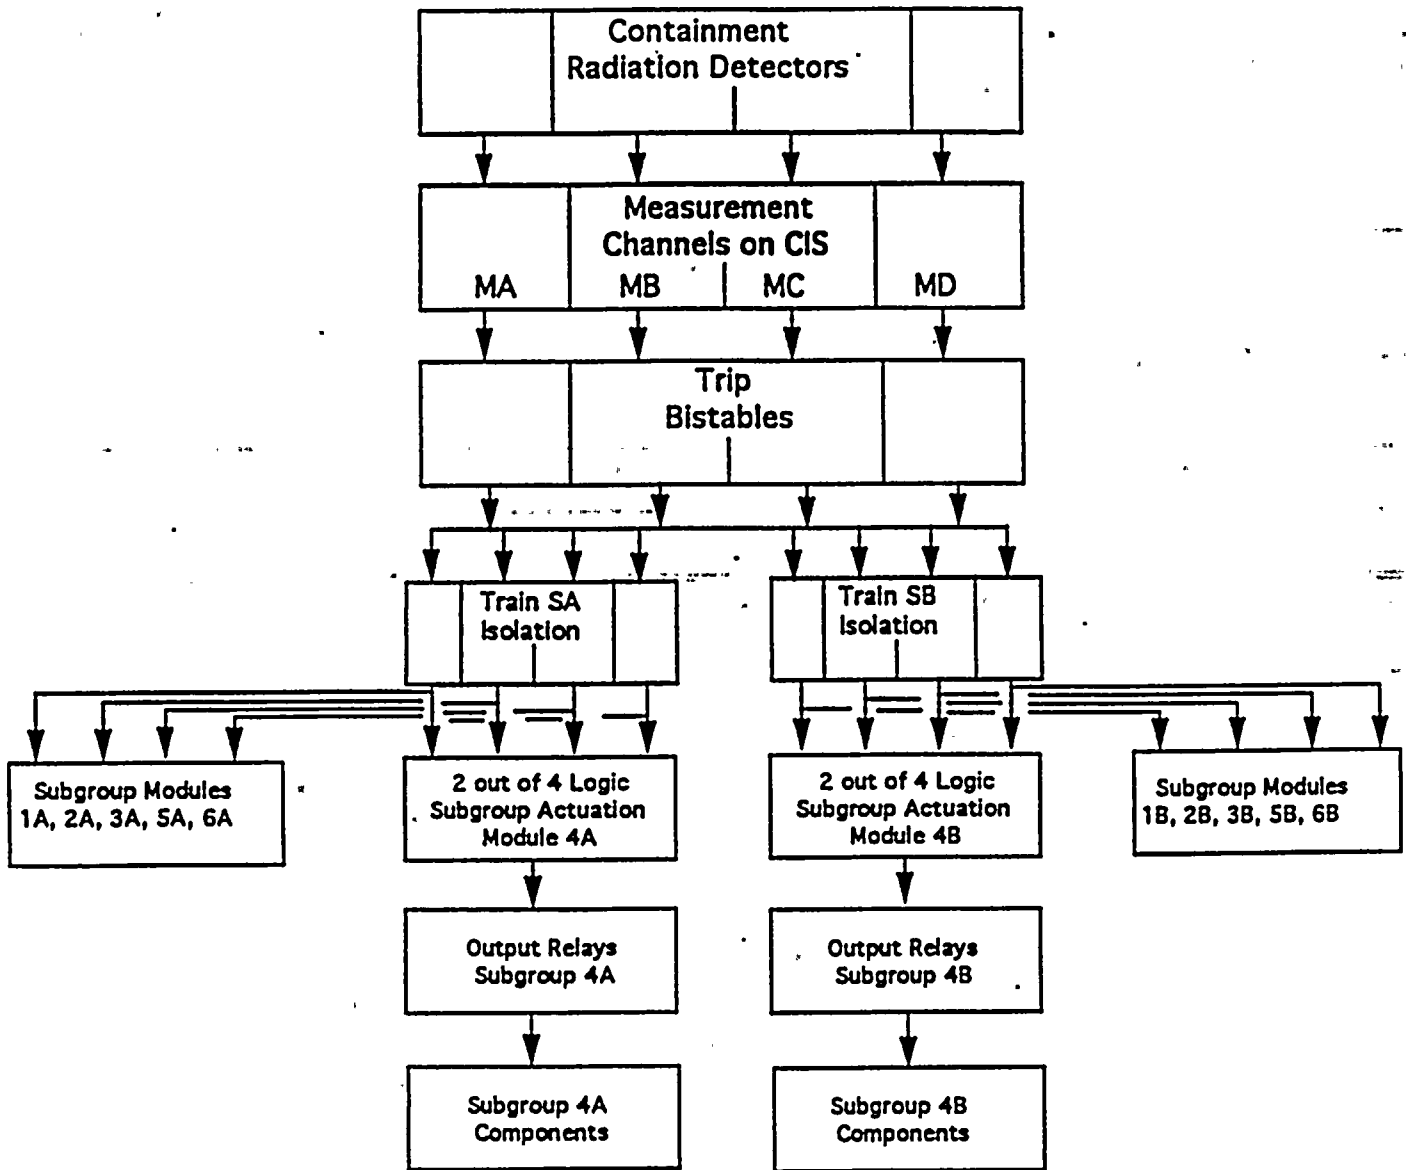
FIGURE ONE - CONTAINMENT ISOLATION SYSTEM

In the containment isolation system the measurement bistables pass a signal to the subgroup actuation modules upon reaching their setpoint and then lock in indication that a signal was present after a specified duration referred to as latch-in time. There are six subgroup actuation modules on both the SA and SB actuation channels (see figure 1). Each subgroup actuation module contains its own individual logic circuit for determining receipt of a signal from two of the four measurement bistables. Upon receipt of this signal the subgroup actuation modules pass a signal to the output relays and then latch in the output signal at a specified duration. The 4B subgroup actuation module was a new type designated to replace the original subgroup actuation modules and was the only one of its type installed in the CIS at the time. This newer module is designed with a 12 millisecond latch-in time. This provides enhanced symmetry with the measurement bistables which lock in indication that a signal was output to the actuation modules if it continues for 15 milliseconds. The original type subgroup actuation module was designed with a 30 millisecond latch-in time. Both the new and original type subgroup actuation modules provide acceptable component actuation times within the design criteria of the ESFAS. With the CIS MA containment radiation bistable in trip, a momentary spurious signal of between 12 and 15 milliseconds did not provide sufficient duration to latch-in indication on one of the other three bistables but was of sufficient duration to cause the 4B actuation module to latch-in. No other subgroup actuation modules actuated since they were of the original design which required 30 milliseconds to latch-in. Therefore, the system response to the spurious signal was in accordance with the design.
