Re: St. Lucie Unit 2
Docket No. 50-389
Reportable Event: 94-006
Date of Event: July 14, 1994
Trip Circuit Breaker Failure due to a Broken Piece
of Phenolic Block Lodged in the Trip Latch Mechanism.

LICENSEE EVENT REPORT (LER)

St. Lucie Unit 2

TITLE (4) Trip Circuit Breaker Failure due to a Broken Piece of Phenolic Block Lodged in the Trip Latch Mechanism.

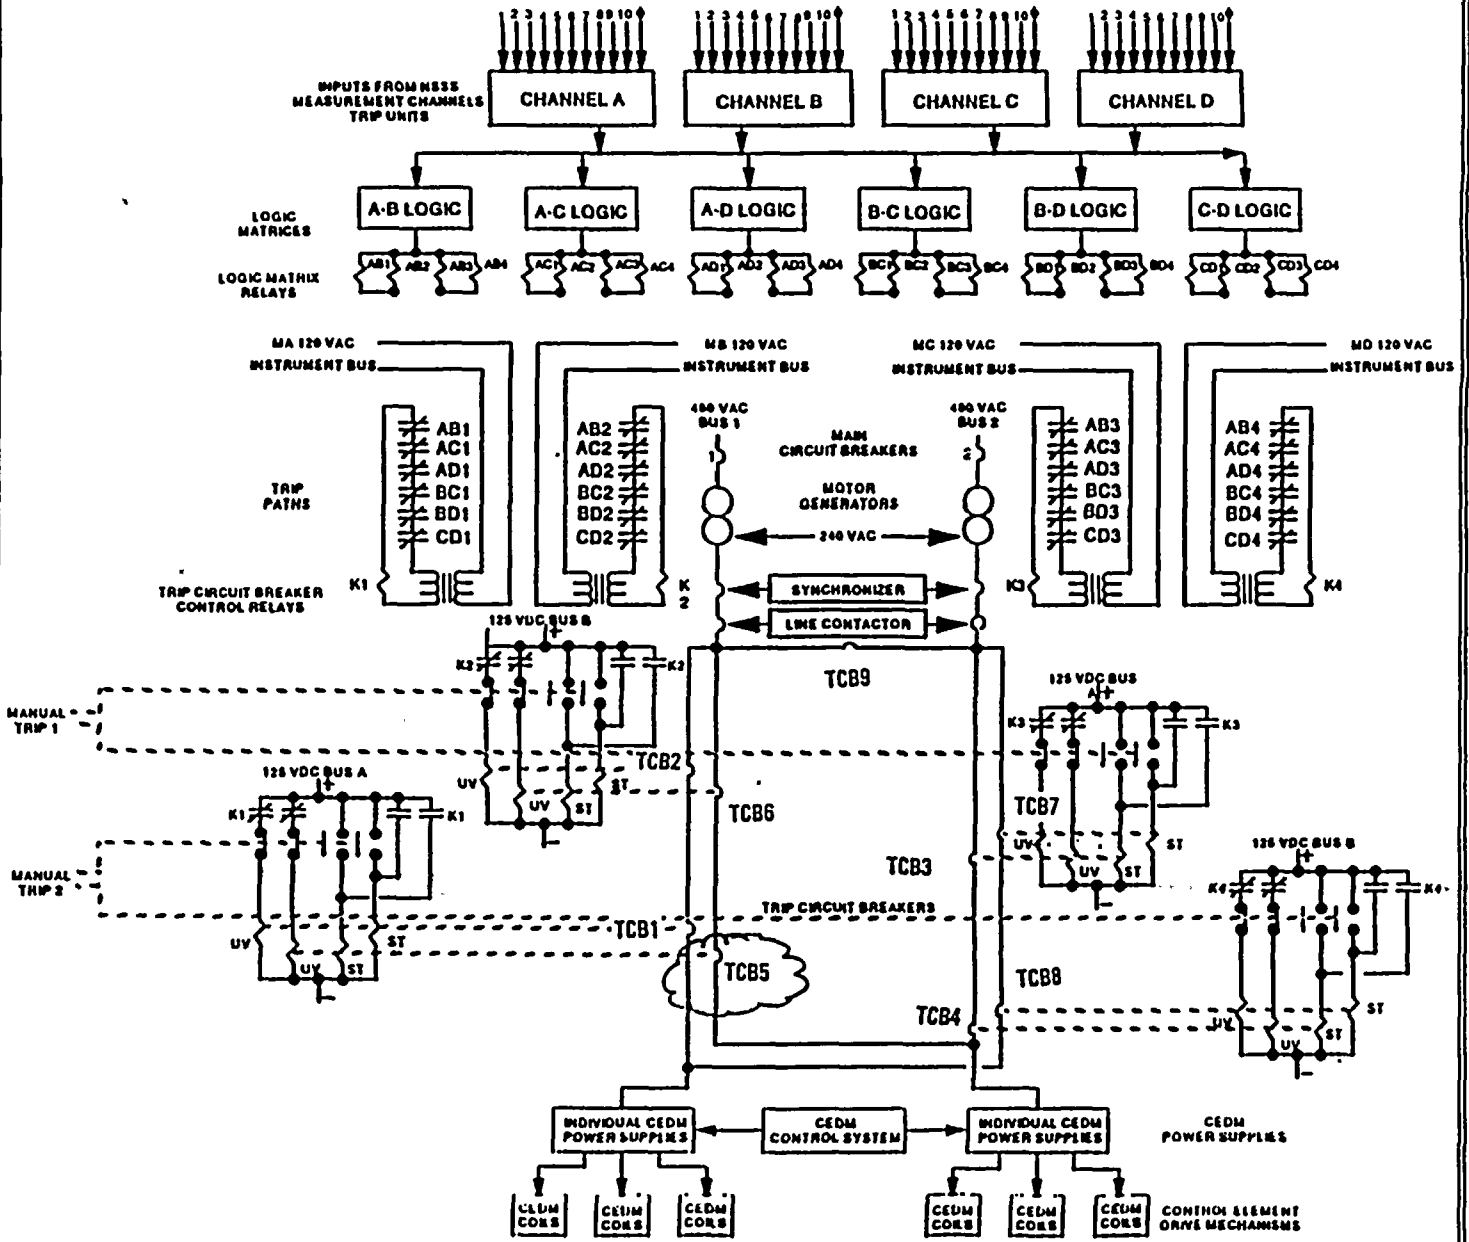
FIGURE ONE - RPS FUNCTIONAL DIAGRAM (TRIPPED CONDITION)

On 7/14/94 at 0200, Unit 2 utility licensed Reactor Operators commenced OP 2-1400059, Reactor Protective System Periodic Logic Matrix Test. At 0230, while testing the fourth logic matrix (AC matrix) of the Reactor Protective System (RPS)(EII:JC), Trip Circuit Breaker (TCB) Five (See Figure One)(EII:AA) failed to open. TCB-5 had just opened three times previously on other matrix tests.

The utility licensed Senior Reactor Operator attempted to open TCB-5 locally with the local pushbutton, the emergency pushbutton and by pulling the breaker fuses. All attempts were unsuccessful. The Reactor Trip pushbutton for channel MA TCBs 1 and 5 was depressed without success. At 0330 TCB-5 was declared out of service. TCBs 1, 2 and 6 were opened at 0418, which opened the series breaker and the parallel supply path to the Control Element Drive Mechanism bus (EII:AA) on the "A" side.

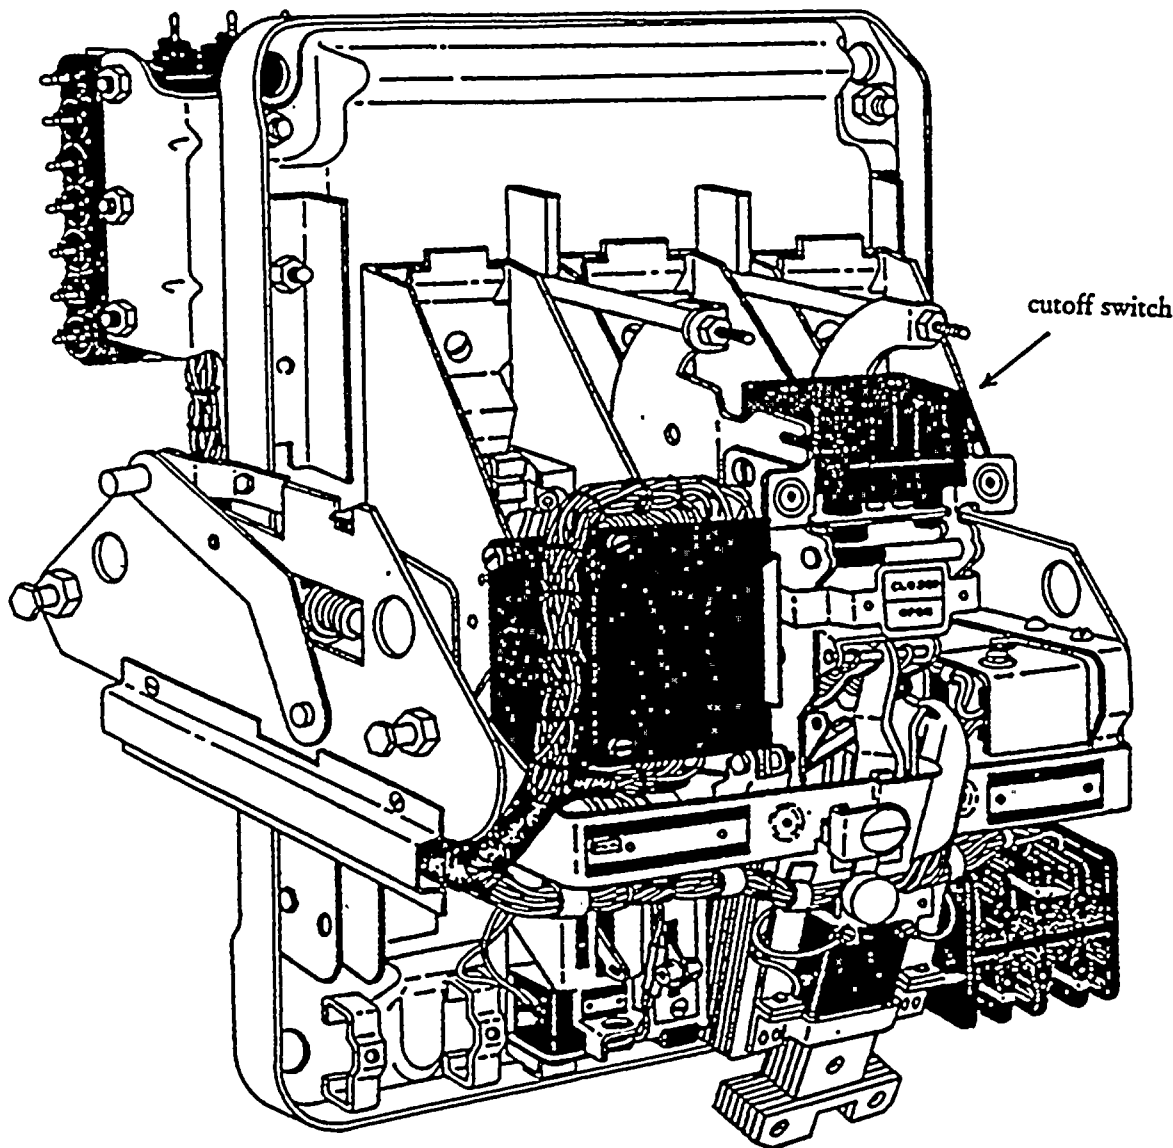
FIGURE TWO
GE AK-2-25 CIRCUIT BREAKER
(FRONT COVER REMOVED)

The cause of the failure of TCB-5 to trip has been identified as obstruction of motion on the trip latch lever. A small piece of broken phenolic insulating material approximately 1/4 inch square in size was found lodged between the trip latch lever and the access slot in the base for the trip latch. When the breaker was called upon to trip, electrically or manually, the phenolic piece restricted the motion of the trip latch lever such that the breaker mechanism would not operate. Upon the removal of the phenolic fragment, the breaker immediately tripped open and was subsequently found to operate freely during manual open and close operations.

The phenolic fragment was found to have originated from the cutoff switch (See Figure Two) used in the breaker anti-pump circuitry, which is physically located directly above the breaker trip latch mechanism. The cutoff switch operates mechanically each time the breaker is opened or closed.

Upon further inspection, it was determined that a screw used in the assembly of the cutoff switch had become loose. This screw holds the switch to the mounting block and if loose will allow the two halves of the switch to separate when the breaker is operated. This most likely led to switch misalignment and breakage of the phenolic block.

The potential root causes of the loose screw and phenolic material breakage are either a manufacturing defect or inadvertent damage during maintenance. A search of industry maintenance records did not indicate any similar type failures and has been determined by FPL Engineering and GE to be a first time event.

- 1) Electrical Maintenance has replaced TCB-5.
- 2) Electrical Maintenance, FPL Engineering and a GE representative inspected the remaining Unit 2 TCBs and the MG Set Output Breakers with satisfactory results.

- 4) Electrical Maintenance has incorporated the inspection of the cutoff switch phenolic block and screw into Unit 1 & 2 periodic maintenance procedures.

- 5) FPL Engineering will evaluate the use of a locking material on the cutoff switch phenolic block screw to prevent its backing out.
- 6) Operations performed OP 2-1400059, Reactor Protective System Periodic Logic Matrix Test, with satisfactory results and declared TCB-5 operable at 0315 on 7/15/94.
