Re: St. Lucie Unit 2
Docket No. 50-389
Reportable Event: 94-006 Revision 1
Date of Event: July 14, 1994
Trip Circuit Breaker Failure due to a Broken Piece
of Phenolic Block Lodged in the Trip Latch Mechanism
Results in a Technical Specification Required Shutdown.

LICENSEE EVENT REPORT (LER)

TITLE (4) Trip Circuit Breaker Failure due to a Broken Piece of Phenolic Block Lodged in the Trip Latch Mechanism Results in a Technical Specification Required Shutdown.

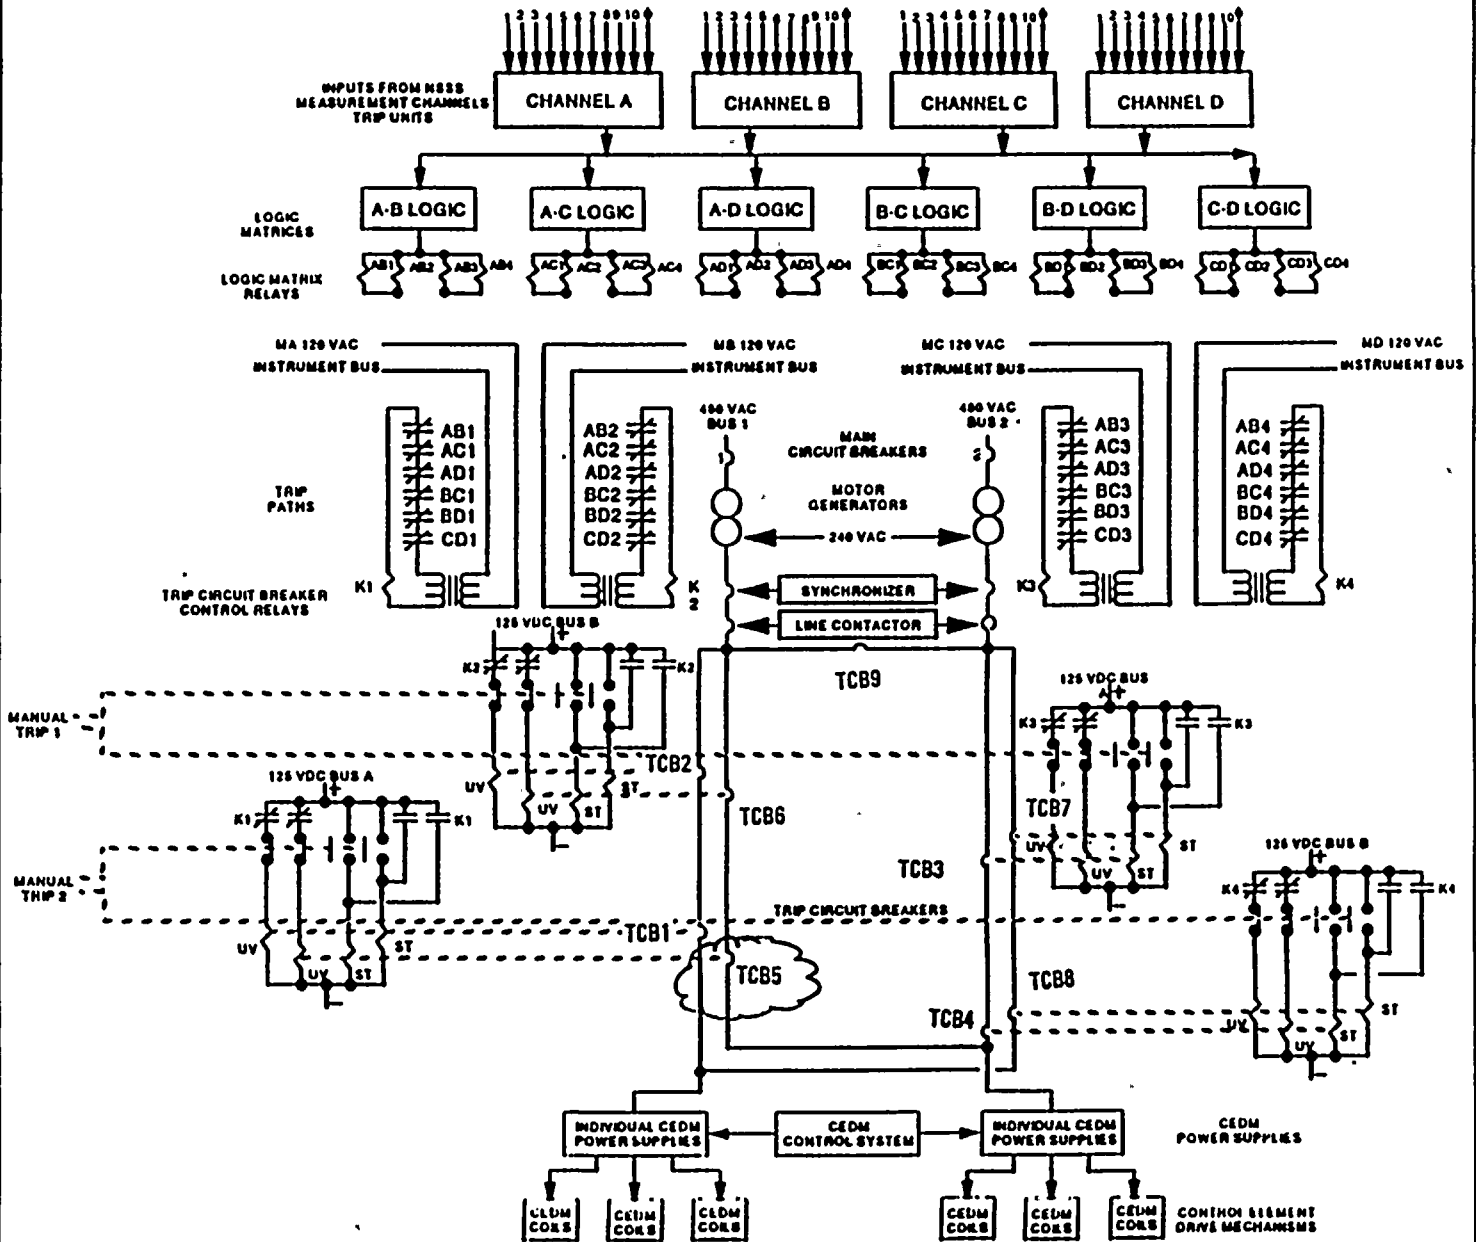
FIGURE ONE - RPS FUNCTIONAL DIAGRAM (TRIPPED CONDITION)

On 7/14/94 at 0200, Unit 2 utility licensed Reactor Operators commenced OP 2-1400059, Reactor Protective System Periodic Logic Matrix Test. At 0230, while testing the fourth logic matrix (AC matrix) of the Reactor Protective System (RPS)(EHC:JC), Trip Circuit Breaker (TCB) Five (See Figure One)(EHC:AA) failed to open. TCB-5 had just opened three times previously on other matrix tests.

The utility licensed Senior Reactor Operator attempted to open TCB-5 locally with the local pushbutton, the emergency pushbutton and by pulling the breaker fuses. All attempts were unsuccessful. The Reactor Trip pushbutton for channel MA TCBs 1 and 5 was depressed without success. At 0330 TCB-5 was declared out of service. TCBs 1, 2 and 6 were opened at 0418, which opened the series breaker and the parallel supply path to the Control Element Drive Mechanism bus (EHC:AA) on the "A" side.

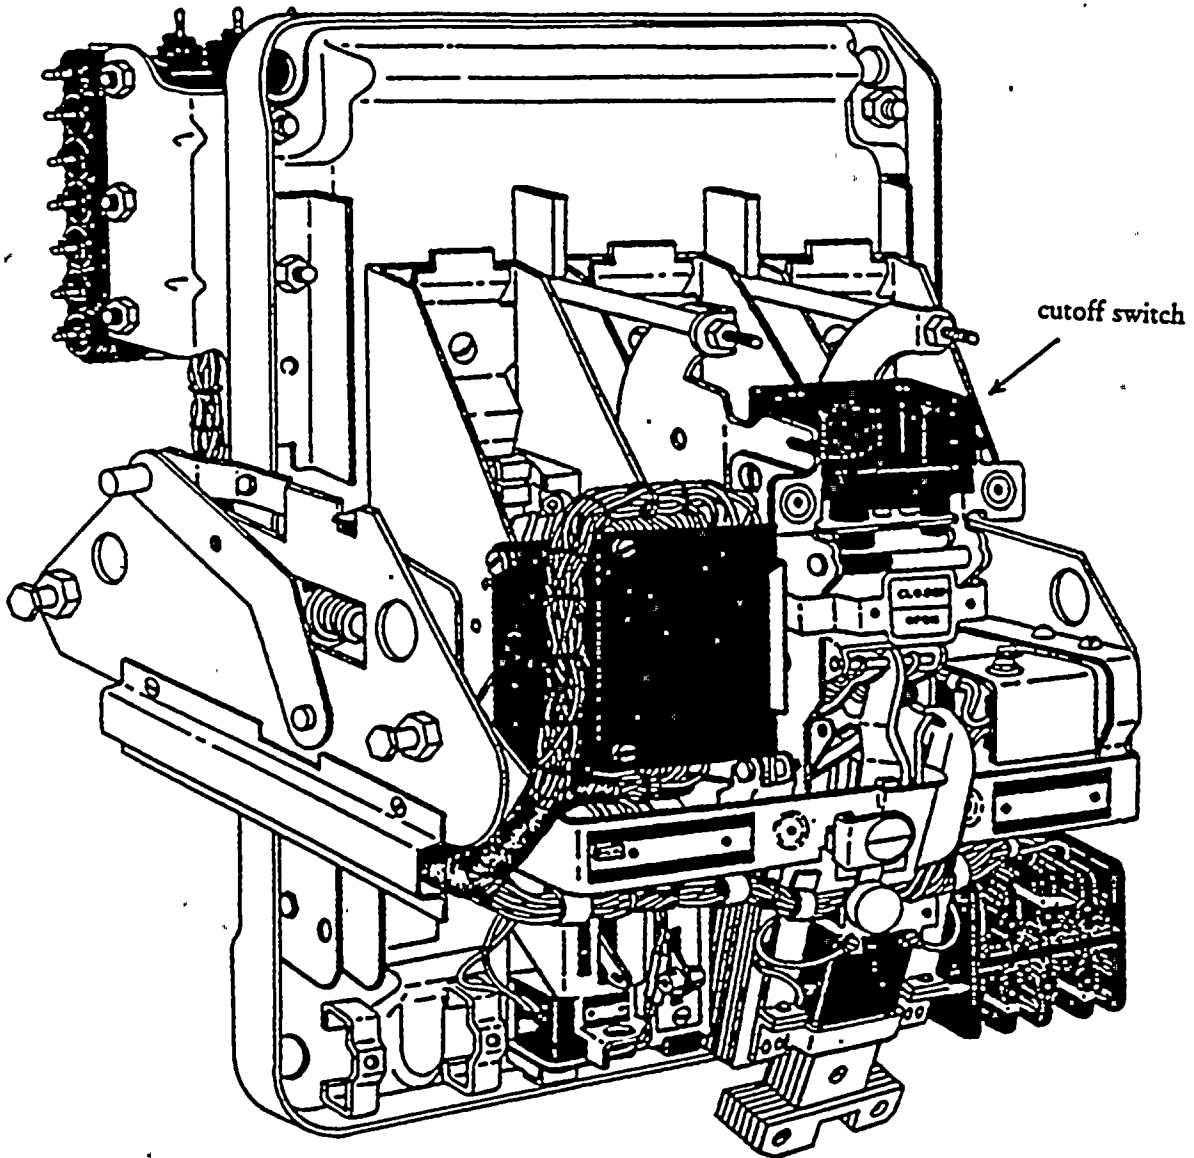
FIGURE TWO
GE AK-2-25 CIRCUIT BREAKER
(FRONT COVER REMOVED)

The cause of the failure of TCB-5 to trip has been identified as obstruction of motion on the trip latch lever. A small piece of broken phenolic insulating material approximately 1/4 inch square in size was found lodged between the trip latch lever and the access slot in the base for the trip latch. When the breaker was called upon to trip, electrically or manually, the phenolic piece restricted the motion of the trip latch lever such that the breaker mechanism would not operate. Upon the removal of the phenolic fragment, the breaker immediately tripped open and was subsequently found to operate freely during manual open and close operations.

The phenolic fragment was found to have originated from the cutoff switch (See Figure Two) used in the breaker anti-pump circuitry, which is physically located directly above the breaker trip latch mechanism. The cutoff switch operates mechanically each time the breaker is opened or closed.

Upon further inspection, it was determined that a screw used in the assembly of the cutoff switch had become loose. This screw holds the switch to the mounting block and if loose will allow the two halves of the switch to separate when the breaker is operated. This most likely led to switch misalignment and breakage of the phenolic block.

The potential root causes of the loose screw and phenolic material breakage are either a manufacturing defect or inadvertent damage during maintenance. A search of industry maintenance records did not indicate any similar type failures and has been determined by FPL Engineering and GE to be a first time event.

- 1) Electrical Maintenance has replaced TCB-5.
- 2) Electrical Maintenance, FPL Engineering and a GE representative inspected the remaining Unit 2 TCBs and the MG Set Output Breakers with satisfactory results.

- 4) Electrical Maintenance has incorporated the inspection of the cutoff switch phenolic block and screw into Unit 1 & 2 periodic maintenance procedures.

- 5) FPL Engineering will evaluate the use of a locking material on the cutoff switch phenolic block screw to prevent its backing out.
- 6) Operations performed OP 2-1400059, Reactor Protective System Periodic Logic Matrix Test, with satisfactory results and declared TCB-5 operable at 0315 on 7/15/94.
