SUBJECT: LER 94-006-00: on 941023, confirmed that stated relief valve for ECCS could lift under certain accident conditions & result in sump inventory in excess of design basis into RAB. Relief valve path in IRS isolated. W/941102 ltr.

Re: St. Lucie Unit 1  
Docket No. 50-335  
Reportable Event: 94-006  
Date of Event: October 23, 1994  
Containment Integrity Outside of FSAR Assumptions  
Under Limited Circumstances due to Design Error

TITLE (4) **Containment integrity outside of FSAR assumptions under limited circumstances due to design error.**

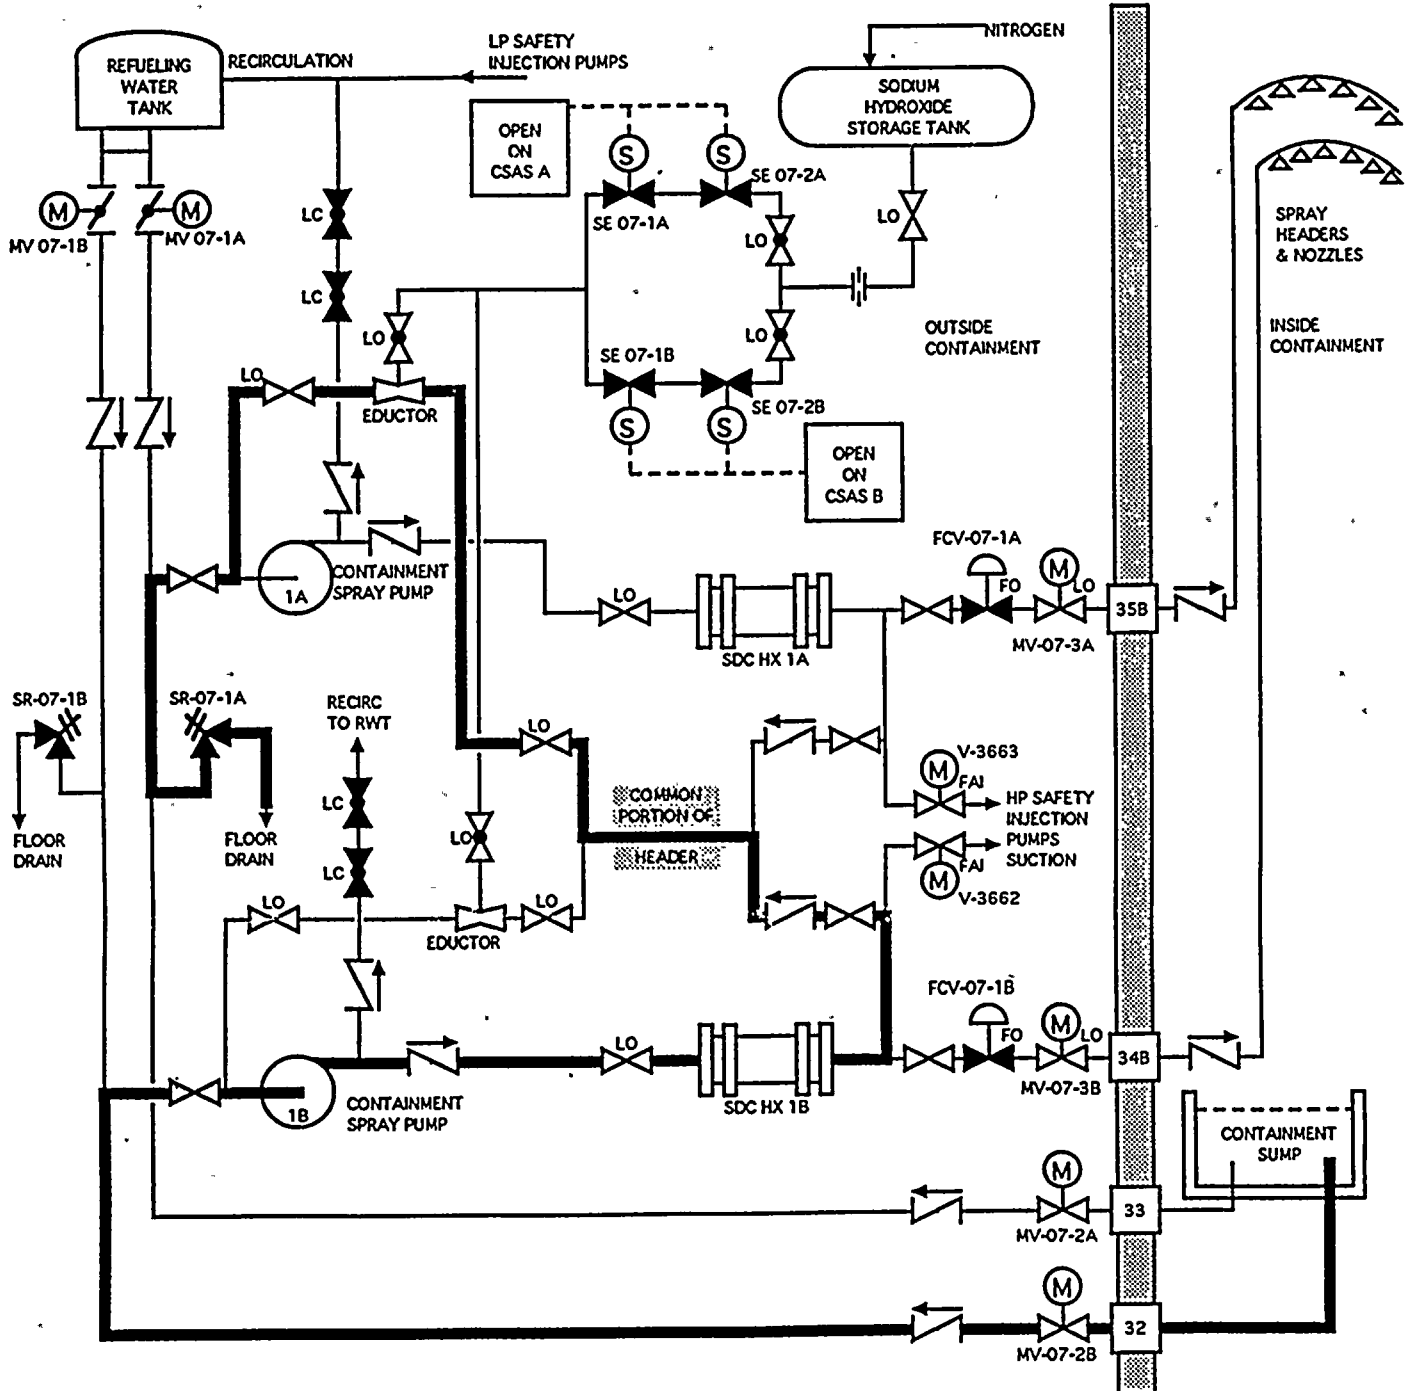
FIGURE ONE- SODIUM HYDROXIDE ADDITION IODINE REMOVAL SYSTEM

Later that same shift, utility licensed operators determined that the relief had lifted during the performance of the valve differential test due to a previously unrecognized pathway for cross train pressurization. The alignment for the test revealed a flow path from the discharge of the 1B Containment Spray pump (EIIS:BE) to the suction of the 1A Containment Spray pump through a common header in the Sodium Hydroxide (NaOH) Spray Additive system (EIIS:BE). A review of plant records showed that during this testing, the maximum pressure at the A ECCS suction piping was 85 psig. The design pressure of the line is 60 psig. The relief setpoint of SR-07-1A and 1B is 60 psig.

The root cause of this event was a design deficiency in the NaOH system. Specifically, the backfit of the NaOH system in 1978 did not consider the adverse potential consequences of using a common return header from the discharge of the two Containment Spray pumps to the two NaOH eductors located near the suction of each Containment Spray pump. The discovery of this event occurred during the GL 89-10 differential pressure testing of the 1B Containment Spray pump cross tie connection to the 1B High Pressure Safety Injection pump. Other plant test and surveillance procedures had isolated the NaOH system and therefore had not detected this design deficiency.
