ACCESSION NBR: 9412080150      DOC. DATE: 94/12/02      NOTARIZED: NO      DOCKET #  
 FACIL: 50-335 St. Lucie Plant, Unit 1, Florida Power & Light Co.      05000335  
 AUTH. NAME      AUTHOR AFFILIATION  
 SNYDER, M.J.      Florida Power & Light Co.  
 SAGER, D.A.      Florida Power & Light Co.  
 RECIP. NAME      RECIPIENT AFFILIATION

SUBJECT: LER 94-006-01: on 941023, containment integrity outside of FSAR assumptions under limited circumstances due to design error. Relief valve path in I removal sys was isolated. W/941202 ltr.

Re: St. Lucie Unit 1  
Docket No. 50-335  
Reportable Event: 94-006 - Revision 1  
Date of Event: November 23, 1994  
Containment Integrity Outside of FSAR Assumptions  
Under Limited Circumstances Due to Design Error

TITLE (4) Containment integrity outside of FSAR assumptions under limited circumstances due to design error.

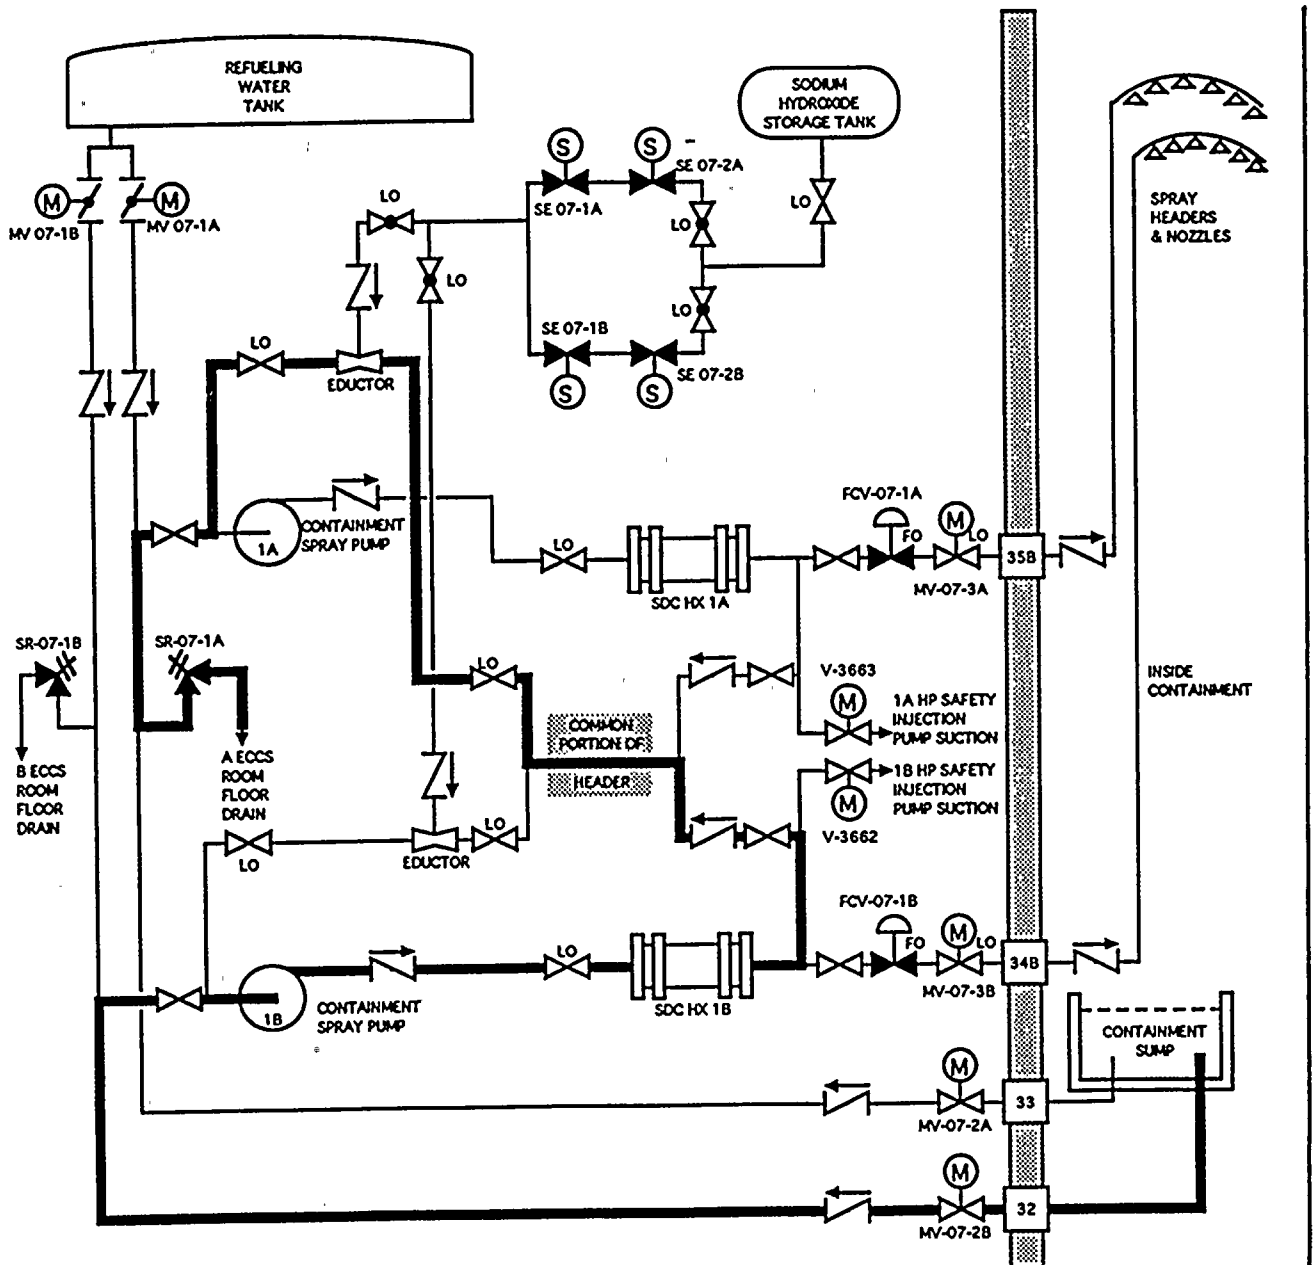
FIGURE ONE - CONTAINMENT SPRAY SYSTEM (ORIGINAL NaOH ADDITION DESIGN)

Later that same shift, utility licensed operators determined that the relief had lifted during the performance of the valve differential test due to a previously unrecognized pathway for cross train pressurization. The alignment for the test revealed a flow path from the discharge of the 1B Containment Spray pump (EIIS:BE) to the suction of the 1A Containment Spray pump through a common header in the Iodine Removal System (EIIS:BE) (See Figure One). A review of plant records showed that during this testing, the maximum pressure at the A ECCS suction piping was 85 psig. The design pressure of the line is 60 psig. The relief setpoint of SR-07-1A and 1B is 60 psig.

The root cause of this event was a design deficiency in the Iodine Removal System. The Iodine Removal system is a subsystem of the Containment Spray system which is used to remove post-accident iodine from the containment atmosphere following a LOCA by adding controlled amounts of sodium hydroxide (NaOH) to the containment spray water. This is accomplished by maintaining the containment spray solution pH within specifications to achieve rapid absorption of the radio-iodines and to minimize caustic corrosion of materials and protective coatings within the containment. The specific design error was that the backfit of the NaOH system in 1978 did not consider the adverse potential consequences of using a common return header from the discharge of the two Containment Spray pumps to the two NaOH eductors located near the suction of each Containment Spray pump. The discovery of this event occurred during the GL 89-10 differential pressure testing of the 1B Containment Spray pump cross tie connection to the 1B High Pressure Safety Injection pump. Other plant test and surveillance procedures had isolated the NaOH system and therefore had not detected this design deficiency.
