SUBJECT: LER 93-007-01: on 930521, manual reactor trip after control element assemblies dropped simultaneously due to failed equipment. Isolated grounded conductors in electrical penetration D-1.W/950316 ltr.

Re: St. Lucie Unit 2  
Docket No. 50-389  
Reportable Event: 93-07 - Revision 1  
Date of Event: May 21, 1993  
Manual Reactor Trip After the Simultaneous Dropping  
of Control Element Assemblies Due to Equipment Failure

TITLE (4) Manual Reactor Trip After the Simultaneous Dropping of Control Element Assemblies due to Equipment Failure

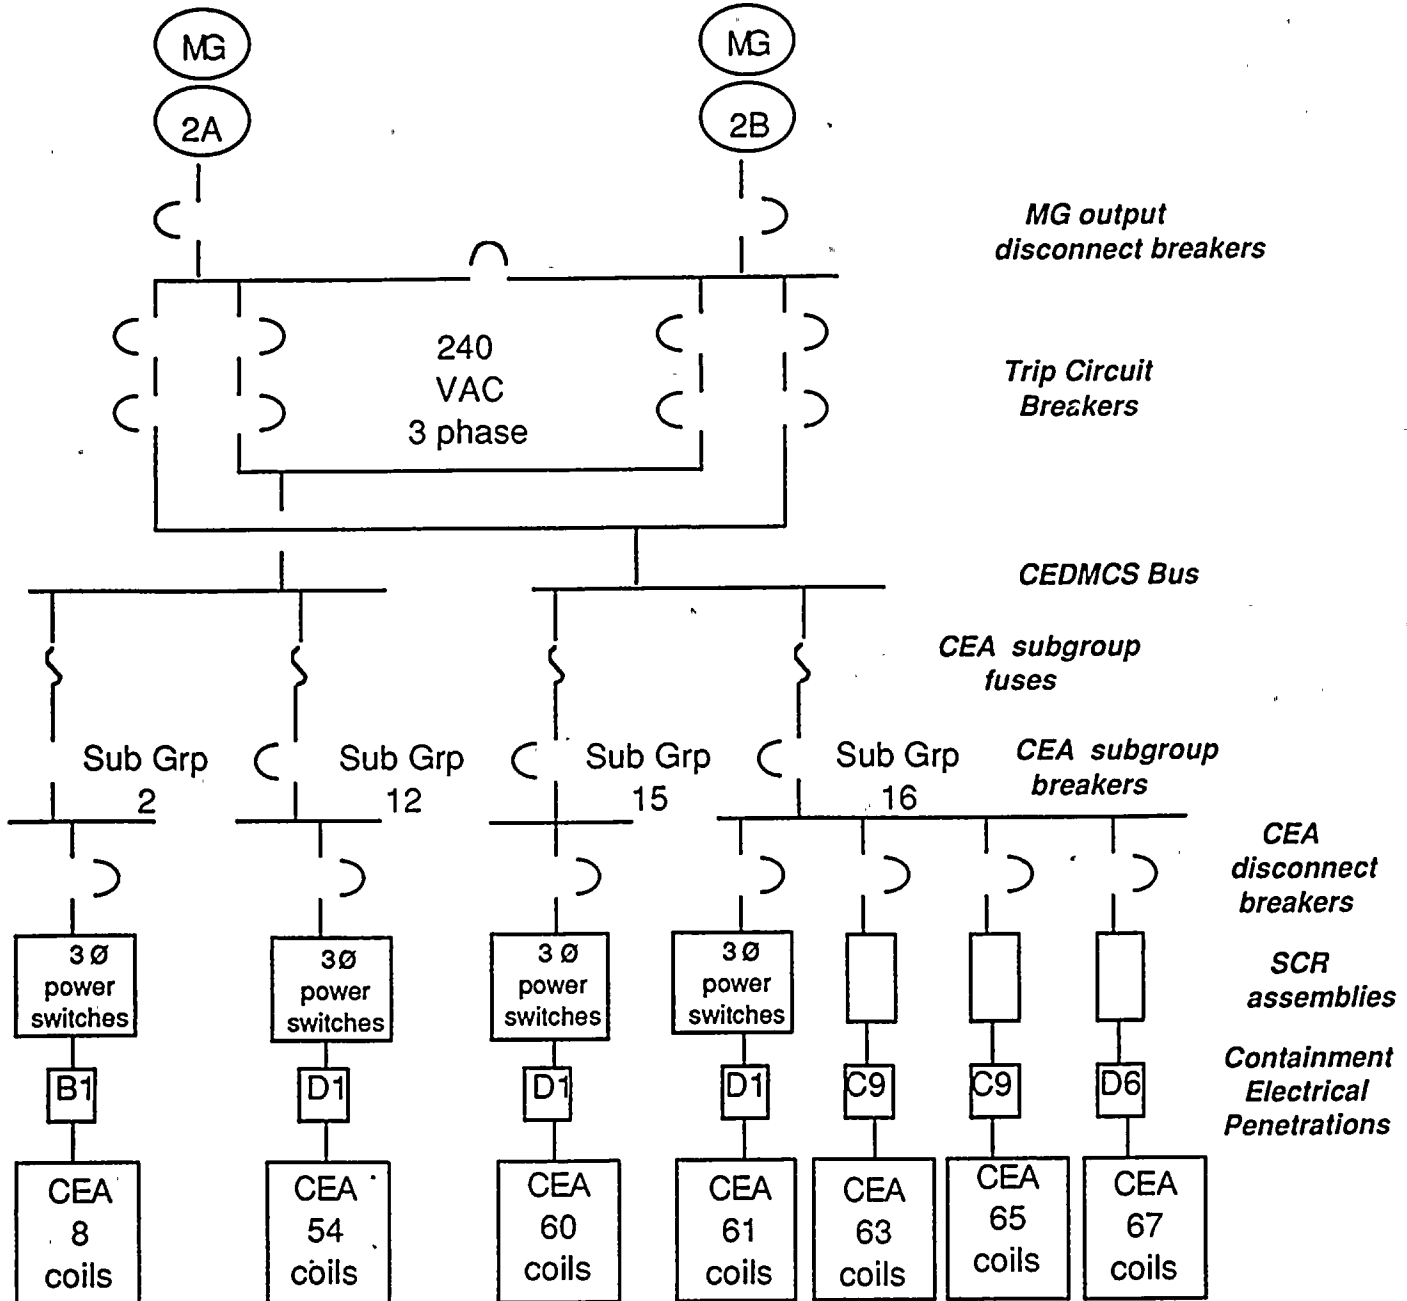
**FIGURE ONE - CEA POWER DISTRIBUTION**

On May 21, 1993, while Unit 2 was at 72% power steady state operation, control room operators observed the indication of multiple dropped Control Element Assemblies (CEA's) (EIS : AA) on the Core Mimic Display and the CEA Display Panel accompanied by the simultaneous annunciation of alarm K-23 "CEDMCS (Control Element Drive Mechanism Control System) (EIS : AA) Trouble". Subsequently, a decrease in Tave was observed. The Digital Data Processing System indicated that the seven dropped CEAs were numbers 8, 54, 60, 61, 53, 65 and 67. Approximately 10 seconds after the CEA's dropped, operators manually tripped the reactor and the turbine in accordance with the immediate operator actions of the CEA Off-Normal procedure, ONOP 2-0110030. Emergency Operating Procedure (EOP) One, "Standard Post Trip Actions", was implemented immediately post-trip. The Steam Bypass Control System (EIS: JI) operated properly to reduce Tave to 532 degrees Fahrenheit. The Steam Generators (SG's) (EIS: AB) were supplied post trip via the Steam Generator Feed Pumps (SGFP) (EIS: SJ) and the 15% feedwater bypass valve. After the successful implementation of standard post trip actions by two Reactor Control Operators, an uncomplicated reactor trip was diagnosed and the Senior Reactor Operator directed the crew to exit EOP-1 and enter EOP-2, "Reactor Trip Recovery". After the completion of EOP-2, the unit was maintained in Mode 3 for the post trip review and event investigation. Subsequent examination of the CEDMCS revealed the following conditions for the seven dropped CEA's: (See Figure One for an abbreviated schematic of the CEA power system)

- CEA 8, Regulating Group 5 - disconnect breaker was not tripped, no Subgroup fuses blown.
- CEA 54, Shutdown Group A - disconnect breaker was tripped.
- CEA 60, Regulating Group 3 (Subgroup 15) - disconnect breaker not tripped, no Subgroup fuses blown.
- CEA 61, Regulating Group 3 (Subgroup 16) - A&B phases of disconnect breaker tripped, 2 Subgroup fuses blown.
- CEA 63, Regulating Group 3 (Subgroup 16) - disconnect breaker closed, 2 Subgroup fuses blown.
- CEA 65, Regulating Group 3 (Subgroup 16) - disconnect breaker closed, 2 Subgroup fuses blown.
- CEA 67, Regulating Group 3 (Subgroup 16) - disconnect breaker closed, 2 Subgroup fuses blown.

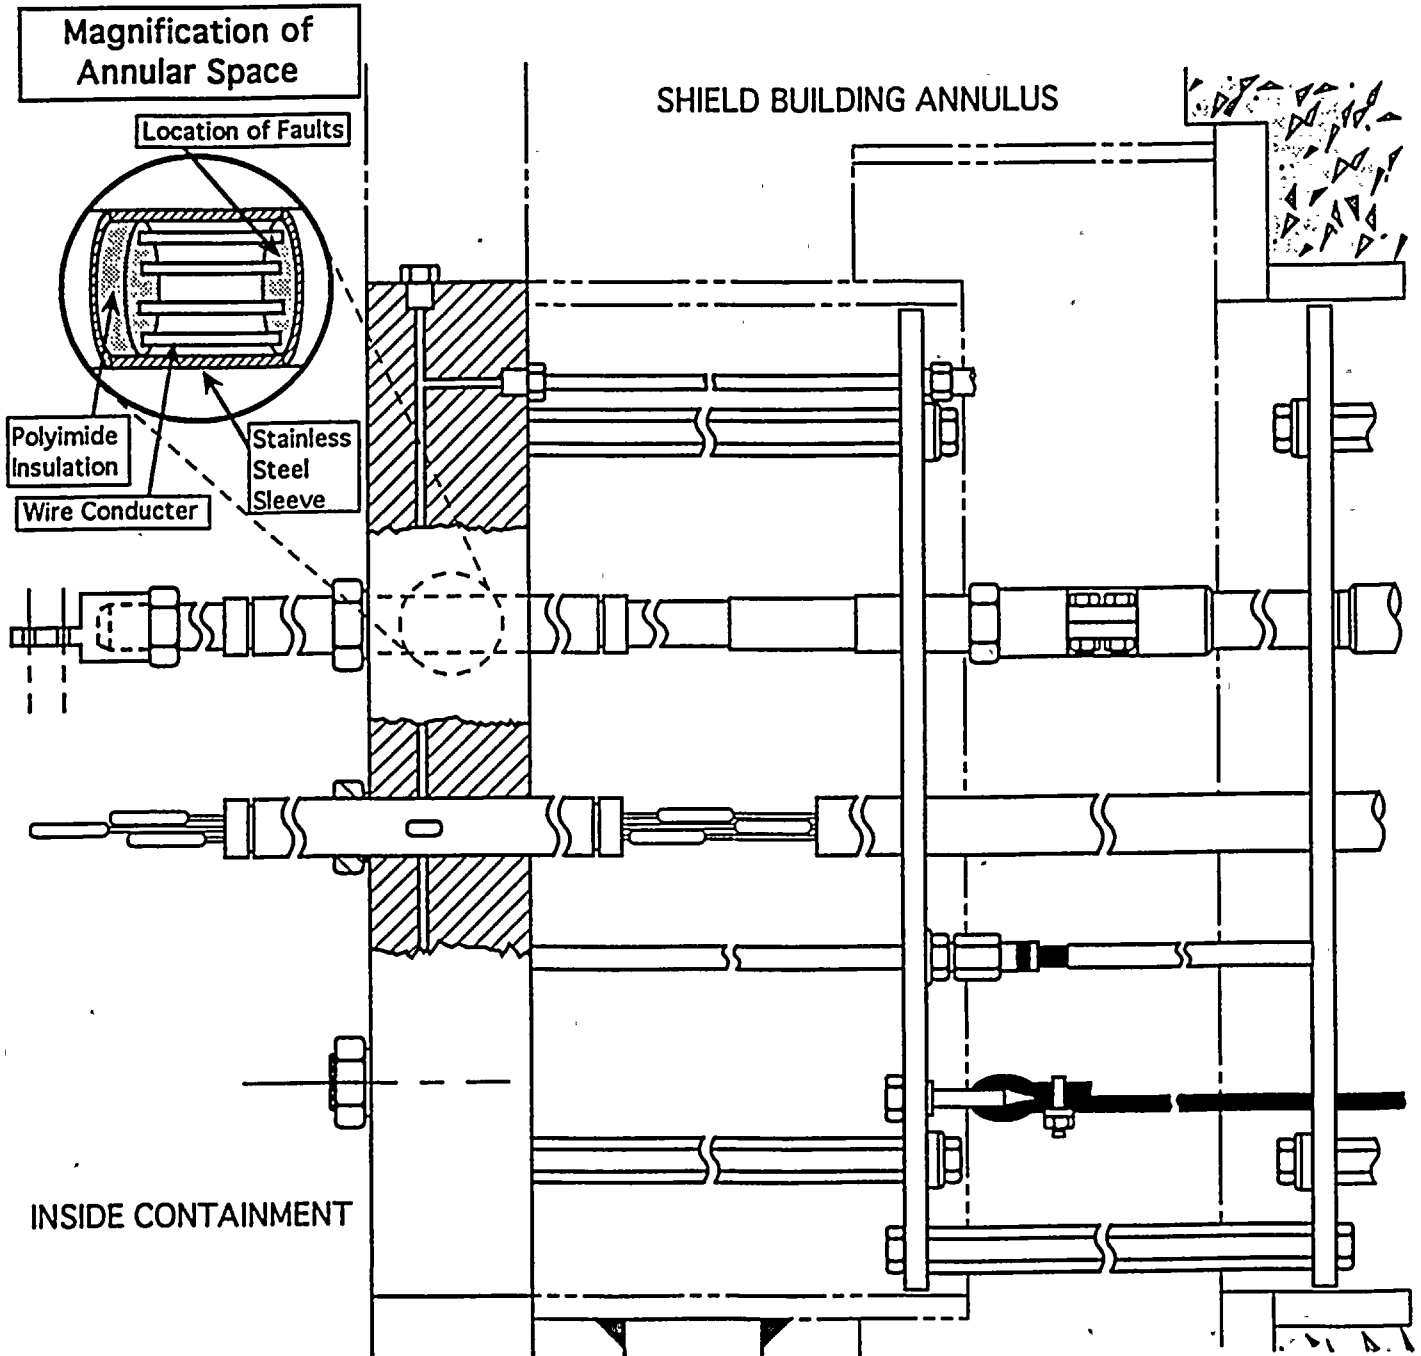
**FIGURE TWO - ELECTRICAL PENETRATION**

A detailed analysis of the conductor grounding was performed after the subsequent refueling outage which began in February, 1994. The Electrical Maintenance department, in conjunction with the original equipment manufacturer (OEM), removed and replaced the grounded feedthrough modules. The electrical penetration consists of two feedthrough assemblies, one for each side of the containment vessel wall with a transition splice area in the containment annulus. (See Figure Two) The faulted portion of the modules was at the connection of the feedthrough assembly to ground at the interior of the containment side module.

the fabrication and/or installation of the conductor bundle. A piece of contamination trapped between the conductor insulation and the module's tube sealant during manufacture could have damaged the insulation. This would have resulted in a localized area with low dielectric strength. If two adjacent conductors have similar types of damage, a hot spot and carbon tracking could develop with an increasingly conductive path forming over time. This scenario is supported by the location of the failures, the large amount of carbonization and thermal degradation found at the failure sites.

2) Spare conductors in modules 20 and 24 of penetration D-1 were meggered to ensure that no faults existed prior to placing those spares in service. The grounded conductors in modules 11 and 17 of penetration D-1 were isolated and the affected CEA cables were reterminated to leads on the five available spares in modules 20 and 24.
