SUBJECT: LER 95-007-00: on 950817, inadvertent containment spray via 1A low pressure SI pump while venting ECCS during startup due to inadequate procedure. Operators stopped 1A LPSI pump & isolated SDC HX to stop spray. W/950827 ltr. O R

Re: St. Lucie Unit 1
Docket No. 50-335
Reportable Event: 95-007
Date of Event: August 17, 1995
Inadvertent Containment Spray via 1A Low Pressure Safety
Injection Pump while Venting the Emergency Core Cooling System
During Startup due to Inadequate Procedure

TITLE (4)
Inadvertent Containment Spray via 1A Low Pressure Safety Injection Pump while Venting the Emergency Core Cooling System During Startup Due to Inadequate Procedure

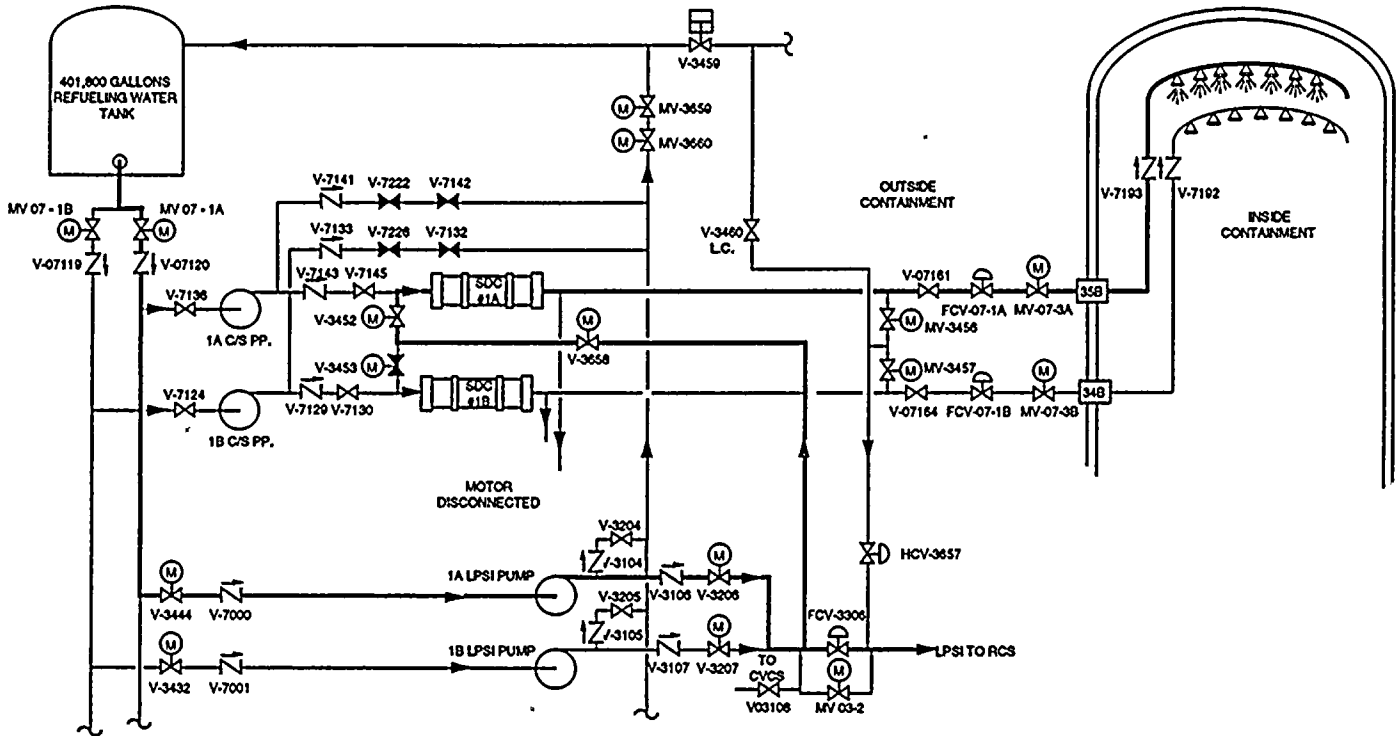
FIGURE 1 - CONTAINMENT SPRAY SYSTEM

With the RCS at 532 degrees and 1550 psia, LPSI maintenance was completed, and the ECCS venting procedure for the LPSI system was started. At 1756, the utility licensed operator started the 1A LPSI Pump and the initial circulation through the SDC warmup line was completed. The SDC HX inlet and outlet valves were opened at approximately 1803 to establish a flow path through the SDC HX. These actions provided a direct flow path from the RWT to the 'A' containment spray header. At 1806, the control room received high reactor cavity leakage annunciators and multiple containment fire alarms. Reactor cavity sump flow recorder, FR-07-03, indicated rapidly increasing flow, and the operators entered the off-normal operating procedure for excessive RCS leakage. The CS pumps were verified to be stopped and the RCS and chemical and volume control system (CVCS) (EIS:CB) parameters were verified to be stable and normal. (Figure 1 is a simplified system diagram and highlights the flow path)

The 1A LPSI Pump was stopped and the flow path from the 1A LPSI pump to the 'A' containment spray header through the 1A SDC HX isolation valves and the open CS header flow control valve (FCV-07-1A) was identified. The SDC HX isolation valves were closed and the venting procedure was exited.
