Re: St. Lucie Unit 1
Docket No. 50-335
Reportable Event: 95-008
Date of Event: August 28, 1995
High Pressure Safety Injection Pump Operation
During Plant Conditions Not Allowed
by Technical Specifications Due to Personnel Error

LICENSEE EVENT REPORT (LER)

TITLE (4)
High Pressure Safety Injection Pump Operation During Plant Conditions Not Allowed by Technical Specifications Due to Personnel Error

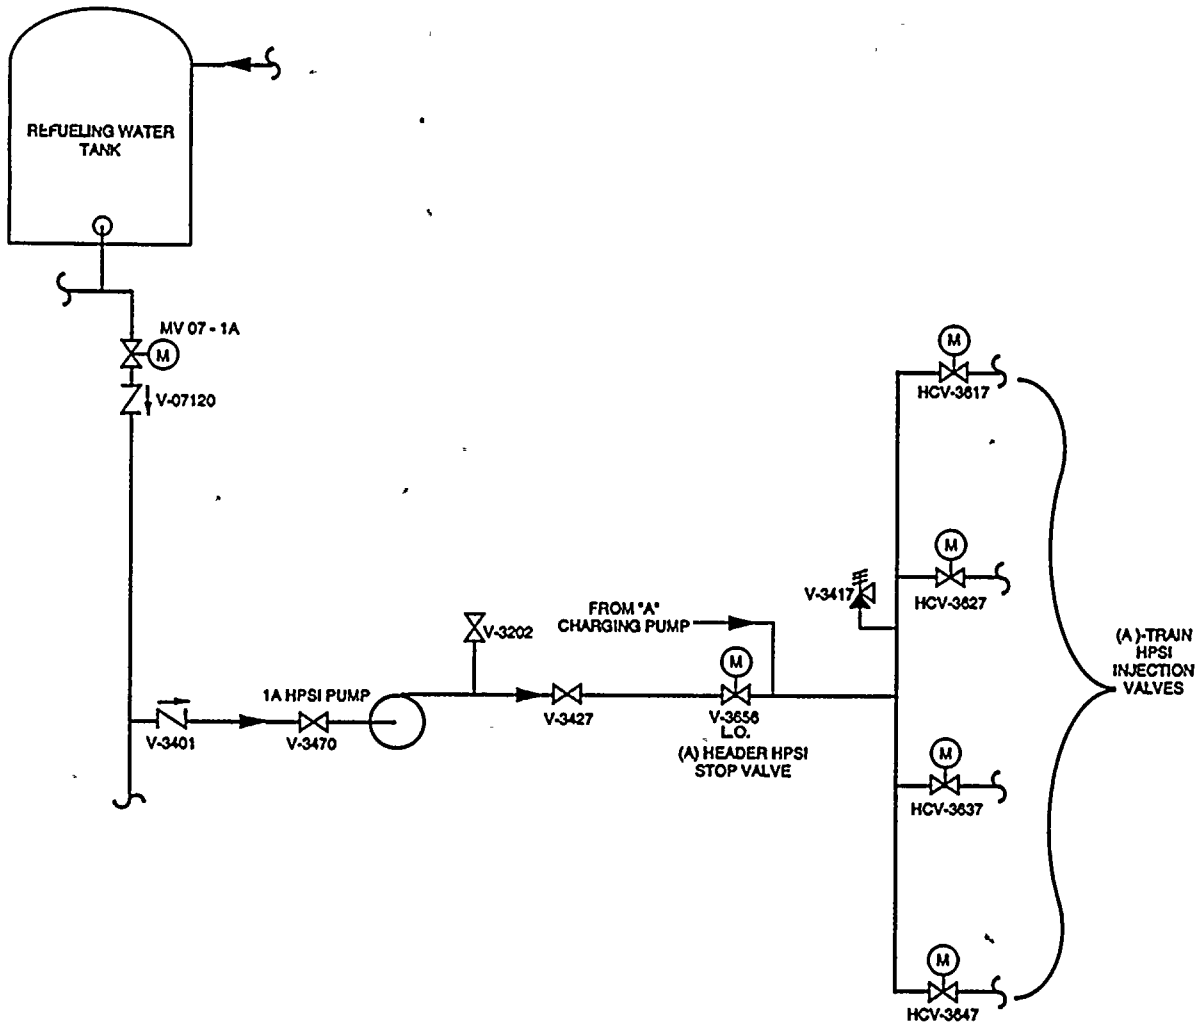
FIGURE 1 SIMPLIFIED HPSI SYSTEM DIAGRAM

The Technical Specification (TS) boration flow path was from the boric acid makeup tank through the gravity feed valve(EIS:CB) to the 1B charging pump(EIS:CB). Both HPSI pumps were disabled and their associated header stop valves were closed in accordance with TS 3.5.3.c prior to decreasing RCS temperature less than 236 degrees. In preparation for an inservice leak test on the A train High Pressure Safety Injection (HPSI)(EIS:BQ) header relief valve (V-3417), the cooldown clearance tag was released on the A train HPSI header stop valve (V-3656) and its associated breaker was placed in the ON position. At approximately 0515, contrary to TS 3.5.3, the A train HPSI header stop valve was cycled to verify its operability. (See figure 1 for a simplified HPSI system diagram)

At approximately 0800 the utility licensed operators started drawing a bubble in the pressurizer. The four A train HPSI injection valves were closed and their breakers were placed in the OFF position. At 1000, the A train HPSI header was filled and vented using the refueling water tank(EIS:CB) head as a pressure source. Following the fill and vent of the A train HPSI header, the 1A HPSI pump clearance tag was released and the pump breaker was racked in. Contrary to TS 3.5.3, the 1A HPSI pump was started at 1025 and the header stop valve (V-3656) was opened a second time to perform an inservice leak test of the header relief valve (V-3417). During the time that valve V-3656 was open and the 1A HPSI pump was running, the four HPSI injection valves were shut and disabled, the pressurizer had a bubble at 250 psia and both pressurizer power operated relief valves (PORV)(EIS:AB) were available for overpressure protection. At 1035, the 1A HPSI pump was stopped and the header stop valve (V-3656) was closed.

The A train emergency core cooling system (ECCS) header venting and header relief valve V-3417 inservice leak test were performed using the clearance release process. The B train piping configuration is significantly different from the A train and the ECCS header venting process is more complicated. Therefore, a specific procedure was written to perform the B train venting. On September 2, 1995, while reviewing the procedure for filling and venting the B train HPSI header, a utility licensed senior operator determined that the procedure could not be executed due to the requirements of TS 3.5.3. Review of the control room chronological log at that time revealed that the TS had previously been violated when the A train HPSI header was filled and the relief valve (V-3417) was leak tested.
