SUBJECT: LER 95-010-00: on 951116, manual reactor trip occurred due to degraded 24 volt DC power supply to 1B SG main feedwater controller. Tested & replaced power supply for 1B feedwater controller. W/undated ltr.

Re: St. Lucie Unit 1  
Docket No. 50-335  
Reportable Event: 95-010  
Date of Event: November 16, 1995  
Manual Reactor Trip Due to Low Steam Generator Water Level  
Caused by Main Feedwater Regulating Valve Closure

Manual Reactor Trip Due to Low Steam Generator Water Level Caused by Main Feedwater Regulating Valve Closure

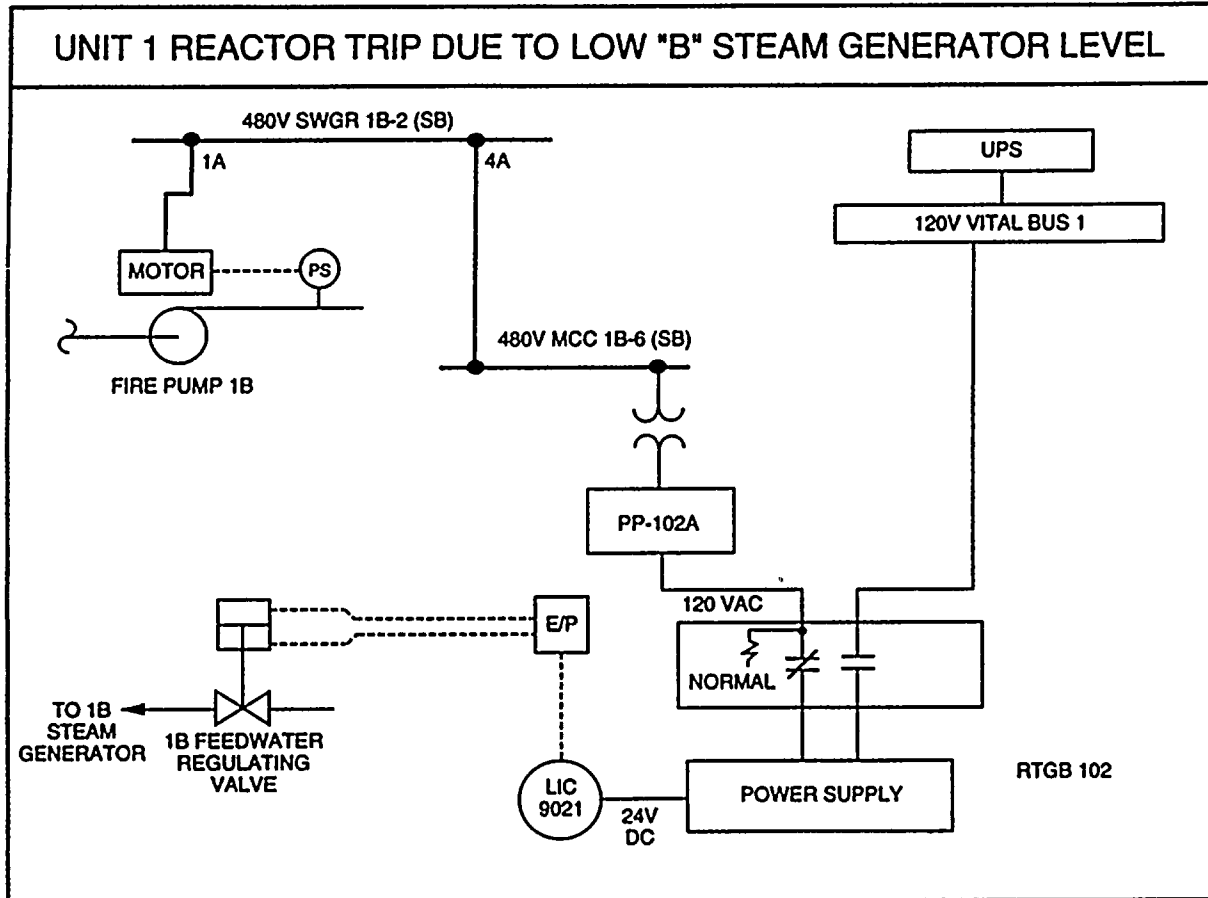
FIGURE 1 - POWER SUPPLY TO 1B FEEDWATER REGULATING SYSTEM

The reactor was manually tripped by the utility licensed operators to mitigate a loss of feedwater transient by early operator action. The cause of this event was the failure of a 24 volt DC power supply to maintain proper voltage to the 1B Main Feedwater Regulating Valve Level Indicating Controller (LIC 9021) (EIS:JB).

When large motors such as the plant Fire Pumps are started, there is a momentary, transient voltage drop on the 480 volt electrical bus (EIS:EC) as the motor comes to full speed. This voltage drop cascades into the dependent loads such as the panel which powers the feedwater regulating system controller power supply. In the case of the Feedwater Regulating System, the 480 volt bus which supplies the Fire pump (1B2), also supplies power panel-102A (EIS:ED), which provides 120 volt AC power to the "B" Feedwater Control System 24 volt DC power supply (refer to Figure 1). The feedwater controller power supply is designed to handle input voltage fluctuations of 10 percent, and maintain an output of 24 volts. During subsequent testing, however, it was found that the power supply had become degraded, and was producing output voltages as low as 20.6 volts, or approximately 17 percent degraded. The drop in voltage to the controller resulted in a loss of control signal to the Main Feedwater Regulating Valve supplying feedwater to the 1B Steam Generator. This resulted in the partial closure of the Main Feedwater Regulating Valve.

- 4) A plant modification was approved to provide a normal source of power to the Feedwater Regulating System from a vital 120 volt electrical bus. When implemented, this change will provide a primary power supply to the feedwater controller which is less likely to be affected by voltage fluctuations.
