SUBJECT: LER 96-001-00: on 960219, control room emergency ventilation sys inoperable due to improper sys configuration occurred. Caused by inadequate guidance & work controls for identifying. CR boundry reviewed. W/960314 ltr.

Re: St. Lucie Unit 1  
Docket No. 50-335  
Reportable Event: 96-001  
Date of Event: February 19, 1996  
Control Room Emergency Ventilation System Inoperable  
Due to Improper System Configuration

TITLE (4)  
**Control Room Emergency Ventilation System Inoperable due to Improper System Configuration**

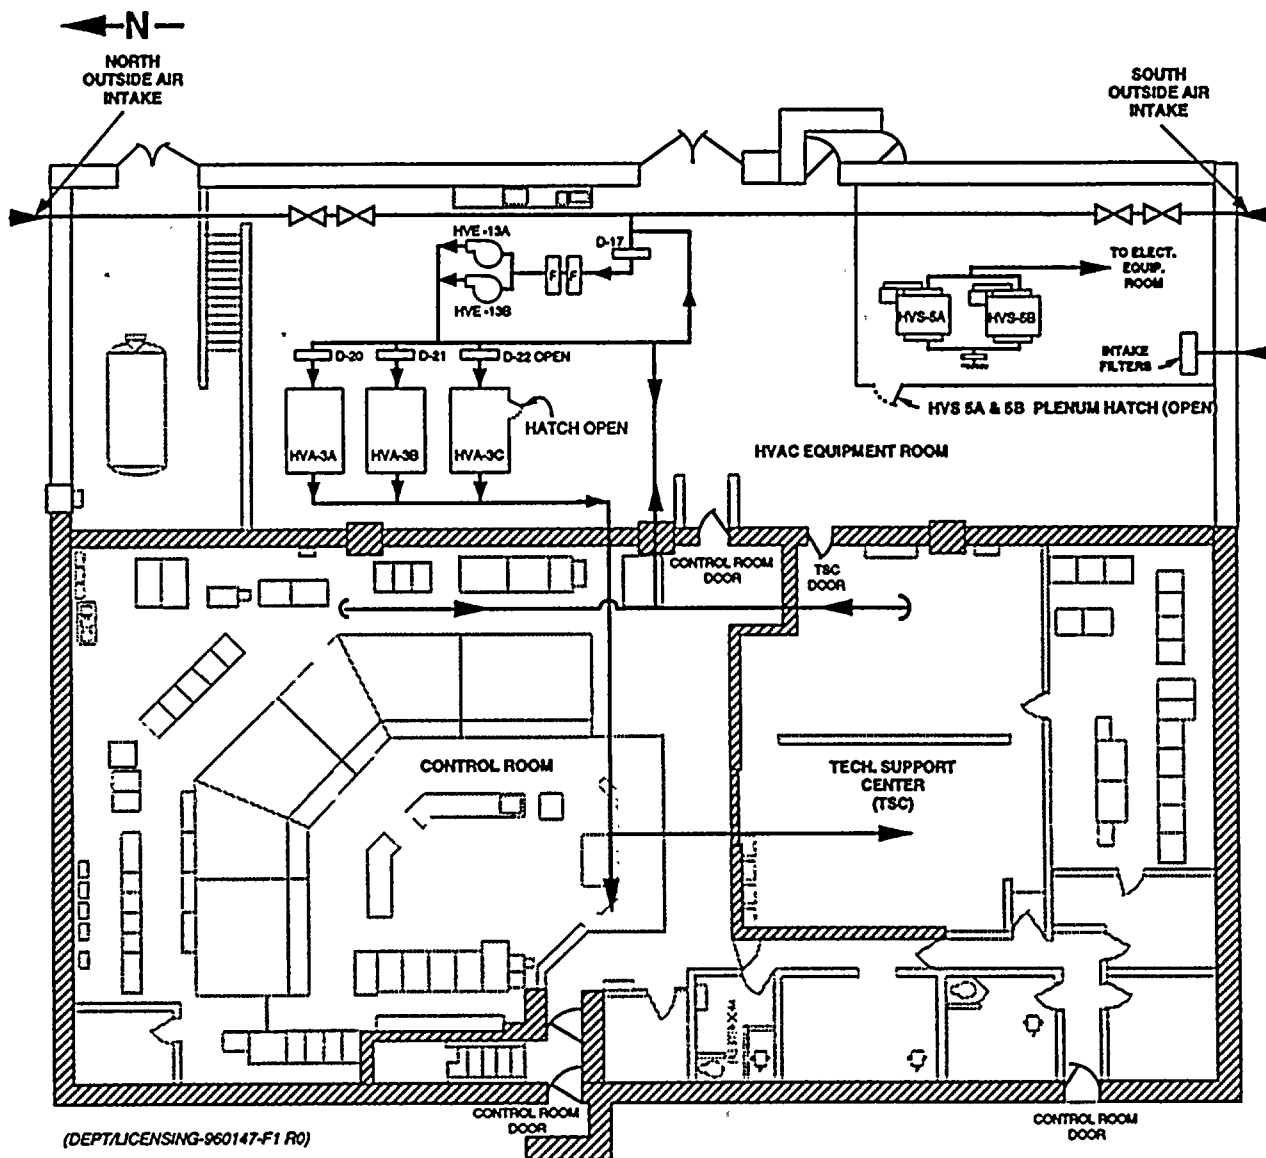
FIGURE 1  
ST. LUCIE UNIT 1 CONTROL ROOM HVAC ARRANGEMENT  
(SIMPLIFIED)

Refer to Figure 1, "St. Lucie Unit 1 Control Room HVAC Arrangement." The STA discovered that an inlet plenum access hatch to the Electrical Equipment Room supply fans, HVS-5A and HVS-5B (EISS:VJ), was open. The hatch had been opened (at approximately 0220 hours) to perform periodic maintenance (PM) of the HVS-5B fan. The "A" side fan (HVS-5A) remained operating during this time. Concurrently, the inlet plenum hatch and inlet damper for Control Room air conditioner HVA-3C (EISS:VI) were found to be open. The access hatch had been opened to facilitate repair of system dampers while the HVA-3C air conditioning unit was out of service for modification work. The inlet damper to HVA-3C, damper D-22 (EISS:VI), had been replaced at approximately 1230 on February 18, 1996, and the damper was left in its fail-open position pending completion of the modification work.

The Electrical Equipment Room supply fans, HVS-5A and HVS-5B share a common inlet plenum, which is aligned to outside air. These fans supply ventilation to the Electrical Equipment Room, which is located one floor below the Control Room. The Control Room air conditioning units, HVA-3A, HVA-3B and HVA-3C (EISS:VI), are located in the same heating, ventilation and air conditioning (HVAC) room as the Electrical Equipment Room supply fans, HVS-5A and HVS-5B. With the Electrical Equipment Room fans' inlet plenum hatch open, the operating fan (HVS-5A) suction was effectively aligned to this HVAC room.

With both the above plenum hatches open, the Electrical Equipment Room supply fan (HVS-5A) suction was aligned to the HVAC room, the Control Room air conditioning inlet plenum, and ultimately to the Unit 1 Control Room via the air handler return ducting. This condition created the negative pressure in the Control Room.

The event was caused by insufficient guidance and work controls associated with identifying and maintaining the integrity of the Control Room pressure boundary during maintenance on the Control Room Emergency Ventilation System. The pressure boundary was breached while maintenance was being performed on one of the Control Room air conditioning units, HVA-3C. Several factors contributed to the loss of this boundary. The boundary had never been clearly defined within plant processes. Control Room boundary penetrations were not labeled or otherwise identified in the field. Because of the lack of awareness regarding the Control Room pressure boundary, work control instructions were not sufficient to prevent the occurrence.

- 1) The plenum access doors for HVA-3C and HVS-5A and HVS-5B were closed, and the Control Room Emergency Ventilation System was returned to an operable condition.
- 2) A list of Unit 1 and Unit 2 Control Room boundary penetrations will be developed. Penetrations which could affect the Control Room boundary will be labeled to provide for identification in the field.
- 3) Plant staff will complete an assessment of other safety related buildings, and provide component level information to address integrity related items.
- 4) Plant staff will perform an assessment of other Unit 1 and Unit 2 HVAC systems for system interaction and generic concerns related to this event.

- 5) The plant Equipment Clearance Orders will be revised as necessary to incorporate additional guidance regarding work activities that could affect system interaction between HVAC systems.
- 6) The plant Equipment Clearance Orders will be revised as necessary to address activities which affect building integrity.
- 7) Engineering will review the operational requirements of the Unit 1 Electrical Equipment room supply fans HVS-5A and HVS-5B, when performing preventative maintenance (PM). Existing PM procedures and administrative controls will be evaluated for change based on the results of the review.
- 8) Administrative controls for HVAC plenum keys will be improved to better control access into the plenums.
