SUBJECT: LER 96-003-00:on 960224,containment particulate & gaseous monitor was OOS & resulted in condition prohibited by TS due to personnel error.CAPGM was placed back in svc.W/960325 ltr.

Re: St. Lucie Unit 1
Docket No. 50-335
Reportable Event: 96-003
Date of Event: February 24, 1996
Containment Particulate and Gaseous Monitor
Out of Service Resulting in a Condition
Prohibited by Technical Specification
Due to Personnel Error

Containment Particulate and Gaseous Monitor Out of Service Resulting in a Condition Prohibited by Technical Specifications Due to Personnel Error

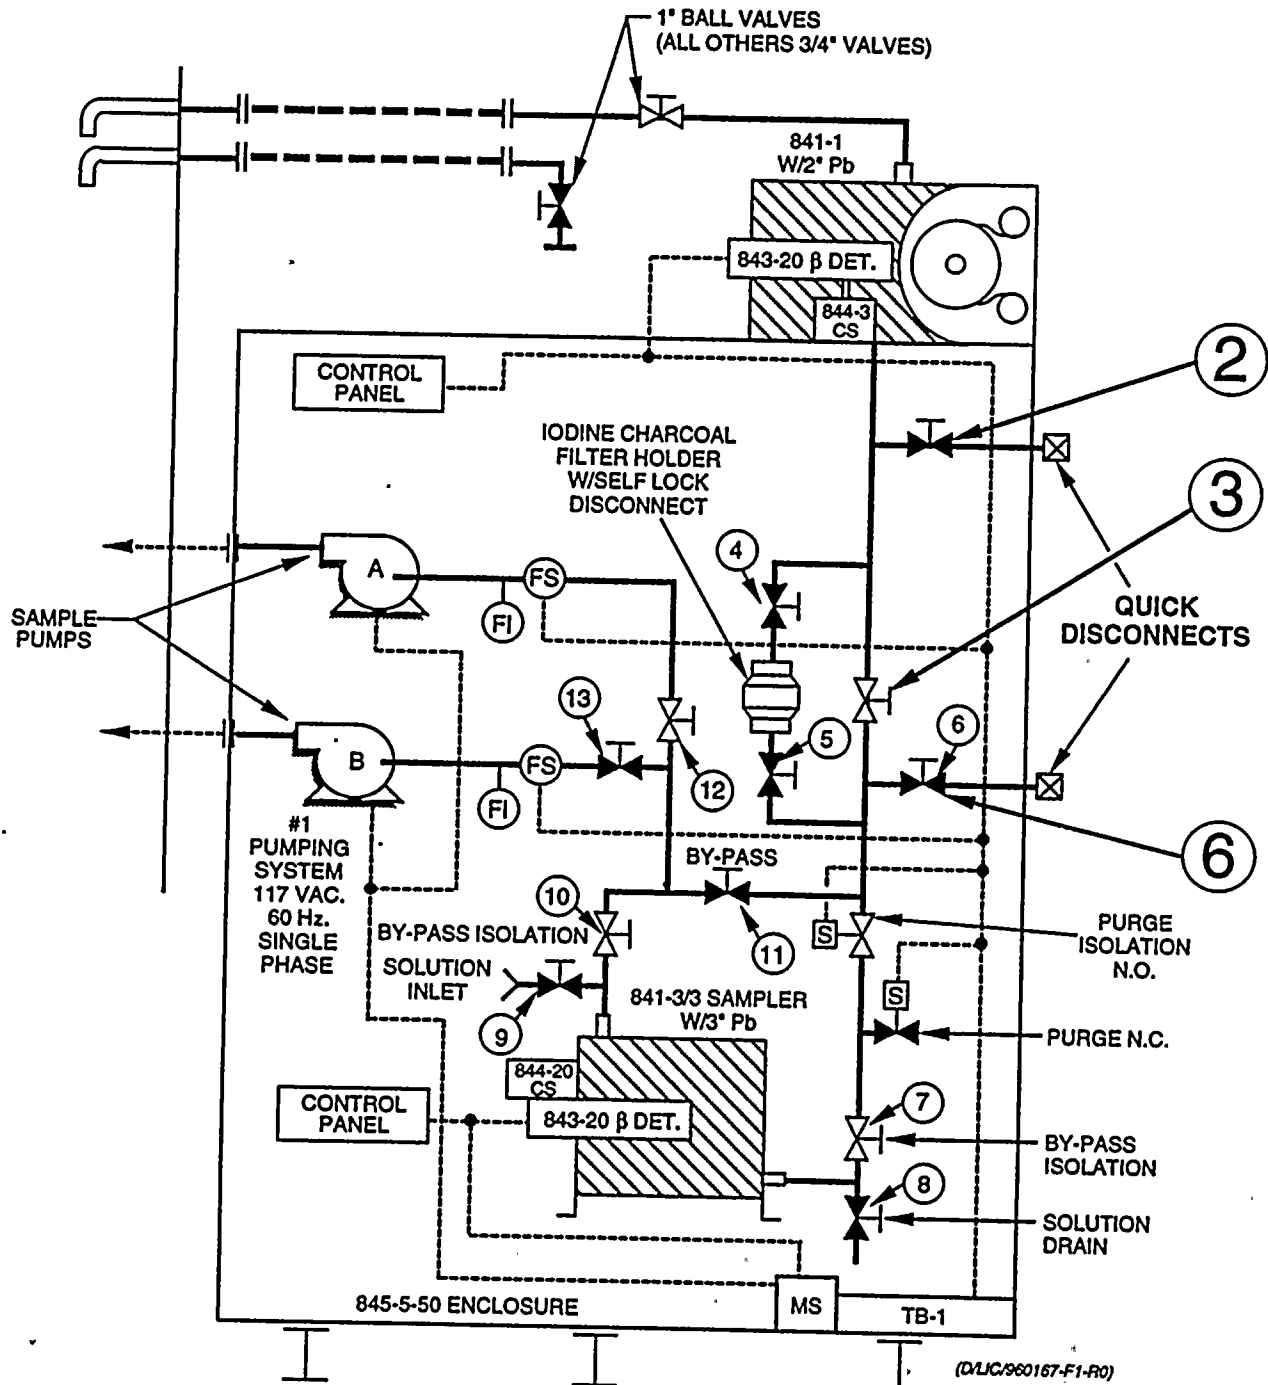
Figure 1

On February 22, 1996, at 1355, with Unit 1 in Mode 3, a health physics (HP) technician sampled the containment atmosphere in preparation for a containment entry following the manual trip of the unit. In accordance with the HP procedure (HPP-22), the sample was taken from the containment atmosphere particulate and gaseous monitor (CAPGM) (EIS:IL) which monitors particulate and gaseous radioactivity. The sample is obtained (see page 6 FIGURE 1) by connecting, via quick disconnect fittings, a removable air sample collection device, then opening valves on both sides of the sample collection device (valves 2 and 6) and throttling the inlet valve (valve 3) to the monitor sample pump. After the sample is gathered the valves (valves 2 and 6) to the sample collection device are closed, the inlet valve (valve 3) to the monitor sample pump is reopened. In this event, valve number 3 was not reopened as required by procedure, and flow to the monitor sample pump was reduced to approximately 15% of the normal design flow.

On February 24, 1996, with Unit 1 in Mode 2, a chemistry technician noticed the monitor's process flow meter reading low. A chemistry supervisor and the technician verified that valve number 3 was throttled and flow was being impeded. They opened the valve fully and flow returned to expected value. The control room was notified of the inoperable monitor and it was declared out of service from the time the HP technician took his sample on February 22 until its return to service at 1210 on February 24, 1996. The flow fault switch did not provide indication because it was adjusted to illuminate on zero flow. An evaluation was initiated to determine if the monitor was Operable at the reduced flow during the time valve number 3 was throttled.

The root cause of the event was personnel error by the HP technician. The technician did not follow the procedure which instructed and cautioned him to reopen valve number 3. The technician did not have the procedure with him while taking the sample.

1. The containment atmosphere particulate and gaseous radioactivity monitor was placed back in service.
2. The HP technician was disciplined and counseled in plant policy on procedural compliance.
