SUBJECT: Forwards response to request for addl info re review of SG tube insp & repair criteria for Unit 1.

RE: St. Lucie Unit 1
Docket No. 50-335
Steam Generator Tube Inspection
Request for Additional Information (RAI) Response

Request for Additional Information Responses

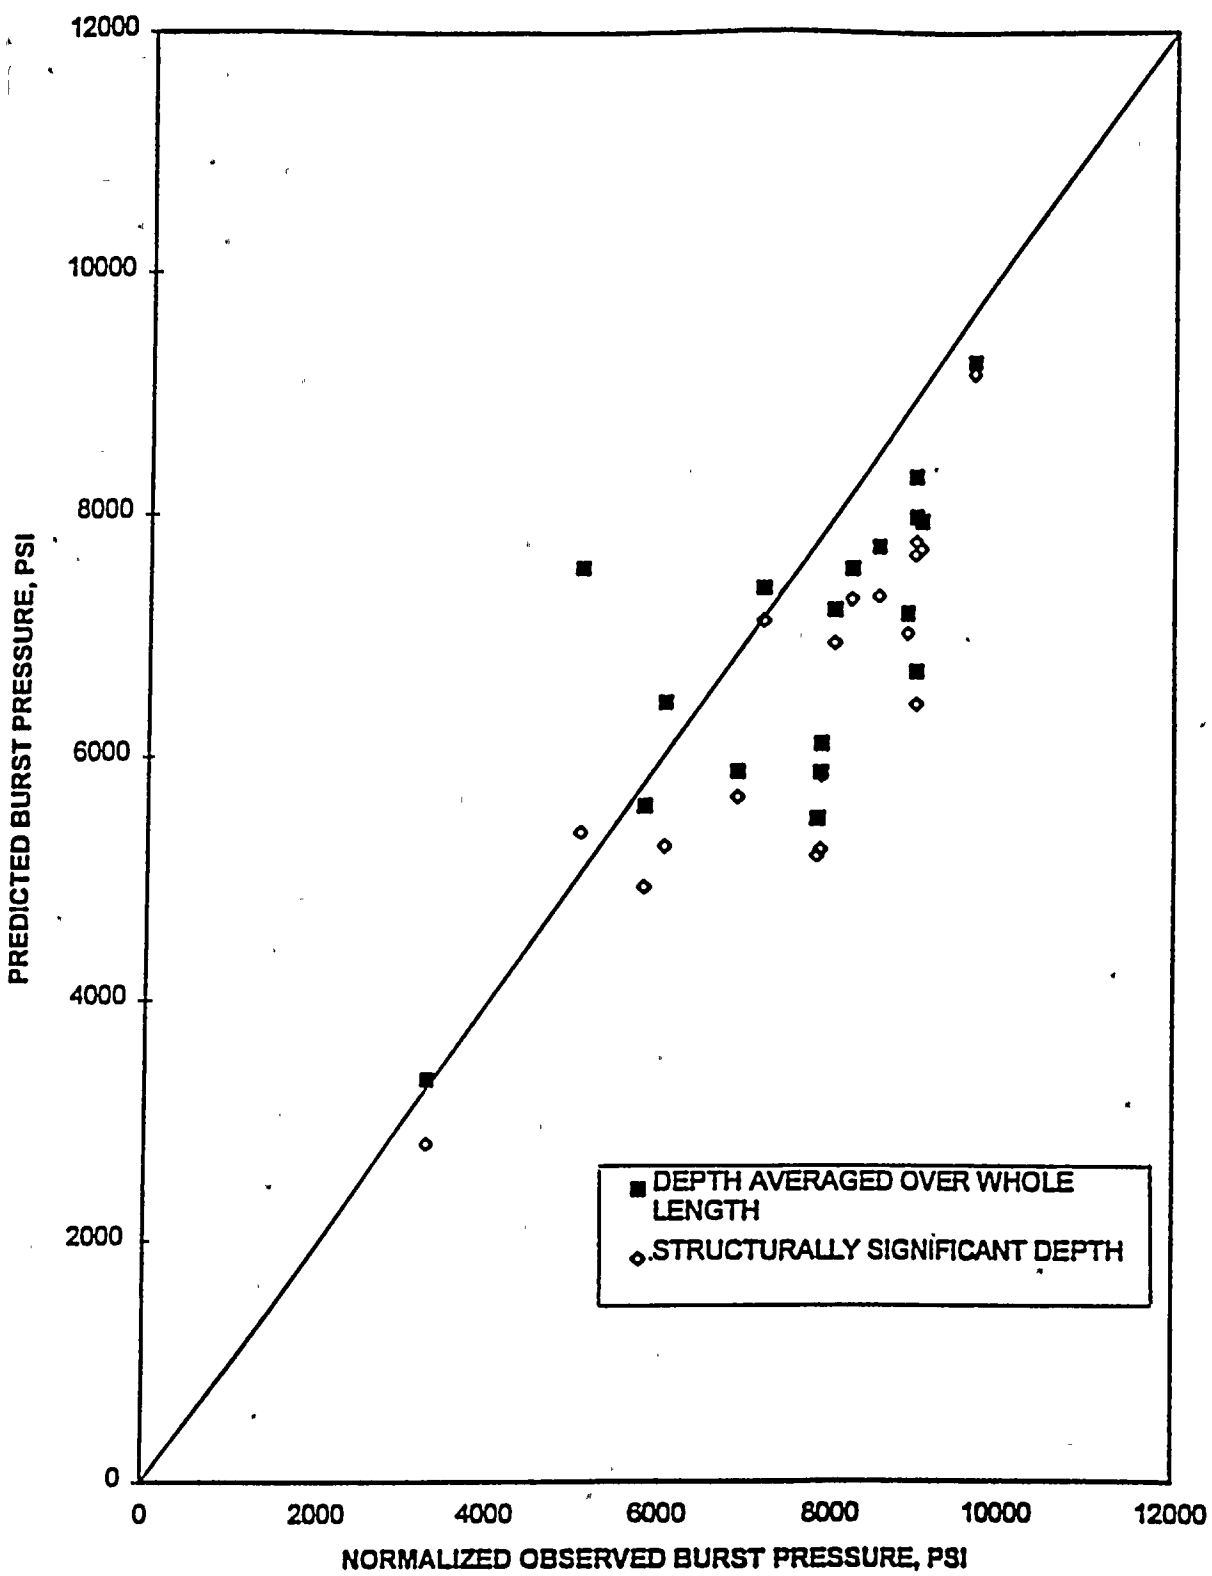
Burst pressure calculations are based on the Framatome equation using average crack depth. Attachment A Figure 1, *Predicted Burst Pressure Versus Normalized Observed Burst Pressure - PVNGS Unit 2 Pulled Tube Data*, shows pulled tube data from Palo Verde Nuclear Generating Station (PVNGS) Unit 2 supporting the use of the Framatome equation. Attachment A Figure 2, *RPC Crack Length Versus Structurally significant Crack Length - PVNGS Unit 2 Pulled Tube Data*, shows that crack length based on pancake coil eddy current data is a conservative estimate of the structurally significant crack length and Attachment A Figure 3, *Maximum Crack depth Versus Average Crack Depth - PVNGS Unit 2 Pulled tube Data*, illustrates that the structurally significant portion of the crack profile has a characteristic ratio of maximum depth to average depth. Attachment A Figure 2 and Attachment A Figure 3 are also based on pulled tube data from PVNGS Unit 2 where the operative degradation mechanism is upper bundle, axial outside diameter stress corrosion cracking/intergranular attack (ODSCC/IGA).

Figure 1. Predicted Burst Pressure Versus Normalized Observed Burst Pressure, PVNGS Unit 2 Pulled Tube Data.

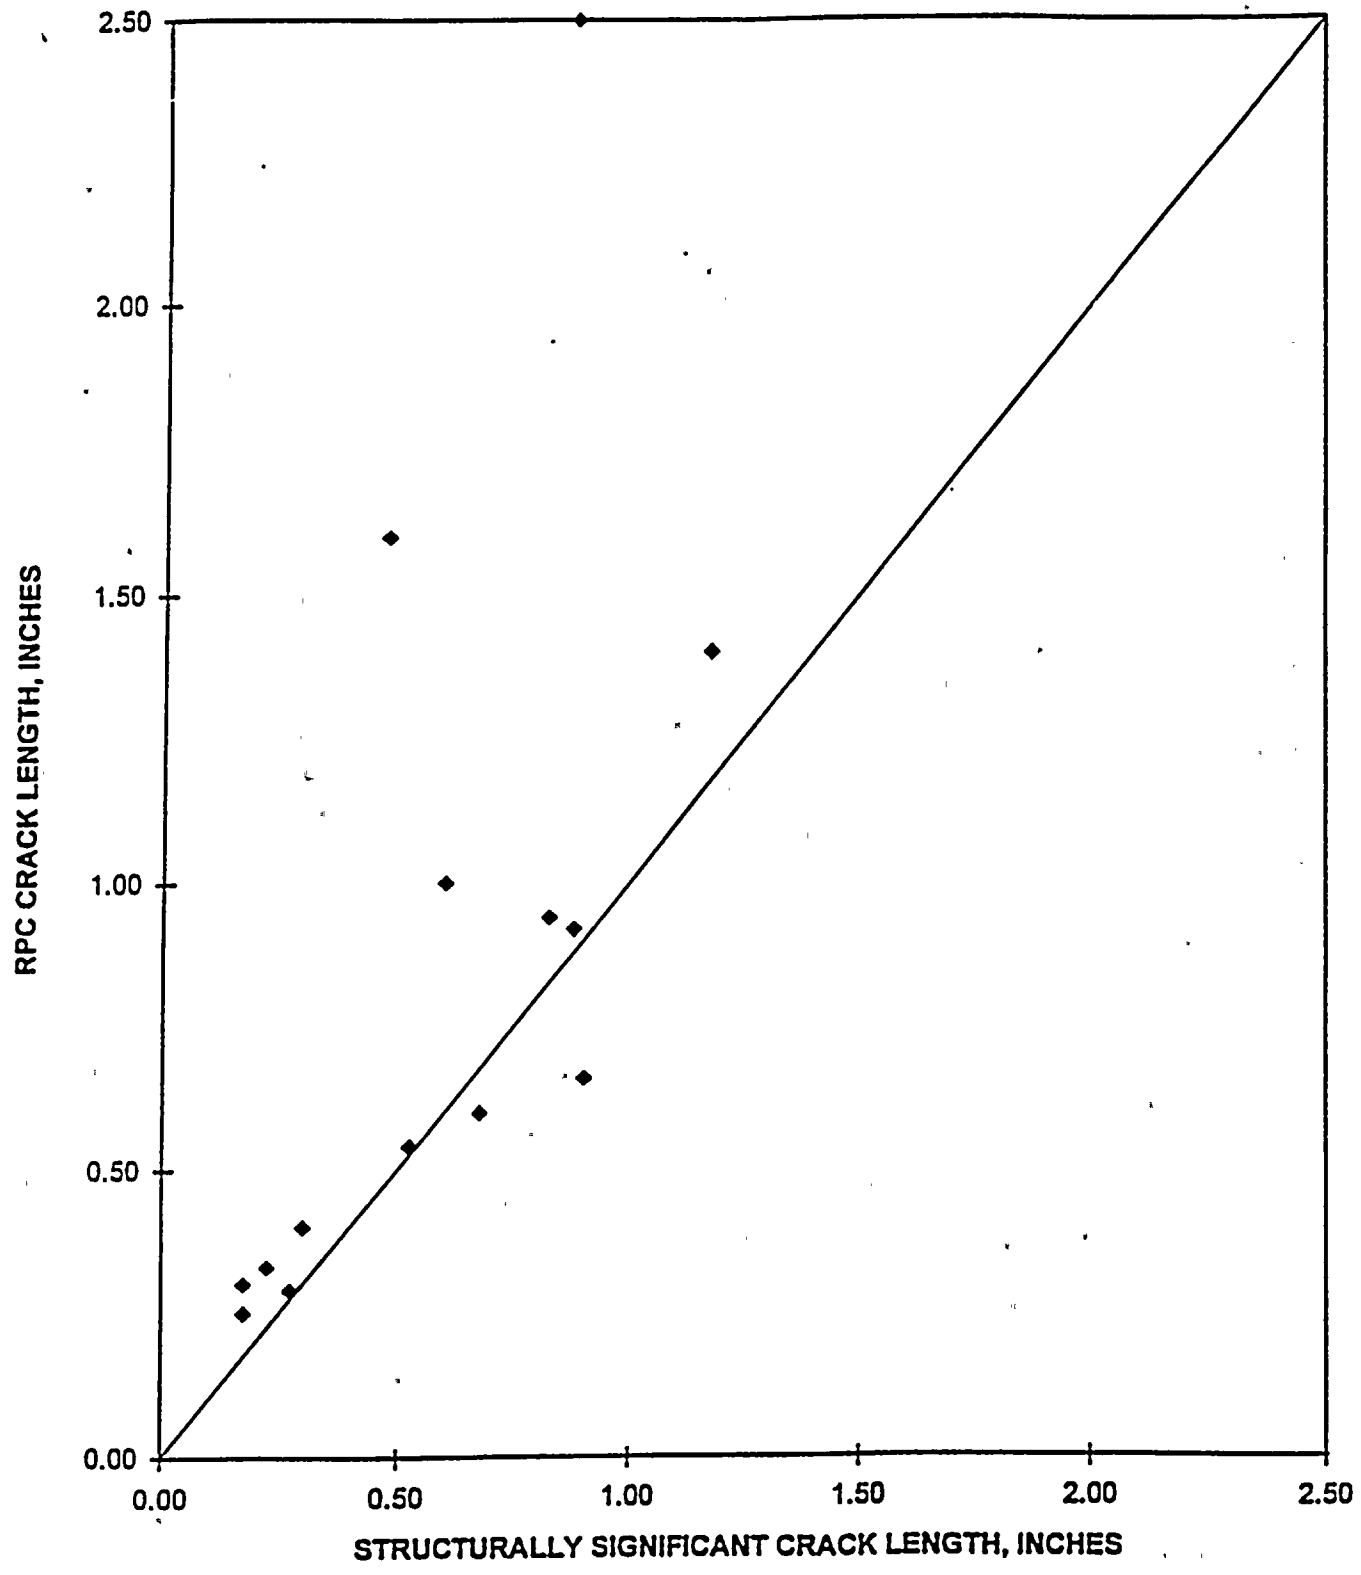
Figure 2. RPC Crack Length Versus Structurally Significant Crack Length, PVNGS Unit 2 Pulled Tube Data.

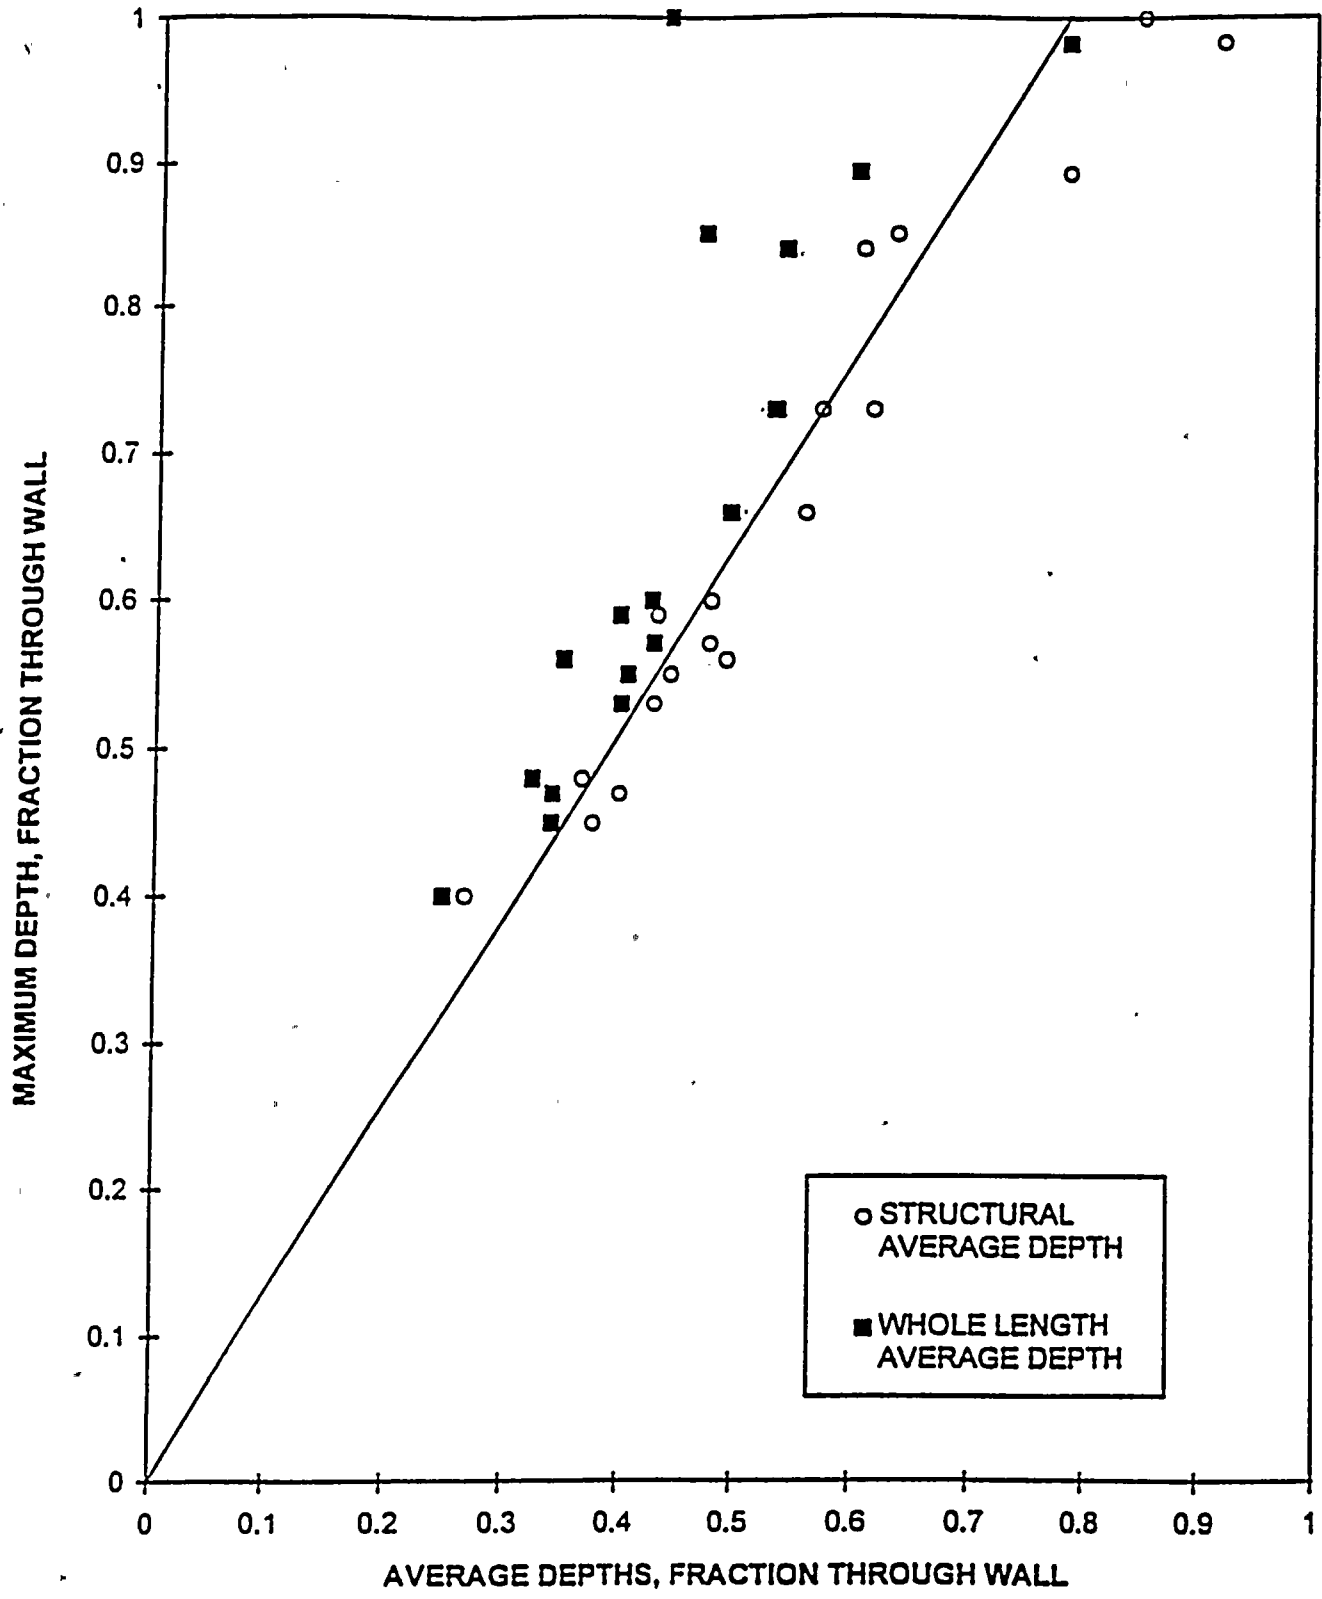
Figure 3. Maximum Crack Depth Versus Average Crack depth, PVNGS Unit 2 Pulled Tube Data.

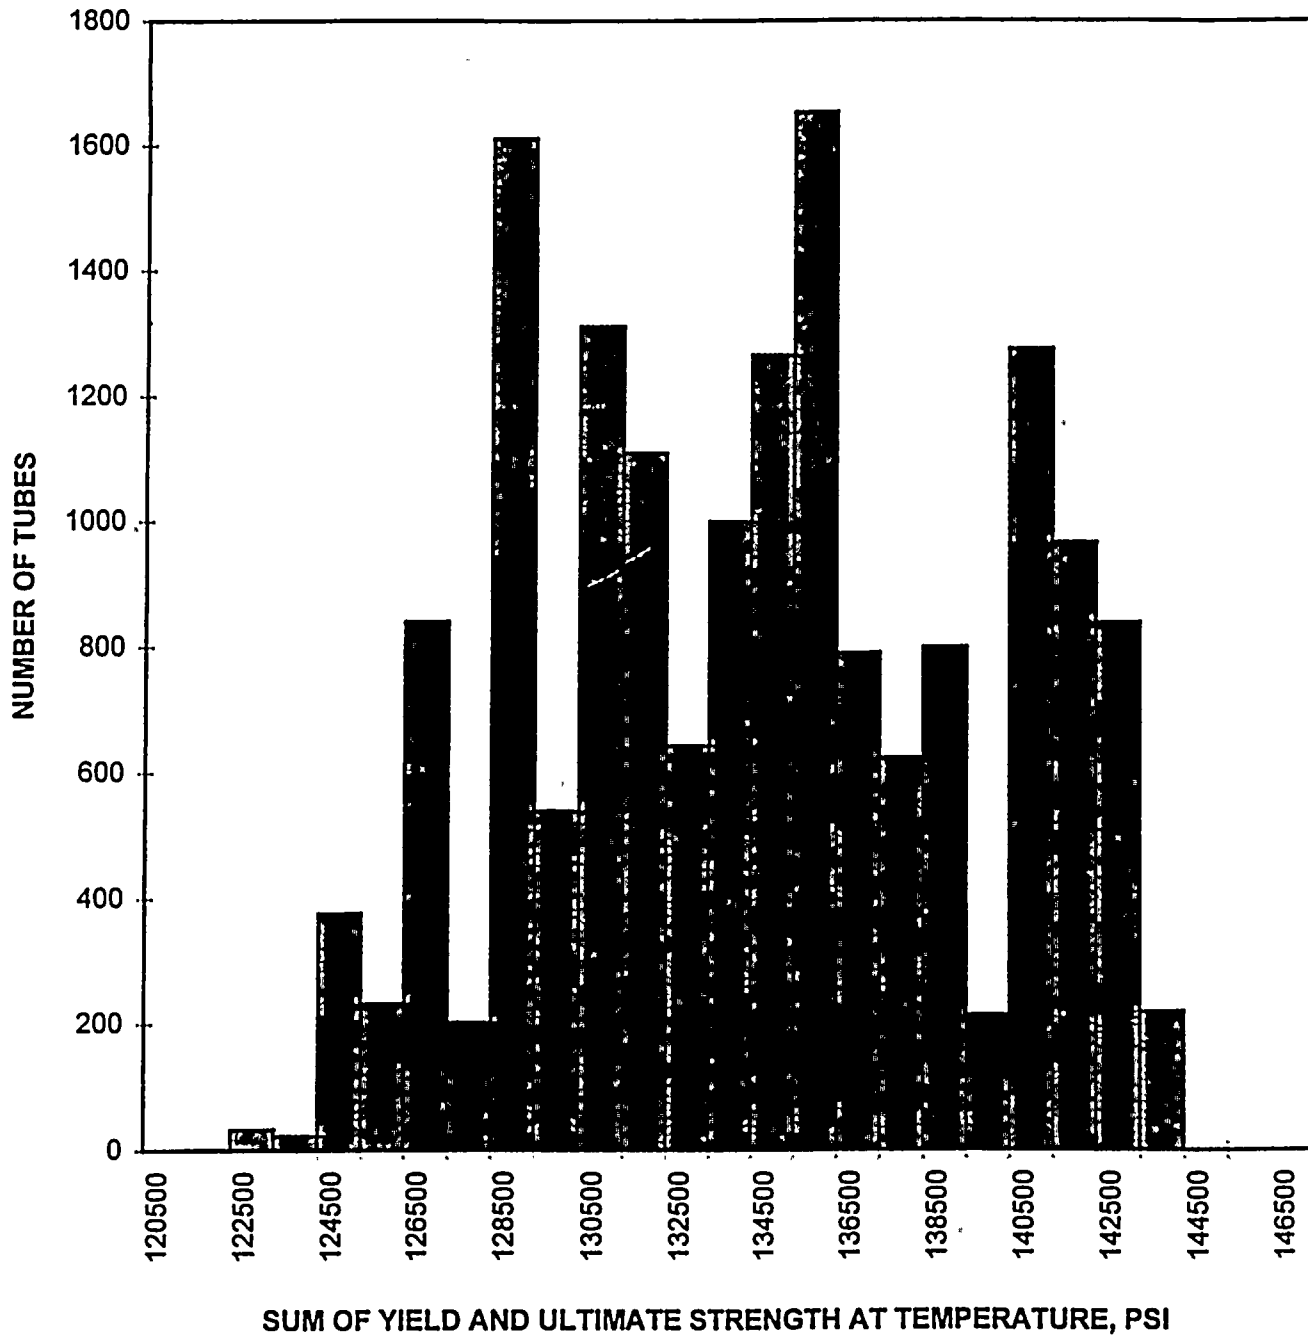
Figure 4, *Distribution of Sum of Yield and Ultimate Strengths of alloy 600 Tubing at Operating Temperature - ANO Unit 2*, is a histogram of these sums for Arkansas Nuclear One (ANO) Unit 2 which provides a good correspondence to St. Lucie Unit 1. Attachment A Figure 5, *Tube Flow Strength Distribution for Unit 2 Analysis*, and Attachment A Figure 6, *Palo Verde Unit 3 Tube Strength Distribution Function*, illustrate that other Combustion Engineering (CE) designed units have very similar lower tolerance limit mechanical properties. In fact the chosen lower tolerance limit value would be a reasonable choice for all Westinghouse, CE, and Babcock and Wilcox (B&W) steam generators.

Figure 4. Distribution of sum of Yield and Ultimate Strengths of Alloy 600 tubing at Operating Temperature, ANO Unit 2.

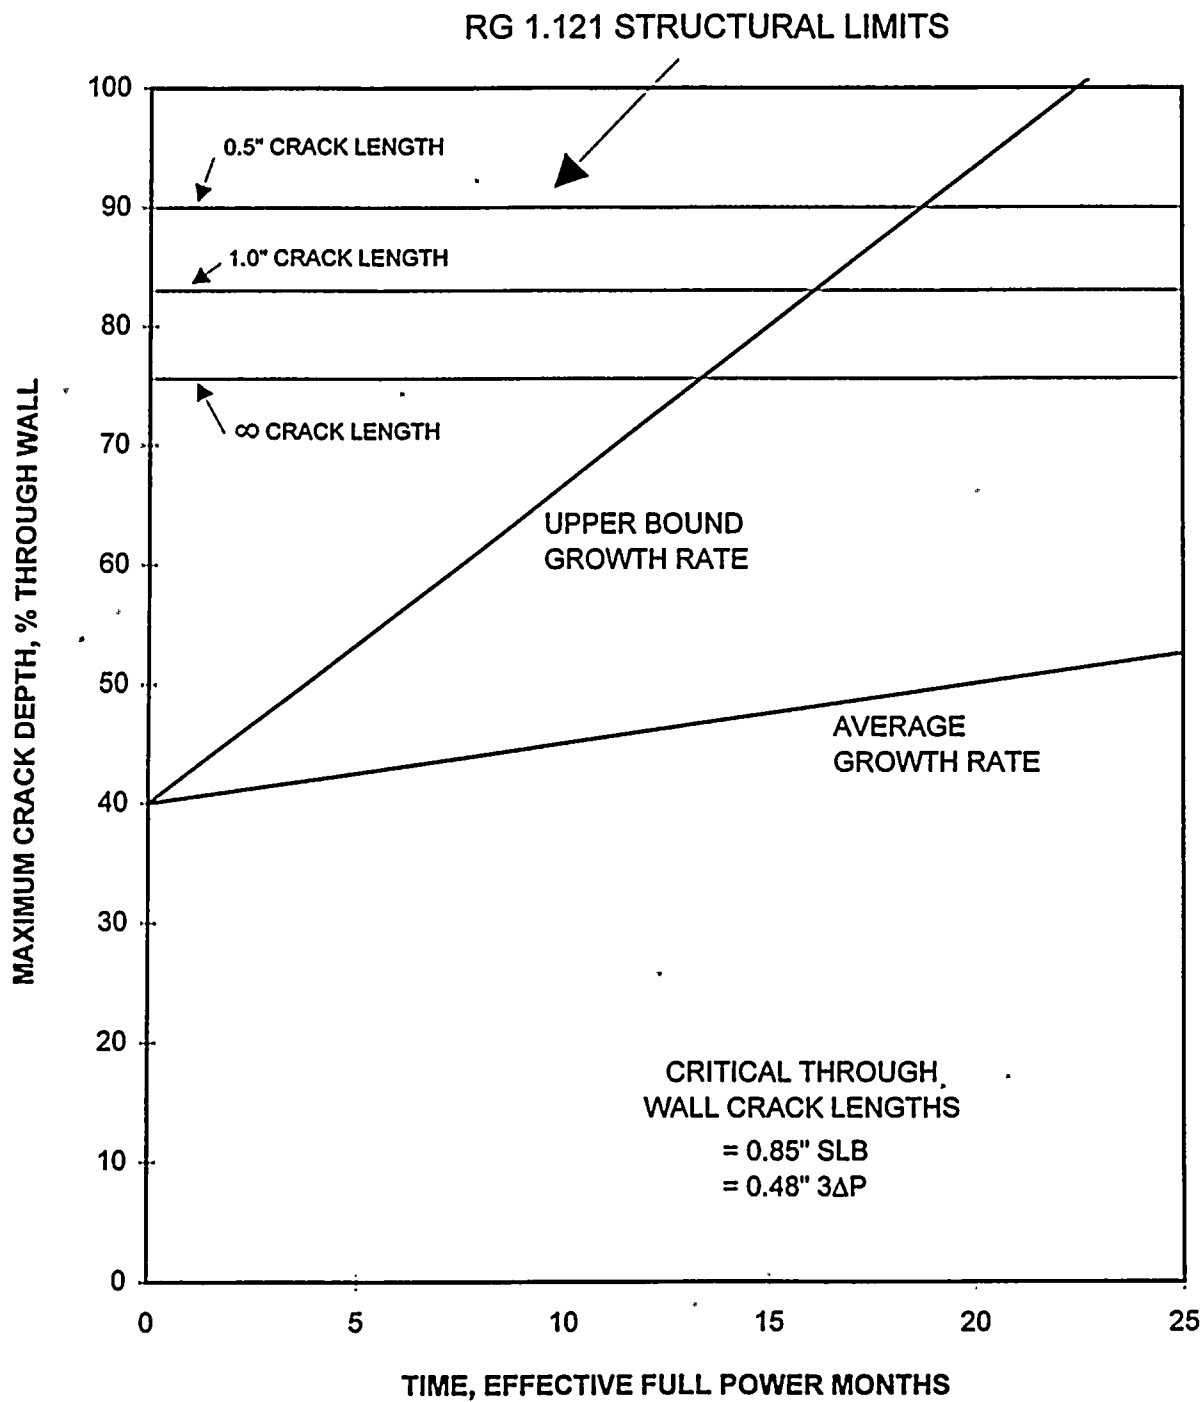
Attachment A Figure 7, *Preliminary Deterministic Analysis for St. Lucie Unit 1 - Axial Corrosion Degradation*, is a plot of maximum crack depth versus runtime. Regulatory Guide 1.121 structural limits on maximum crack depth for St. Lucie are shown for different crack lengths using lower tolerance limits mechanical properties. Projected depth versus time is illustrated for both an average and a 95 percent upper bound growth rate, as determined from St. Lucie Unit 1 bobbin probe eddy current data. Finally, the through wall crack lengths meeting 3 times differential pressure and steam line break differential pressures are listed in a note on Attachment A Figure 7.

Figure 7. Preliminary Deterministic Analysis for St. Lucie Unit 1, Axial Corrosion Degradation.

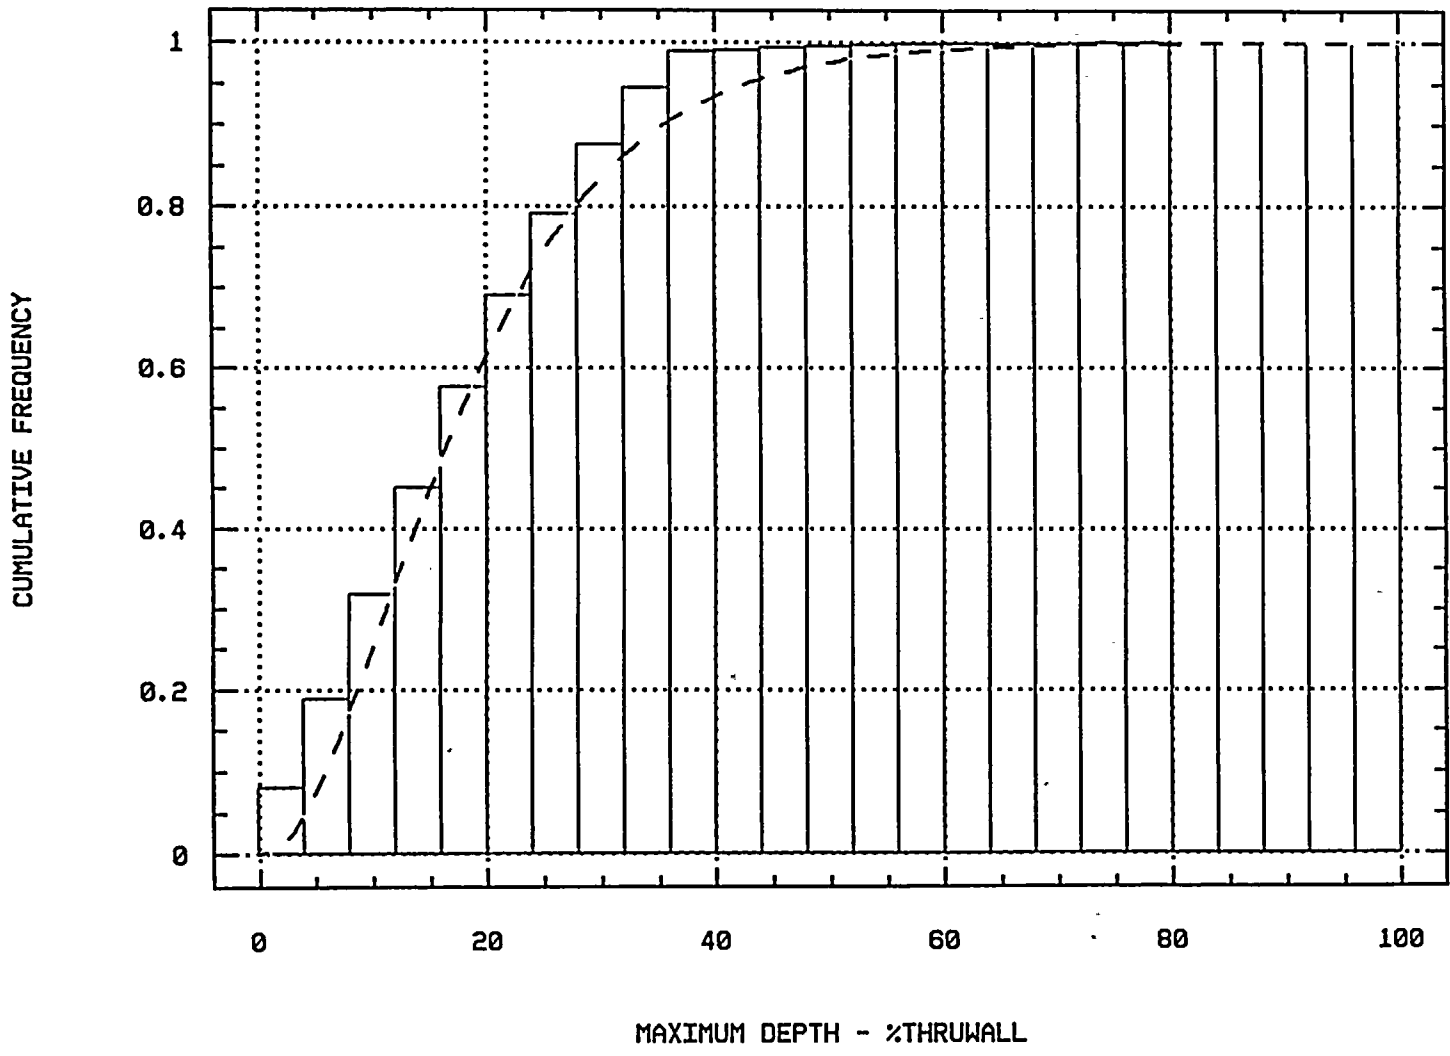
Figure 1.

The distribution of defects for St. Lucie Unit 1 is given in Attachment B Figure 1, *PSL-1 Distribution of Indication Maximum Depths*. The data is from bobbin coil inspection during the current refueling outage (SL1-14) and consists of more than 17000 data points from both steam generators. The upper 95 percent probability/confidence value for this data is less than 40 percent through wall.

PSL-1 DISTRIBUTION OF INDICATION MAXIMUM DEPTHS

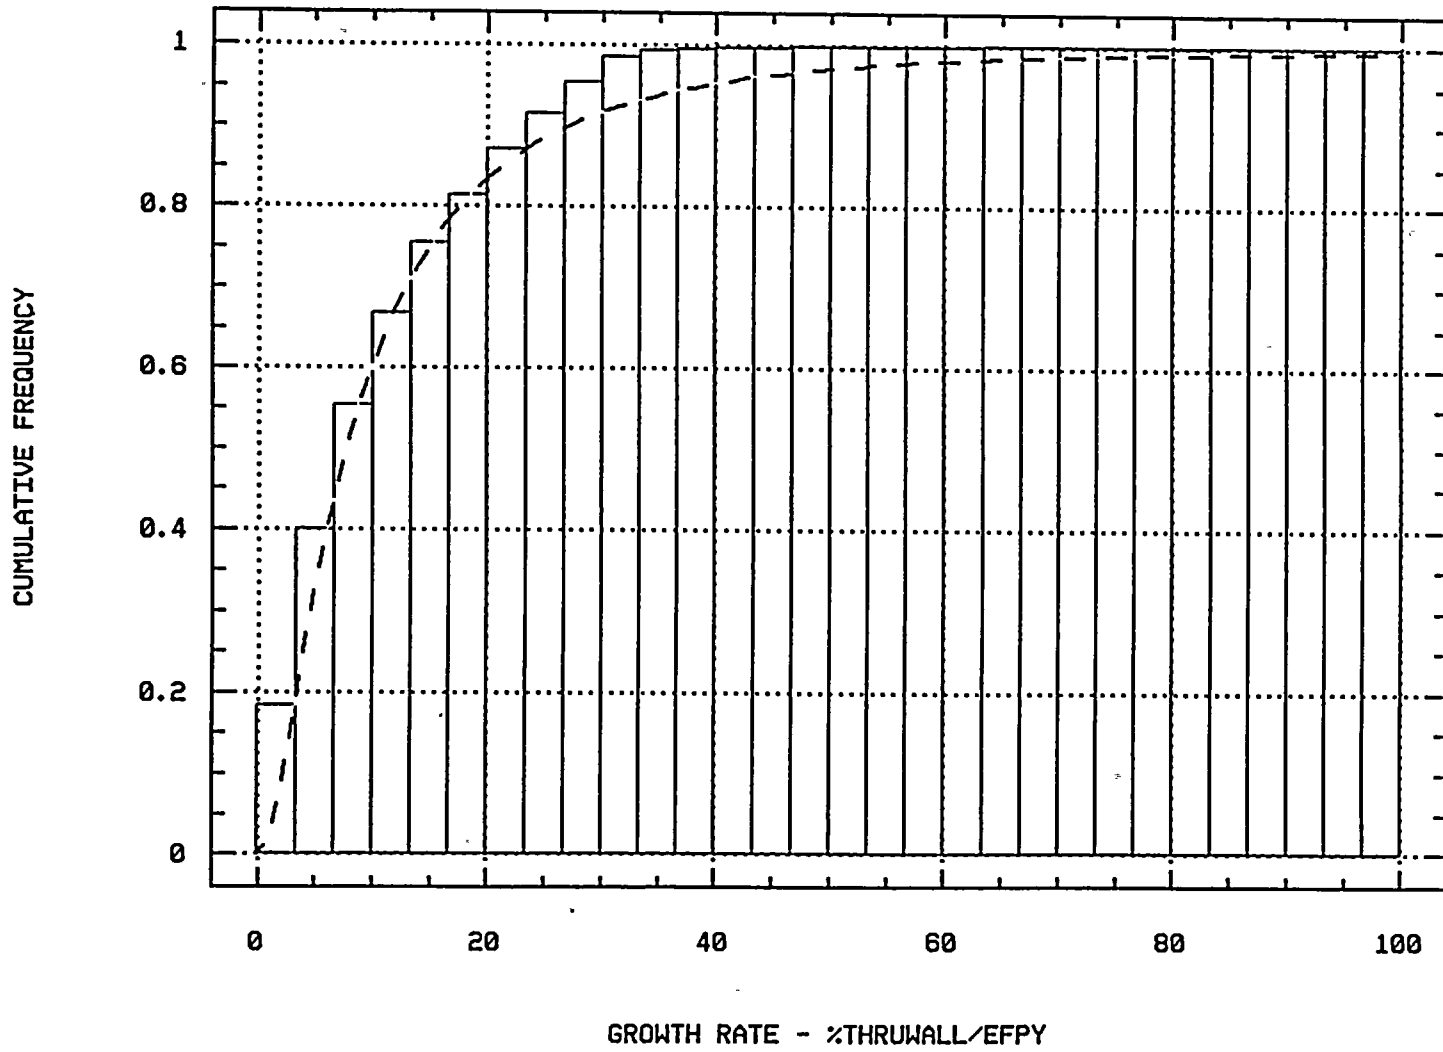
Figure 2.

The distribution of defect growth rates for the St. Lucie Unit 1 bobbin data is given in Attachment B Figure 2, *PSL-1 Distribution of Indication Growth Rates*. The upper 95 percent probability/confidence value for this data is less than 32 percent through wall/EPFY.

PSL-1 DISTRIBUTION OF INDICATION
GROWTH RATES

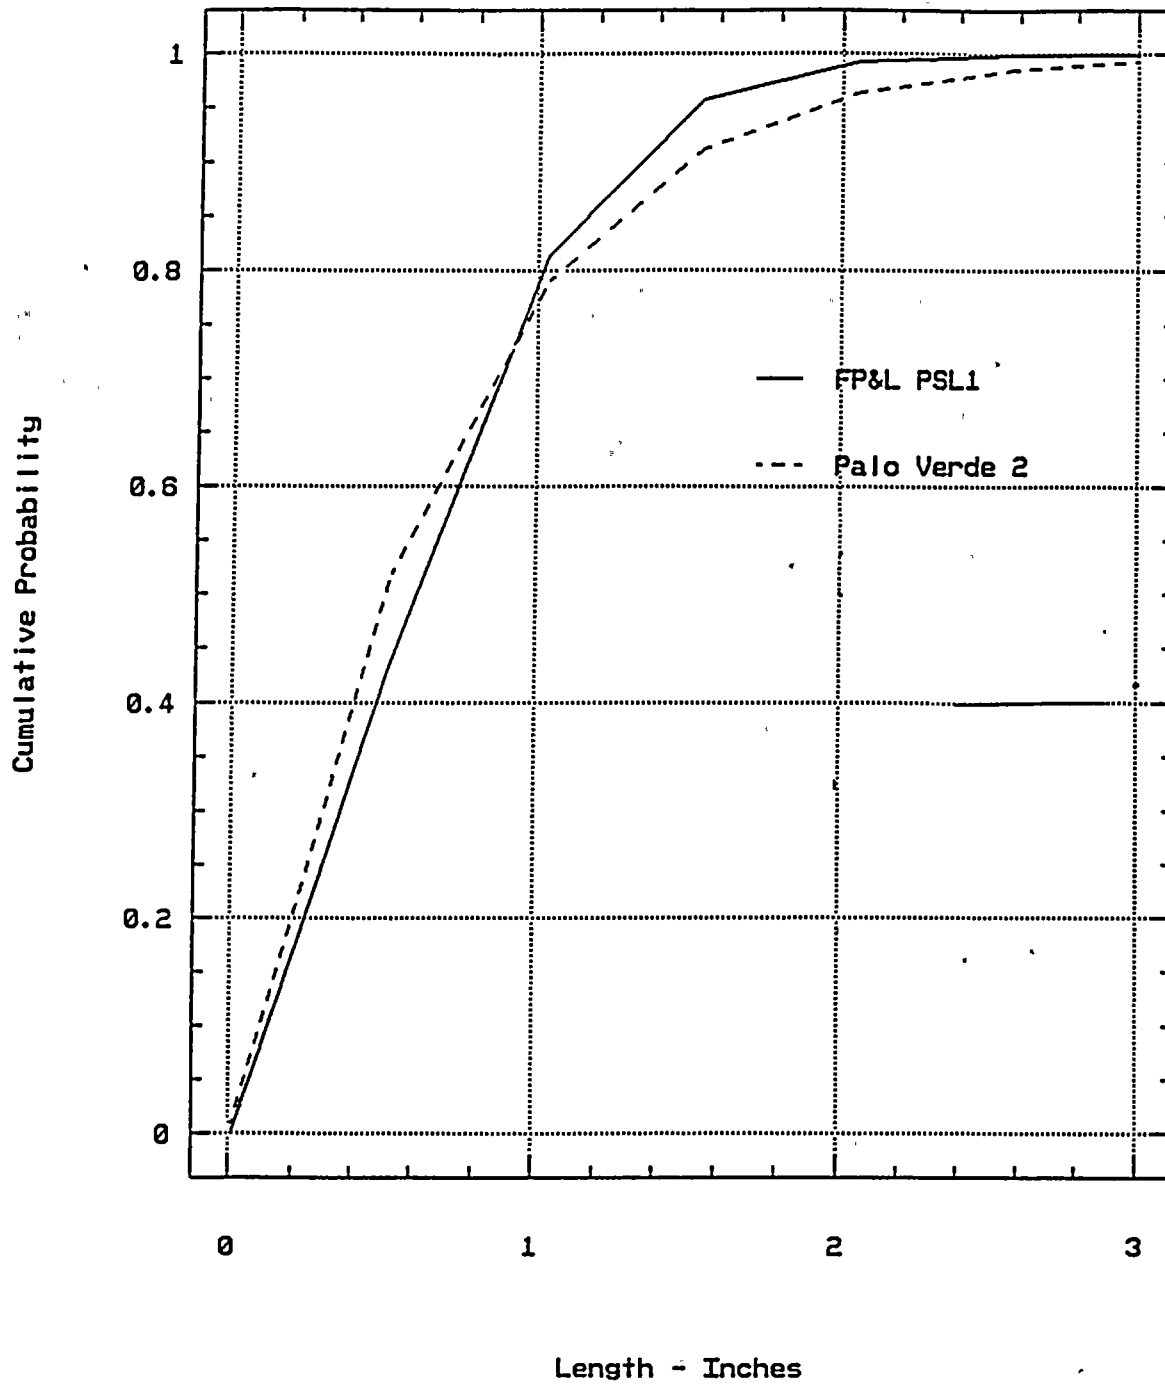
Figure 3.

The defect length distribution for the more limited size rotating pancake coil (RPC) data set is given in Attachment B Figure 3, *Comparison of PSL1 Crack Lengths with Palo Verde Unit 2 Crack Lengths*, and compared with the length distribution (RPC) obtained for PVNGS Unit 2. The distributions for the two plants are comparable.

Comparison of PSL1 Crack Lengths with
Palo Verde Unit 2 Crack Lengths

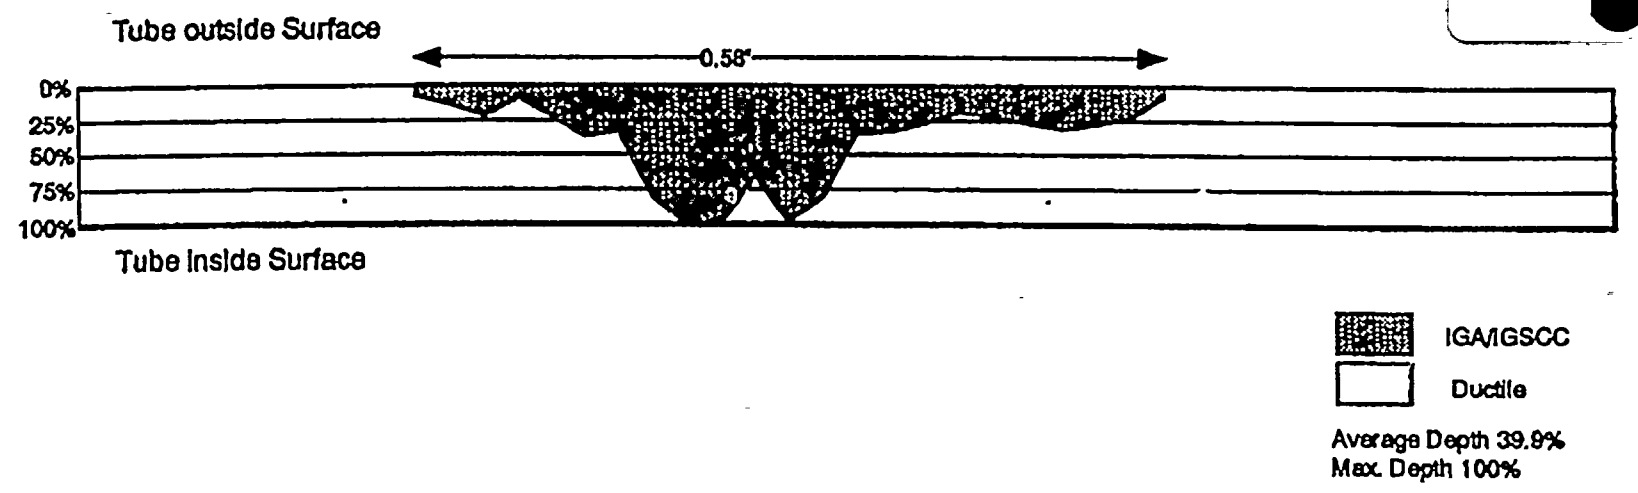
Figure 10-18 shows a portion of the burst face of Tube R127L140 Section 13. The figure shows the cracking extending to the outer surface of the tube. Cracking is intergranular and was branched. No transgranular cracking was evident. In this particular location there was no evidence of elongated grains near the outer surface.

Figure 10-29. Steam Generator 22 Tube R127L140 Section 13 Burst Face Crack Depth Diagram.

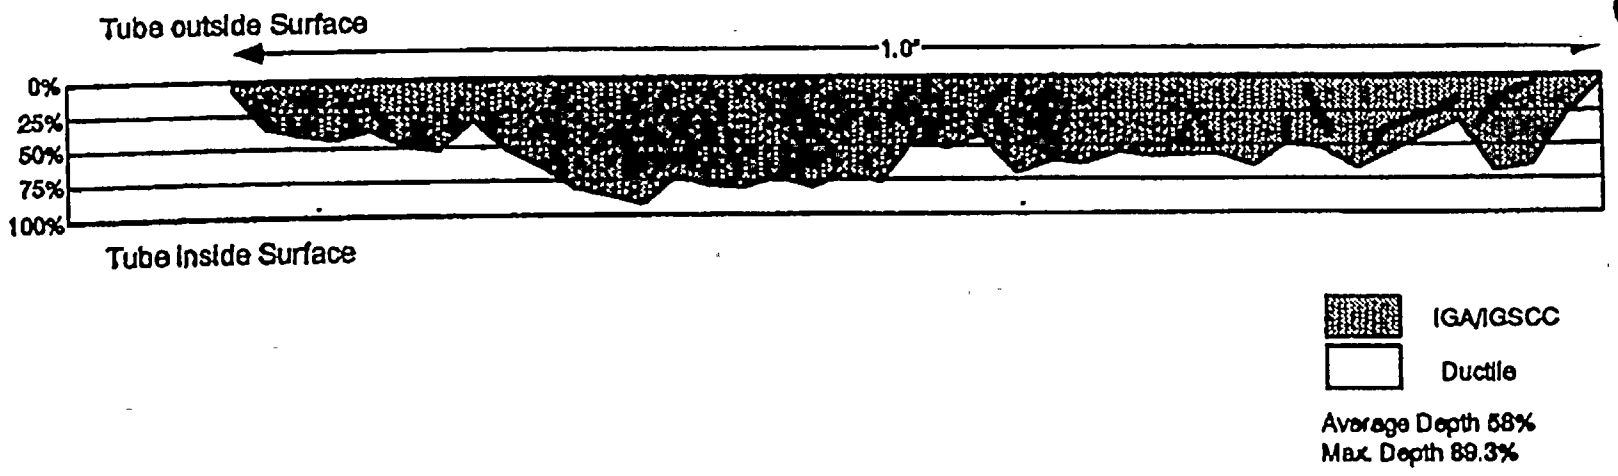
The portion of Tube R127L140 that contacted the 08H support (Section 15) also experienced intergranular corrosion. This section was burst tested, sectioned and then examined by SEM. The corrosion in this section was similar, but not as deep as that of the 07H support. The maximum penetration (%TW) was 89.3 and the average penetration (%TW) was 58.0. Also smeared grains were not seen on this sample. Cracking was similar to the cases presented earlier; cracking was OD initiated, intergranular, with no signs of transgranular cracking, branching can be seen from the main crack and there were numerous ligaments on the burst crack.

Figure 10-30. Steam Generator 22 Tube R127L140 Section 15 Burst Face Crack Depth Diagram.
