SUBJECT: LER 96-007-00:on 960607,inadvertent start of 1B Emergency Diesel Generator (EDG).Caused by procedural inadequacy. Reset Containment Isolation Actuation Signal,restored 1B3 4160 Volt bus & unloaded & secured EDG.W/960708 ltr.

Re: St. Lucie Unit 1
Docket No. 50-335
Reportable Event: 96-007
Date of Event: May 14, 1996
Inadvertent Start of the 1B Emergency Diesel Generator
During "B" Channel Containment Isolation Actuation Signal
Testing due to Procedural Inadequacy.

Inadvertent Start of the 1B Emergency Diesel Generator During "B" Channel Containment Isolation Actuation Signal Testing Due to Procedural Inadequacy.

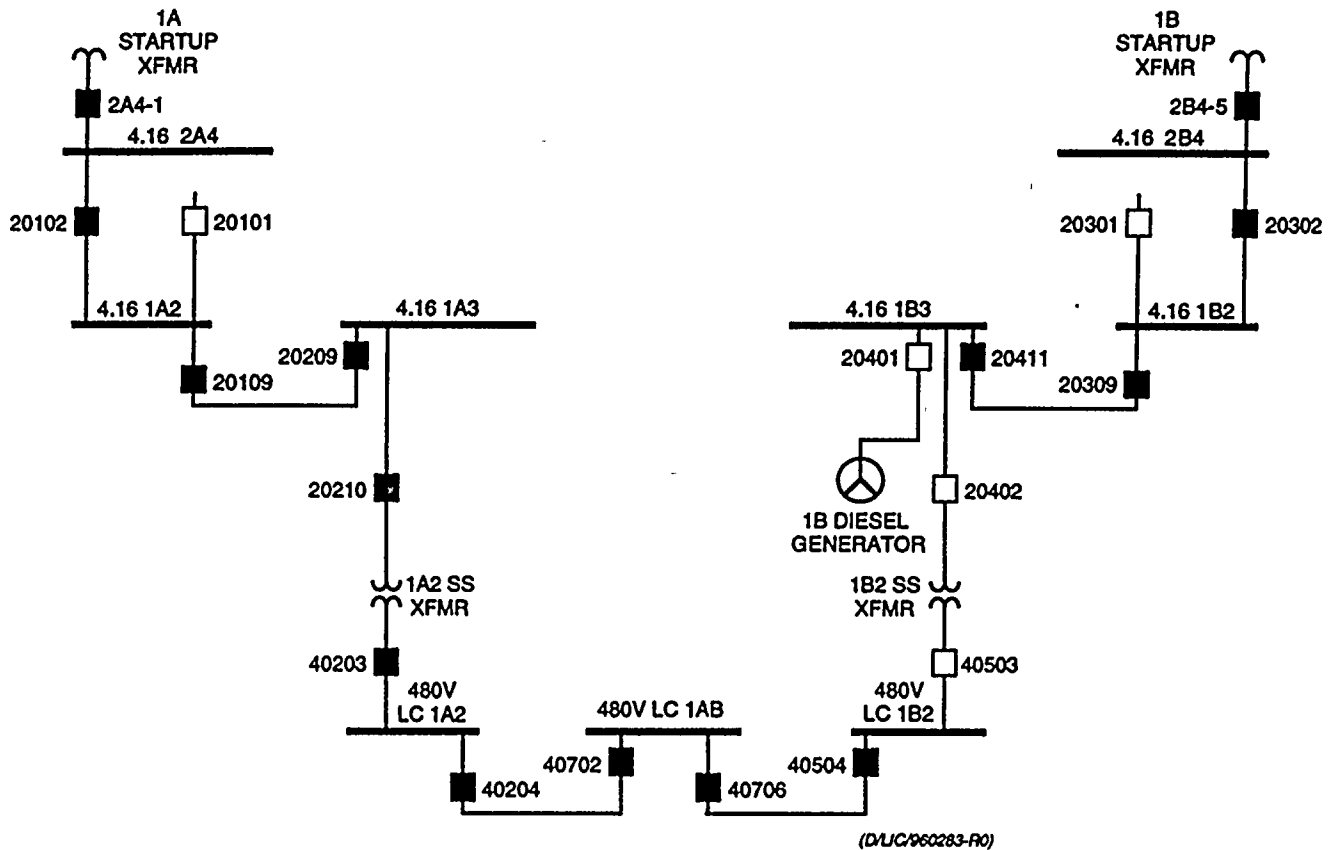
Figure 1

The 1B2 480 Volt load center (EIS:EC) was electrically cross-tied to the "A" electrical train (EIS:EC) (see Figure 1) in accordance with OP 1-0910024 "Cross-tying/Removal/Restoration of 480 Volt Busses". This alignment allowed continued operation of "B" side auxiliary components during previous maintenance activities performed on the 1B3 4160 Volt bus (EIS:EA). The 1B3 4160 Volt bus is the normal supply for the 1B2 480 Volt bus. The 1B3 4160 Volt bus was energized from offsite power through the 1B startup transformer (EIS:EA) in preparation for returning the entire "B" train electrical to service.
