Re: St. Lucie Unit 1
Docket No. 50-335
Reportable Event: 96-008
Date of Event: June 8, 1996
Inadvertent Actuation of the Safety Injection Actuation
Signal and Containment Isolation Actuation Signal Due to
Loss of the 15 VDC Regulated Power Supply During Maintenance.

ST LUCIE UNIT 1

Inadvertant Actuation of the Safety Injection Actuation Signal and Containment Isolation Actuation Signal Due to Loss of the 15 VDC Regulated Power Supply During Maintenance.

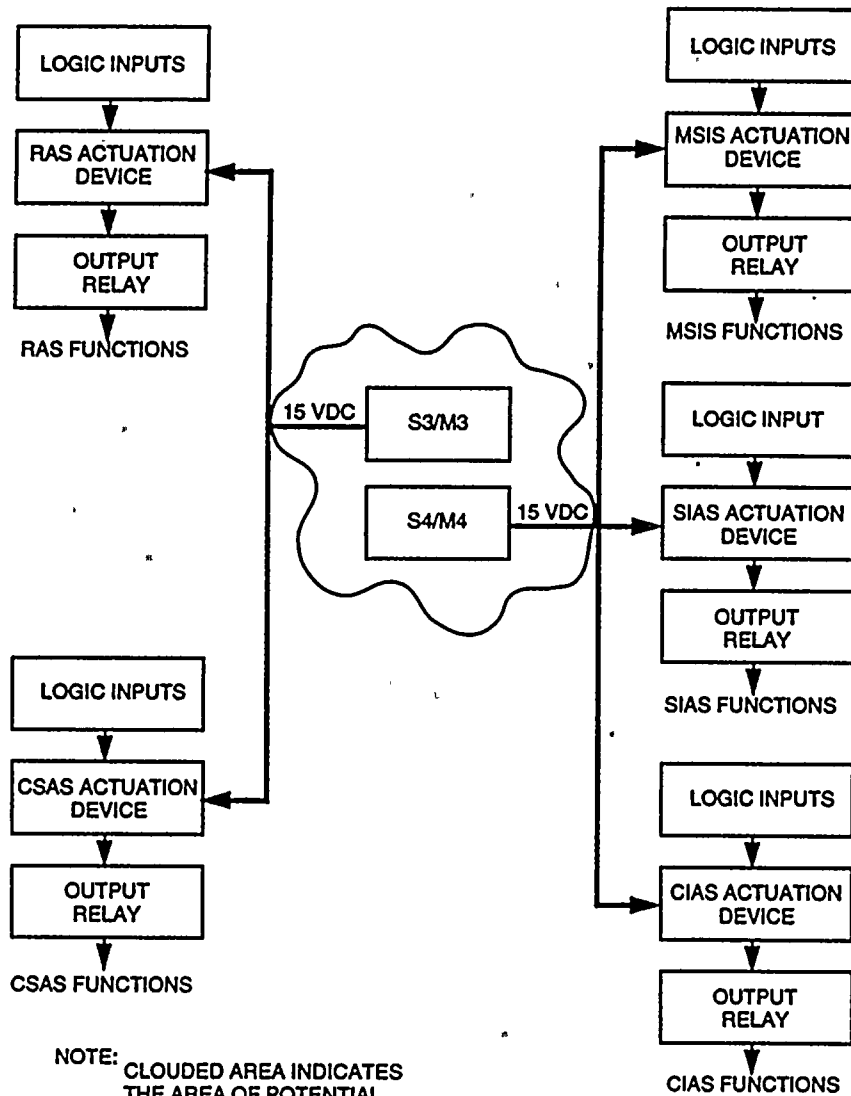
FIGURE 1

The ERT determined that the spurious channel B SIAS and CIAS actuation was a direct result of the maintenance activity (i.e., a result of the S3/M3 power supply failure) and not due to a coincident external event. The vendor manual drawings indicate that the S3/M3 power supply is associated with CSAS and RAS, therefore, loss of the S3/M3 power supply would not be expected to result in a SIAS or CIAS. Because a loss of the S3/M3 power supply did result in SIAS/CIAS, it is apparent that the field wiring configuration of this power supply differs from the vendor technical manual drawings (Figure 1 illustrates the documented power supply configuration). This difference would not affect the safety function of the CIAS circuits required in Mode 6, but does represent a configuration control issue and therefore involves an impact on maintenance activities. A visual inspection of the ESFAS cabinet wiring was made. A work order has been initiated to perform the testing and trouble shooting necessary to resolve the apparent wiring discrepancies. The results of this testing will be included in a supplement to this LER. The supplemental LER will also address the cause of the configuration discrepancies.

The S3/M3 power supply apparently failed during reinstallation of the A10 card. The reason why failure of the S3/M3 power supply resulted in a spurious SIAS/CIAS is still under investigation. The subsequent actuation of the B channel SIAS and CIAS components occurred as designed. The power supply wiring discrepancies found would not compromise the function of any engineered safety feature actuation under design bases assumptions and therefore, were not apparent during previous ESFAS testing. The B train ESF equipment was out of service and the Technical Specification required equipment was supplied from the A electrical train. There was no interruption to any equipment on the A electrical train. The unit was shutdown at the time of the event and the root cause and corrective actions will be completed prior to entering mode 4. Therefore the health and safety of the public were not adversely affected.

SIMPLIFIED 15 VDC POWER SUPPLY INPUTS TO ESFAS ACTUATION LOGIC

NOTE: CLOUDED AREA INDICATES THE AREA OF POTENTIAL WIRING CONFIGURATION DISCREPANCIES

- A. A preliminary design review and visual inspection of the ESFAS cabinet was conducted. No additional anomalies (e.g., incorrect connections, damaged wires) were detected.
- B. Additional testing is being conducted to determine why the power supply failed and why failure of the S3/M3 power supply resulted in SIAS/CIAS actuation. This testing will also resolve the apparent configuration discrepancies. The results of this testing will be used to determine the additional corrective actions required. This testing and corrective action will be completed prior to the unit entering mode 4.
