SUBJECT: LER 96-008-01: on 960703, inadvertent actuation of safety injection actuation signal & containment isolation signal occurred due to loss of 15 VDC regulated power supply during maint. Design review performed. W/960731 ltr. ooting W/960731.

Re: St. Lucie Unit 1
Docket No. 50-335
Reportable Event: 96-008 Supplement 1
Date of Original Event: June 8, 1996
Date of Subsequent Event: July 3, 1996
Inadvertent Actuation of the Engineered Safety
Features Actuation System During Maintenance

Inadvertent Actuation of the Safety Injection Actuation Signal and Containment Isolation Actuation Signal Due to Loss of the 15 VDC Regulated Power Supply During Maintenance.

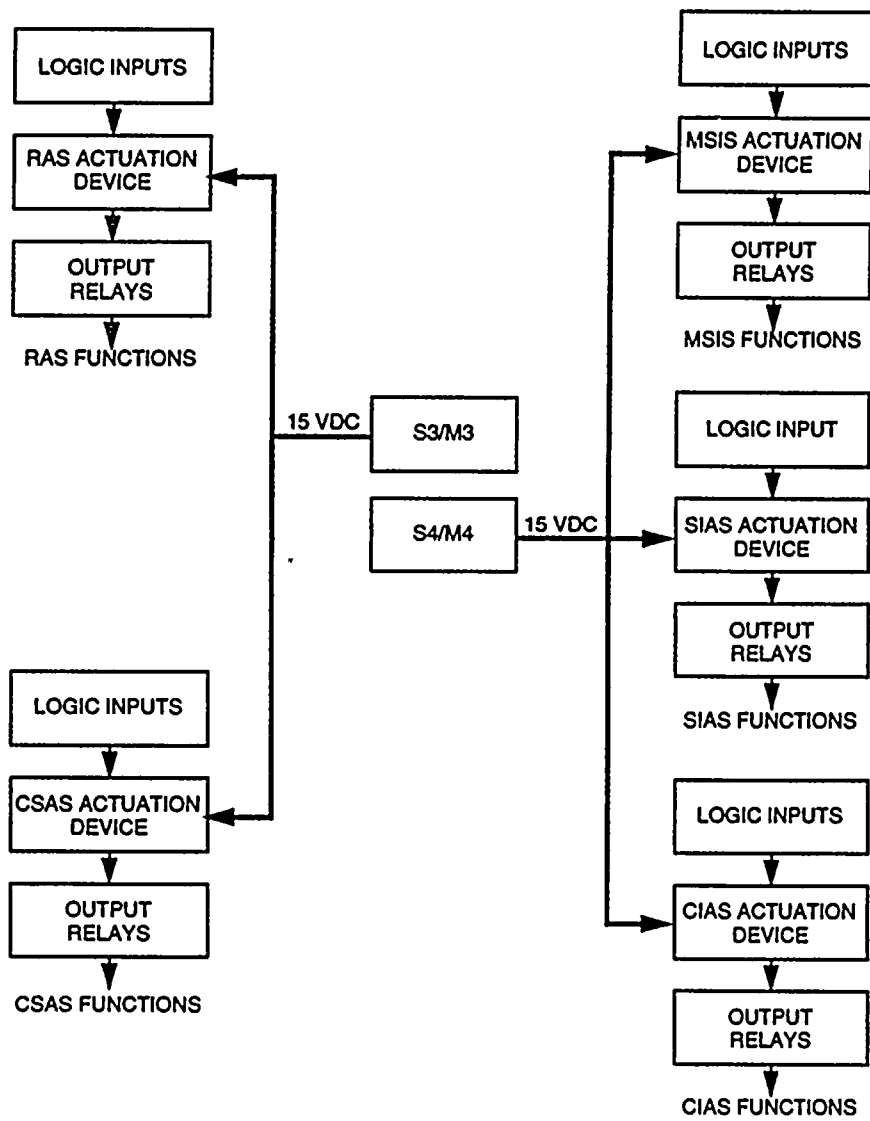
FIGURE 1

Review of vendor manual drawings, during troubleshooting, indicated that the 15 volt dc power supply (S3/M3) should have been associated with CSAS and RAS functions and not with the SIAS or CIAS function. Troubleshooting activities were stopped at this point and an event response team (ERT) was formed.

SIMPLIFIED 15 VDC POWER SUPPLY INPUTS TO ESFAS ACTUATION LOGIC
(DESIGN CONFIGURATION)

- B. The ESFAS cabinet channel A and B power supply configuration was restored to original design and tested prior to return to service.
- C. An action item has been issued to Engineering to add precautions and explanations to the vendor manual and Design Basis Documents regarding the failure mode of the energize to actuate circuits on a loss of a 15 vdc power supply when 24vdc power is available.

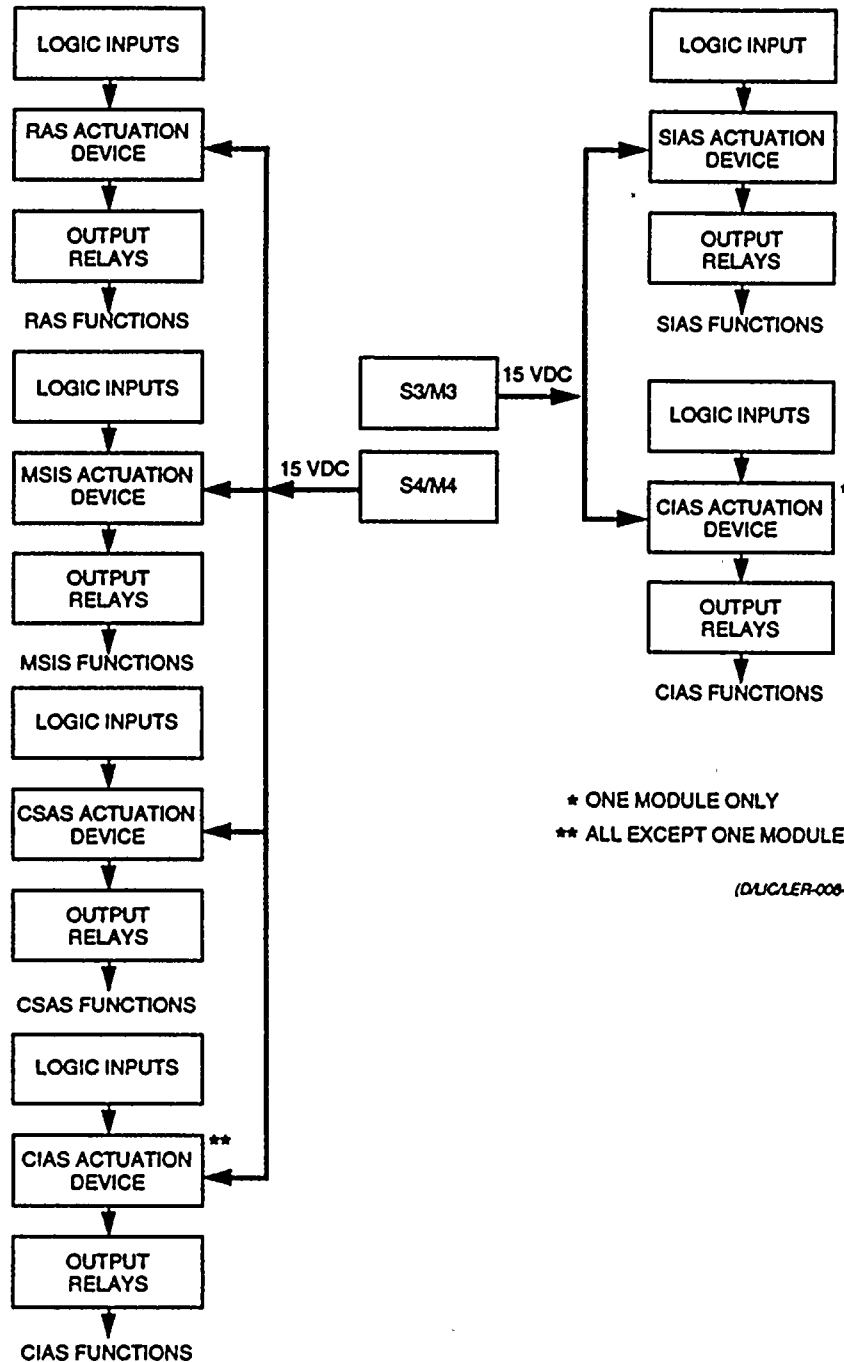
FIGURE 2

The channel B SIAS and CIAS actuation was a direct result of the maintenance activity (i.e., a result of the S3/M3 power supply failure) and not due to a coincident external event. The ESFAS cabinets contain two 15 vdc (auctioneered S3/M3 and auctioneered S4/M4) and two 24 vdc power supplies. The 15 vdc supplies power the logic circuits and the 24 vdc supplies power the actuation relays. According to the vendor manual drawings, the S3/M3 power supply is associated with CSAS and RAS, therefore, loss of the S3/M3 power supply would not be expected to result in a SIAS or CIAS. Because a loss of the S3/M3 power supply did result in SIAS/CIAS, it was apparent that the field wiring configuration of this power supply differed from the vendor technical manual drawings (Figure 1 illustrates the documented/design power supply configuration). The actual as-found field wiring condition was later determined to be as shown in Figure 2. In this configuration, the S3/M3 supply powers SIAS and one module of CIAS; and the S4/M4 supply powers the other seven modules of CIAS, CSAS, RAS, and MSIS. This difference was a vendor configuration issue only, and did not affect the safety function of the CIAS circuits.

The S3/M3 power supply failed during reinstallation of the A10 card as a result of an electrical short or transient. Failure of the S3/M3 power supply resulted in a SIAS and partial CIAS, because the logic circuits for SIAS and one module of CIAS were powered from this supply, contrary to the vendor manual drawings. The subsequent actuation of the B channel SIAS and CIAS components occurred as designed. The power supply wiring discrepancies found would not compromise the function of any engineered safety feature actuation under design bases assumptions and therefore, were not apparent during previous ESFAS testing. The B train ESF equipment was out of service and the Technical Specification required equipment was supplied from the A electrical train. There was no interruption to any equipment on the A electrical train. The unit was shutdown at the time of the event.

SIMPLIFIED 15 VDC POWER SUPPLY INPUTS TO ESFAS ACTUATION LOGIC
(FIELD CONFIGURATION)

* ONE MODULE ONLY
** ALL EXCEPT ONE MODULE
